BOSTON EDISON

Pilgrim Nuclear Power Station
Rocky Hill Road
Plymouth, Massachusetts 02360

The enclosed Licensee Event Report (LER) 94-007-00, "Primary Containment Pressure Boundary Degraded due to Uninstalled Instrument Plug", is submitted in accordance with 10 CFR Part 50.73.

FACILITY NAME (1) PILGRIM NUCLEAR POWER STATION						DOCKET NUMBER (2) 05000 - 293			PAGE (3) 1 of 12					
TITLE (4) Primary Containment Pressure Boundary Degraded due to Uninstalled Instrument Plug														
EVENT DATE (5)			LER NUMBER (6)			REPORT DATE (7)			OTHER FACILITIES INVOLVED (8)					
MONTH	DAY	YEAR	YEAR	SEQUENTIAL NUMBER	REVISION NUMBER	MONTH	DAY	YEAR	FACILITY NAME	DOCKET NUMBER				
12	28	94	94	007	00	01	27	95	N/A	05000				
OPERATING MODE (9) N			THIS REPORT IS SUBMITTED PURSUANT TO THE REQUIREMENTS OF 10 CFR §: (Check one or more) (11)											
POWER LEVEL (10) 100			20.402(b)			20.405(c)			50.73(a)(2)(iv)

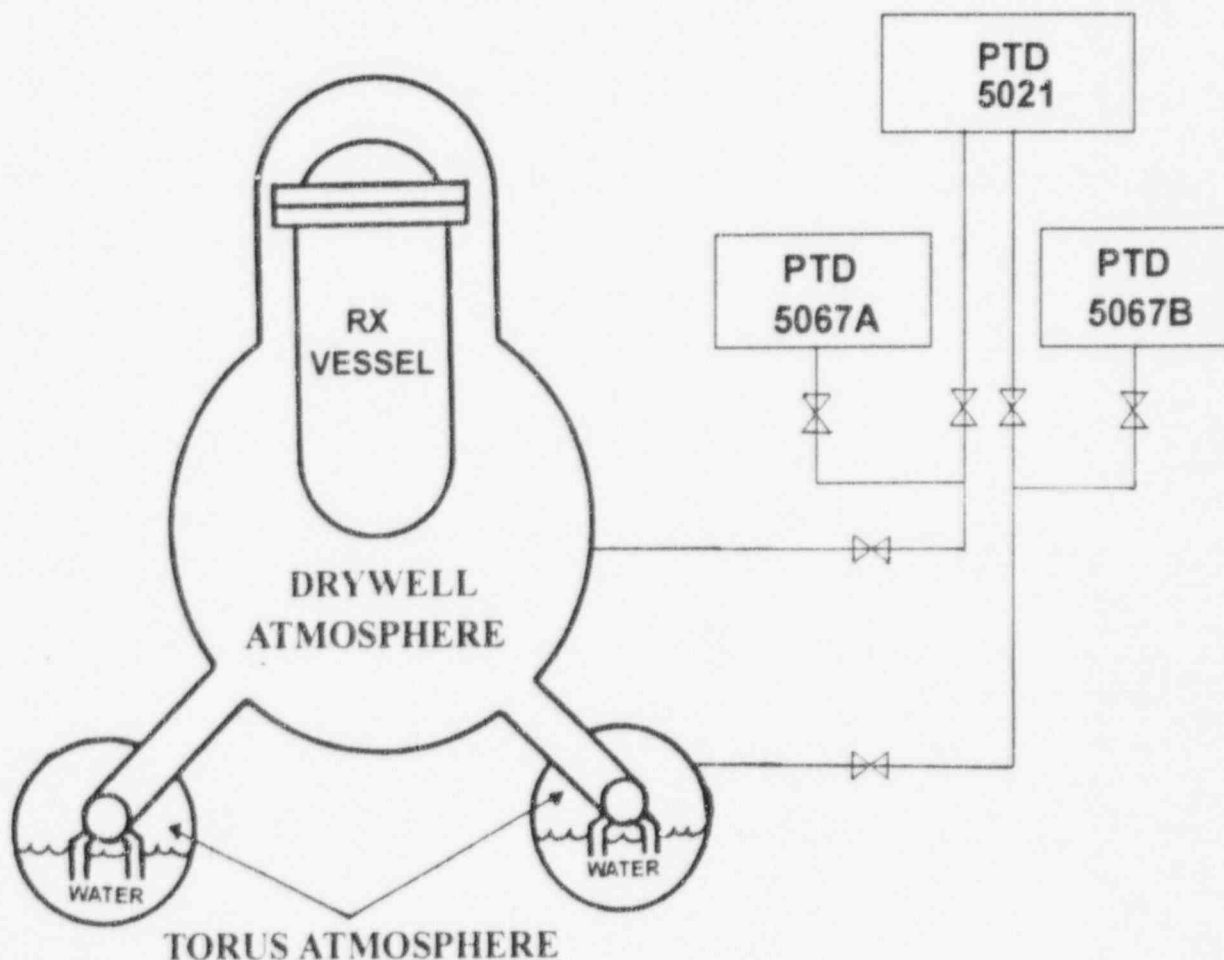
**SIMPLIFIED SKETCH OF DRYWELL-TORUS
ATMOSPHERE PRESSURE TRANSMITTERS**

The instrumentation that monitors the Drywell atmosphere pressure includes PTD/PID-5067A. The instrumentation that monitors the Torus atmosphere pressure includes PTD/PID-5067B. The instrumentation that monitors the Drywell-to-Torus atmosphere differential pressure includes PTD/PID-5021. Transmitters PTD-5021, PTD-5067A and PTD-5067B are located on Panel C-88 and were manufactured by the Foxboro Company (Model E13DM). The E13 series transmitters operate on the force-balance principle. In operation, a difference in pressure between the high pressure side and low pressure side of the transmitter is sensed and converted to a signal sent to a pressure indicating instrument (e.g., PID-5021). The sensing cell is mounted in the transmitter's manifold that is equipped with high and low pressure connections, vent and drain plugs. For PTD-5021, the Drywell atmosphere is connected to the high pressure side of the transmitter, and the Torus atmosphere is connected to the low pressure side of the transmitter. For PTD-5067A, the Drywell atmosphere is connected to the high pressure side of the transmitter, and the Reactor Building atmosphere is introduced into the low pressure side of the transmitter. For PTD-5067B, the Torus atmosphere is connected to the high pressure side of the transmitter, and the Reactor Building atmosphere is introduced into the low pressure side of the transmitter. Located at the end of this report is a simplified sketch depicting the Drywell, Torus, and transmitters PTD-5067A, PTD-5067, and PTD-5021.

On December 28, 1994, at approximately 1040 hours, a plug on the Torus atmosphere portion of the Drywell-to-Torus atmosphere differential pressure transmitter DPT-5021 was discovered to be not installed.

- Instrument design and installation:
 - Transmitter PTD-5021 is located on Panel C-88 approximately 18"-24" above floor level. The low pressure side of PTD-5021 has two test plugs one of which is removed from the low pressure side of the transmitter for a calibration. The plug that is removed for a calibration is located on the bottom surface of the transmitter's manifold and, as such, is not readily visible without crouching or significant body adjustment.

- Transmitters PTD-5067A and PTD-5067B that are also calibrated as part of Procedure 8.M.2-6.2 Attachment 2 are also located on Panel C-88. Transmitters PTD-5067A and PTD-5067B are located side-by-side and approximately five feet above floor level. Since these transmitters measure Drywell atmosphere pressure and Torus atmosphere pressure relative to Reactor Building atmosphere pressure, one of the low pressure side plugs is not installed during operation. This configuration is different from that of PTD-5021 which requires both low pressure side (Torus atmosphere) plugs to be installed during operation.

Immediate corrective action taken consisted of the installation of a temporary, non-qualified, plug where the plug was not installed on PTD-5021. The temporary plug installed on PTD-5021 was replaced with a qualified plug on December 28, 1994 (via MR19403991) with PTD-5021 isolated for the replacement and returned to service after the replacement. The LCO (A94-236) was terminated at 1646 hours on December 28, 1994, following the installation of the qualified plug.

A modification document (FRN 95-04-05) was approved on January 20, 1995. The modification includes provision for installing additional tubing, fittings, and valves to the drain/calibration ports of transmitters PTD-5067A, PTD-5067B, and PTD-5021. The changes have been scheduled for implementation beginning in the first week of February 1995.
