Prairie Island Nuclear Generating Plant

Auto-Start of One Train of Auxiliary Building
Special Ventilation System on High Radiation
During Restoration of a Seal Water Return Filter

LICENSEE EVENT REPORT (LER)

TITLE (4) Auto-Start of One Train of ABSVS on High Radiation During Restoration of a Unit 2 Seal Water Return Filter

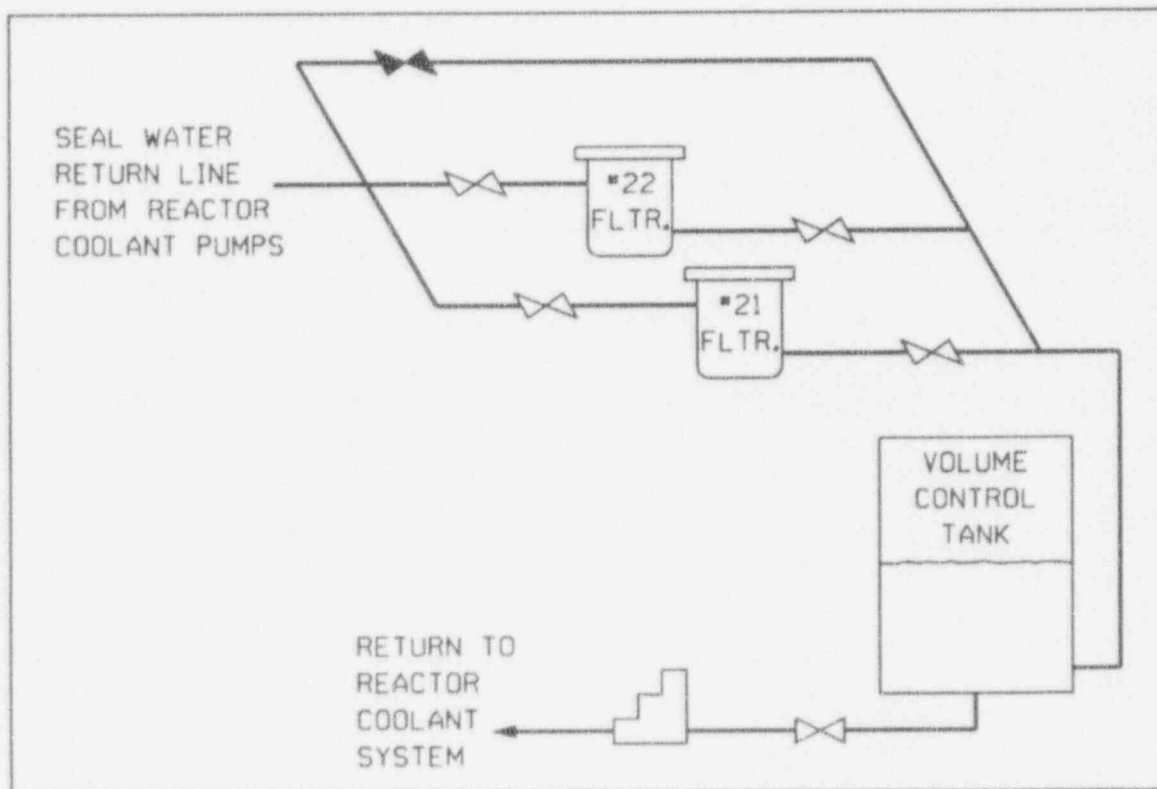
The filter is refilled by cracking open its inlet valve; displaced air escapes through the filter housing vent. Some gas is always released during the process since the filter is at atmospheric pressure when it is refilled, so dissolved gases come out of solution when the pressure of the fill fluid, reactor coolant, is reduced. But the amount of gas released in this event is not consistent with the amount of coolant used for filling, so it is believed that gas was drawn from the in-service filter and from the inlet line to the filter being refilled. See attached Figure. The filters are physically located at an elevation approximately 20 feet higher than the Volume Control Tank (VCT). Because of this difference, the absolute pressure in the filter housing and inlet piping is less than VCT pressure. Dissolved gases apparently come out of solution and collect in the upper portions of each filter and the inlet piping. The inlet connection to each filter is in the upper portion of the filter housing. If a

sufficient gas space is present in the in-service filter and the inlet piping, it is possible to draw that gas into the filter being filled and vented.

Procedures will be revised to eliminate the need to vent the filter housing when refilling.
