SUBJECT: Calvert Cliffs Nuclear Power Plant  
Unit No. 2; Docket No. 50-318; License No. DPR 69  
Licensee Event Report 94-006  
Reactor Shutdown Due to Turbine Trip Caused by Improperly Installed Link

## LICENSEE EVENT REPORT (LER)

TITLE (4)  
Reactor Shutdown Due to Turbine Trip Caused by Improperly Installed Link

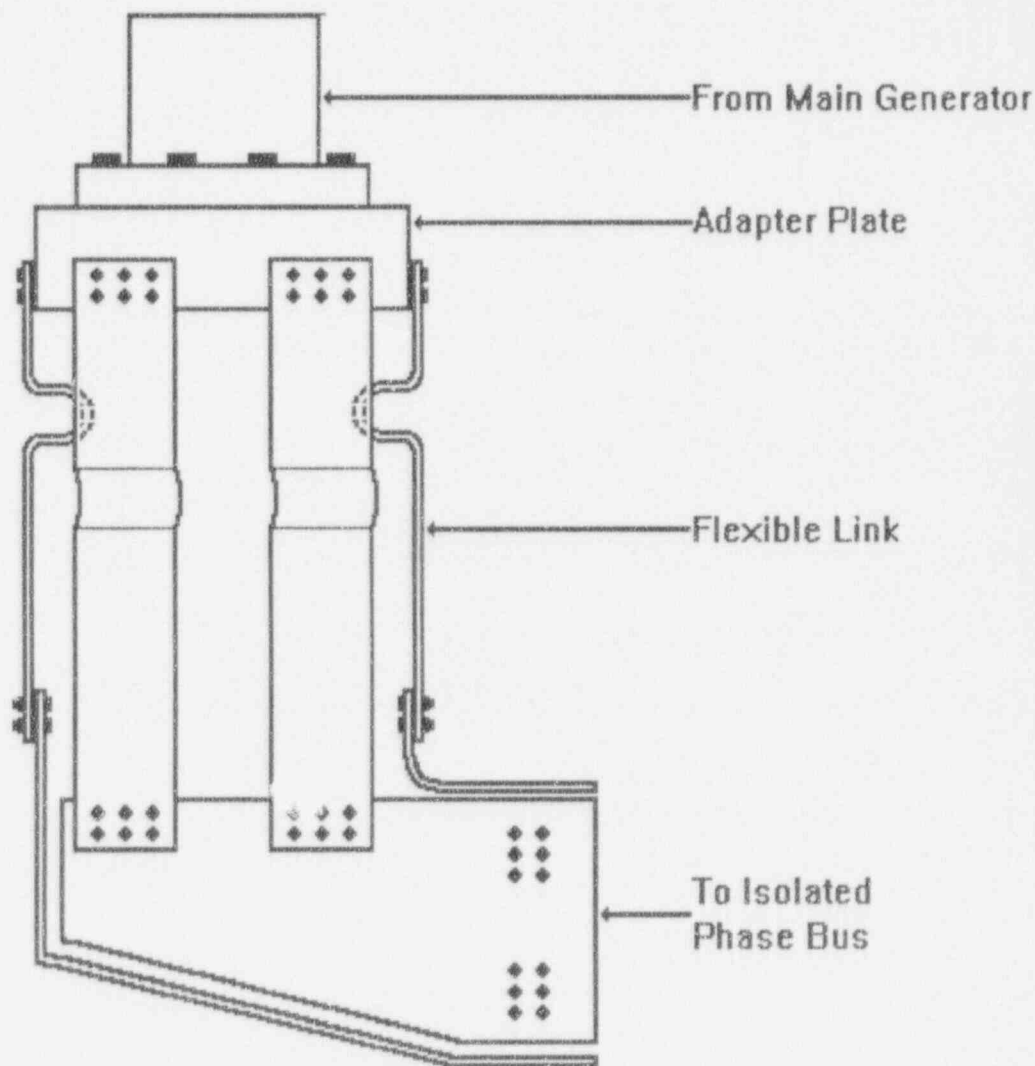
FIGURE 1

The Main Generator output runs to each of three isolated phase bus bars via a transition assembly connected from the generator high voltage bushing to the isolated phase bus bushing. The transition assembly on each phase consists of eight flexible copper links joined by six bolts each to solid copper adapter plates attached to the generator high voltage bushing above and solid copper connectors running to the isolated phase bus bushing below (see Figure 1). Each flexible link consists of fifty thin copper plates laminated together and is coated with black paint, leaving only the connecting surface bare and coated initially with silver. Each link also has an omega-shaped bend which allows for expansion. The links are attached to the adapter plate by bolts which are significantly smaller in diameter than the holes in the adapter plate. As a result, when the bolts are torqued down, the copper mating surface on each link is extruded into the adapter bolt holes while the surface of the connector develops an indentation (see Figure 2).

Investigators who opened the Isolated Phase Bus Duct covers found all of the "A" phase transition links and adapter plates severely damaged while the "B" and "C" phases were unaffected. The damaged "A" phase equipment was removed for analysis. Materials analysis of the remnants of the "A" phase transition links revealed that they had been installed backwards, the painted side of the links being attached to the adapter plate. This resulted in a high resistance connection due to a combination of contact area reduction and poor contact

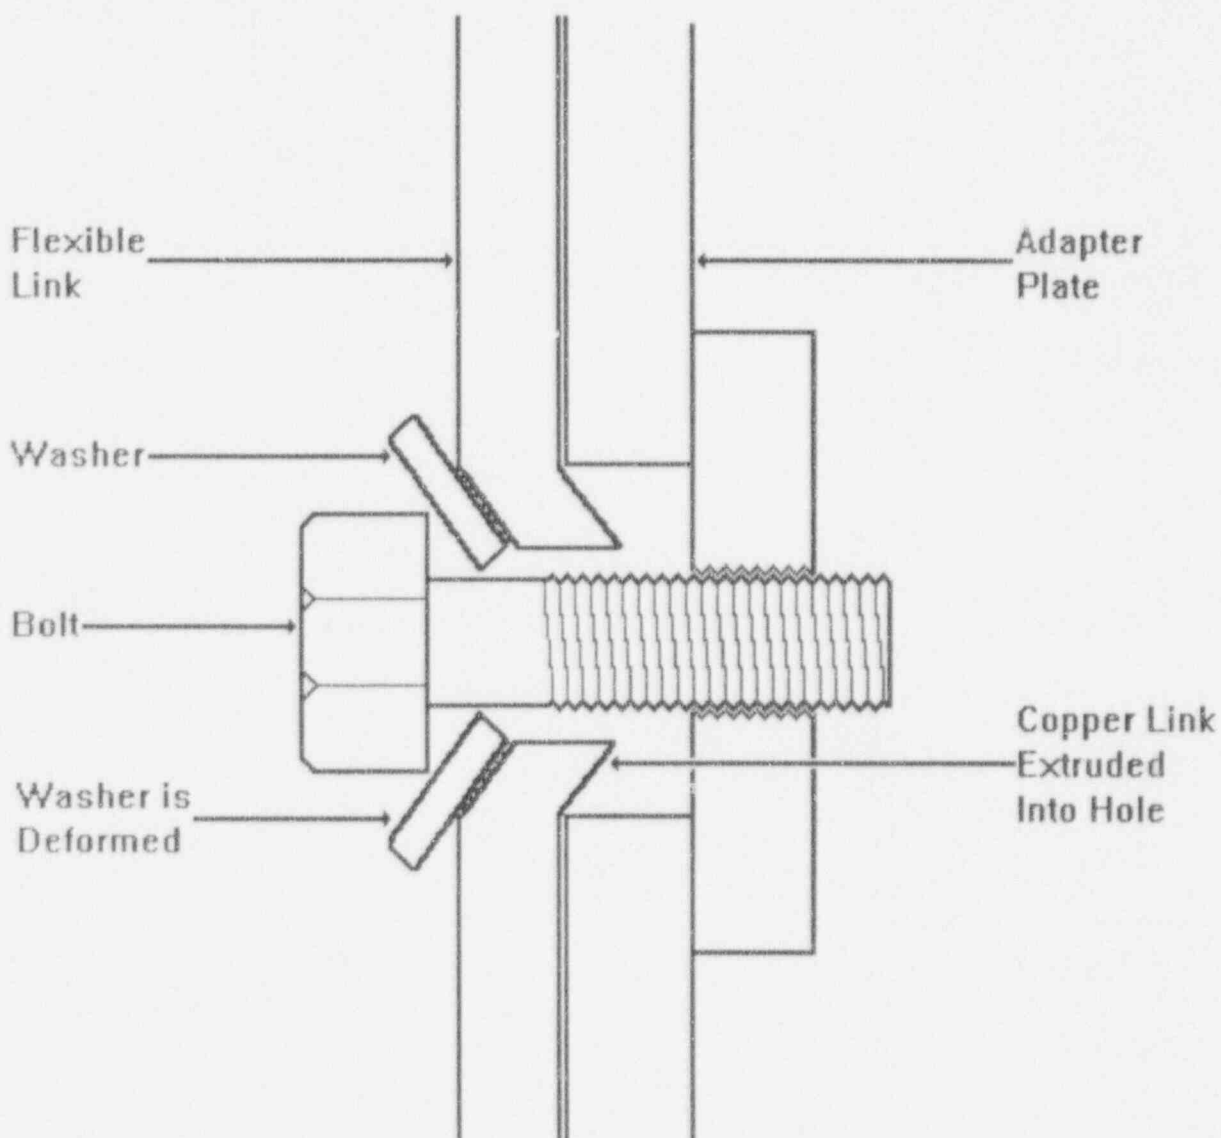
FIGURE 2

surface conductivity characteristics. Since the links had been previously installed correctly and indentations formed in both surfaces, reversal of the links resulted in a decrease in contact area. As the assembly heated up during operation, the link indentations relaxed, causing a loosening of the bolted connection, increasing resistance. The contact surface of each link is supposed to be coated with silver. The back of the link is not. The lack of silver, combined with the paint, reduced the conductivity of the surface. This, combined with the loosened connection resulted in some links not carrying sufficient current, overloading others. The overloaded links gradually oxidized, embrittled, and broke. This overloaded the remaining links, which failed due to overheating.

On November 4, 1994, new links were correctly installed and the Unit was brought back on line the following day.
