CNSS913708

LICENSEE EVENT REPORT (LER)

FACILITY NAME (1) Cooper Nuclear Station										DOCKET NUMBER (2) 0 5 0 0 0 2 9 8 1 OF 0 6										PAGE (3) 1 OF 0 6			
TITLE (4) Reactor Water Cleanup Isolations Due To High System Temperature Caused By Inadequate Design																							
EVENT DATE (5)			LER NUMBER (6)				REPORT DATE (7)			OTHER FACILITIES INVOLVED (8)													
MONTH	DAY	YEAR	YEAR	SEQUENTIAL NUMBER	REVISION NUMBER	MONTH	DAY	YEAR	FACILITY NAMES					DOCKET NUMBER(S)									
0 3	2 4	9 1	9 1	0 0 2	0 1 0	0 6	0 3	9 1						0 5 0 0 0									
OPERATING MODE (2)			THIS REPORT IS SUBMITTED PURSUANT TO THE REQUIREMENTS OF 10 CFR 5. (Check one or more of the following) (11)																				
POWER LEVEL (10)			20.402(b)				20.405(c)				X 60.73(a)(2)(i)				73.71(b)								
0 0 0			20.405(a)(1)(i)				60.36(a)(1)				60.73(a)(2)(iv)				73.71(c)

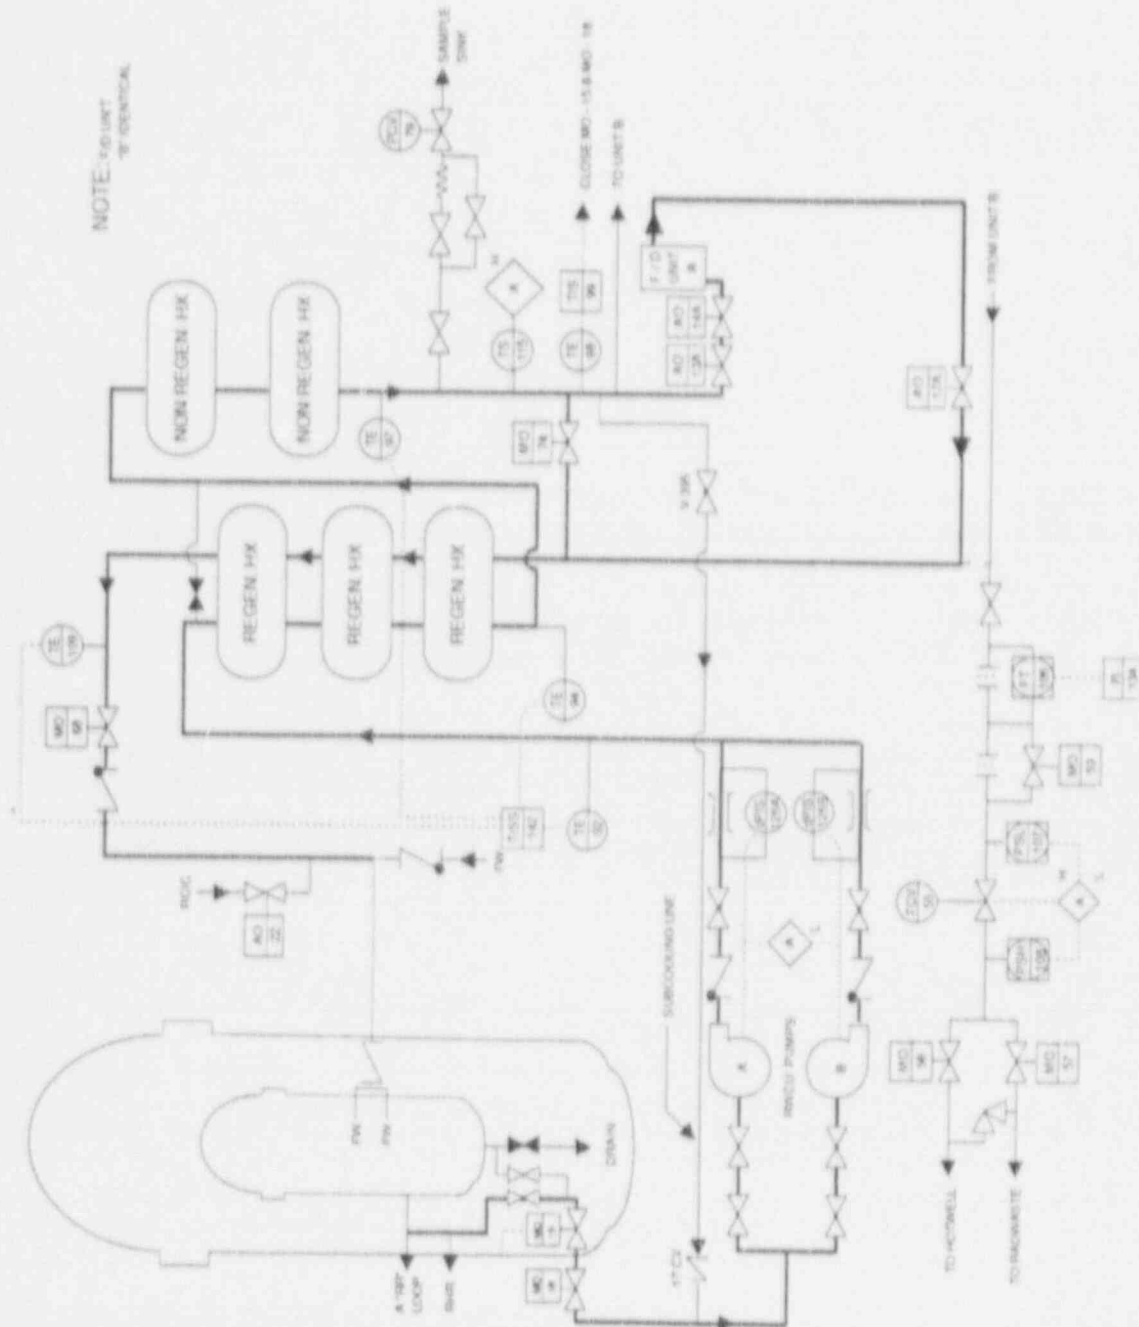
REACTOR WATER CLEAN-UP

The high temperature condition in the piping downstream of the RWCU NRHX resulted from backflow through the check valve (CV-17) in the RWCU subcooling line installed between the NRHX outlet and the RWCU system inlet piping (see attached sketch). The subcooling line, installed during the 1990 Refueling Outage, is designed to prevent flashing at the RWCU pump suction by providing cooled water from the outlet of the NRHX. The check valve is a metal seat piston type lift check valve, which requires a differential pressure of 500 psi to obtain a leaktight shutoff. The differential pressure available when the RWCU pumps are secured is small, allowing backflow sufficient to cause the observed events. Operation of the system in this mode was not considered during the design process, and thus a check valve was not selected which would provide tight shutoff at low differential pressures.

The isolations were not preceded by indications of high temperature. The physical arrangement of the subcooling line and the temperature sensing elements is such that backflow through the check valve contacts the isolation switch prior to reaching the indication devices. Although the alarm switch and temperature element were found to be defective following the March 24 events, the only influence they had was to make diagnosis of the events more difficult. The failure of these components is due to lack of preventive maintenance and random component failure, respectively.

A caution tag was placed on the RWCU pump control switch requiring that the subcooling line isolation valve be closed except during Reactor cooldown. The design of the subcooling line will be reviewed and a permanent solution determined.
