Report No. LER 91-002-00

LICENSEE EVENT REPORT (LER)

FACILITY NAME (1): NORTH ANNA POWER STATION UNIT 2										DOCKET NUMBER (2): 0 5 0 0 0 3 3 9 1 OF 0 4										PAGE (3): 1		
TITLE (4): Automatic Start Of The 2H Emergency Diesel Generator Caused By De-energization Of The 2H Emergency Bus Due To Personnel Error.																						
EVENT DATE (5):				LER NUMBER (6):				REPORT DATE (7):				OTHER FACILITIES INVOLVED (8):										
MONTH	DAY	YEAR	YEAR	SEQUENTIAL NUMBER	REVISION NUMBER	MONTH	DAY	YEAR	FACILITY NAMES					DOCKET NUMBER(S)								
0	5	1	4	9	1	0	0	2	0	0	6	0	3	9	1	0	5	0	0	0	0	0
OPERATING MODE (9): 1				THIS REPORT IS SUBMITTED PURSUANT TO THE REQUIREMENTS OF 10 CFR 50. (Check one or more of the following) (11):																		
POWER LEVEL (10): 19.7				20.402(b)				20.405(a)				<input checked="" type="checkbox"/> 50.73(a)(2)(iv)				73.71(b)

NORTH ANNA POWER STATION
UNIT 2

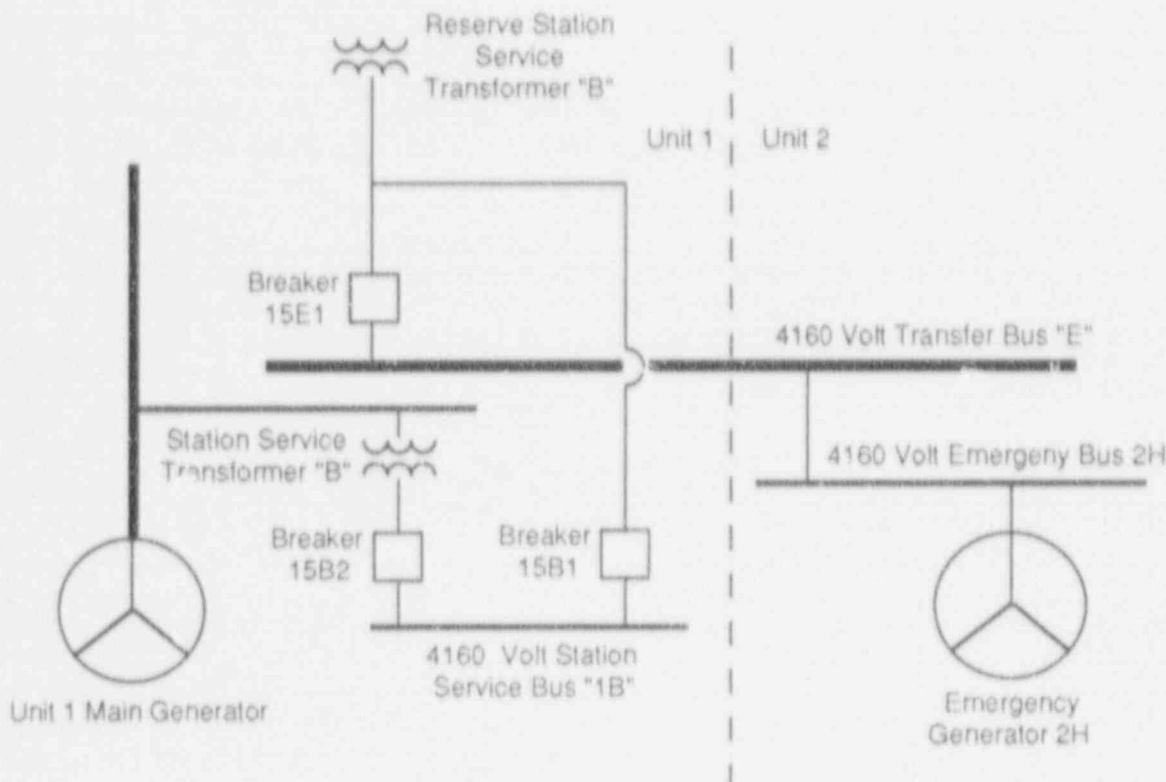
Operating Procedure 1-OP-26.1, "TRANSFERRING 4160-VOLT BUSES" implements the bus transfer by closing breaker 15B1 (connecting B RSST to Bus 1B), then opening breaker 15B2 (disconnecting Bus 1B from B SST). However, instead of opening 15B2 as directed in the procedure, the licensed control room operator inadvertently opened breaker 15E1. This de-energized the 4160 Volt Transfer Bus E (common to both Units) and Unit 2 bus 2H. As designed, the 2H EDG automatically started on the bus undervoltage and re-energized the 2H bus loads (refer to Figure 1 for a simplified one line diagram of the electrical buses).

The cause of this event was personnel error by the licensed control room operator. The operator was following the instructions of the operating procedure and understood that he was required to manipulate breaker 15B2, but accidentally opened breaker 15E1.

Abnormal Procedure 0-AP-10, "Loss of Electrical Power" was entered to determine the extent of power loss. Offsite Power was restored to the 2H bus. Alternate power sources were verified operable. Pumps that automatically actuated or shutdown as a result of the event were restored to normal. The EDG performed a one hour full load run and was returned to automatic operation.

The individual that made the error was counseled on the importance of self checking and verification of components prior to manipulation.
