VERMONT YANKEE NUCLEAR POWER CORPORATION

LICENSEE EVENT REPORT (LER)

VERMONT YANKEE NUCLEAR POWER STATION

Reactor Scram Due to Loss of Normal Off-site Power (LNP) Caused By Inadequate Procedure Guideline

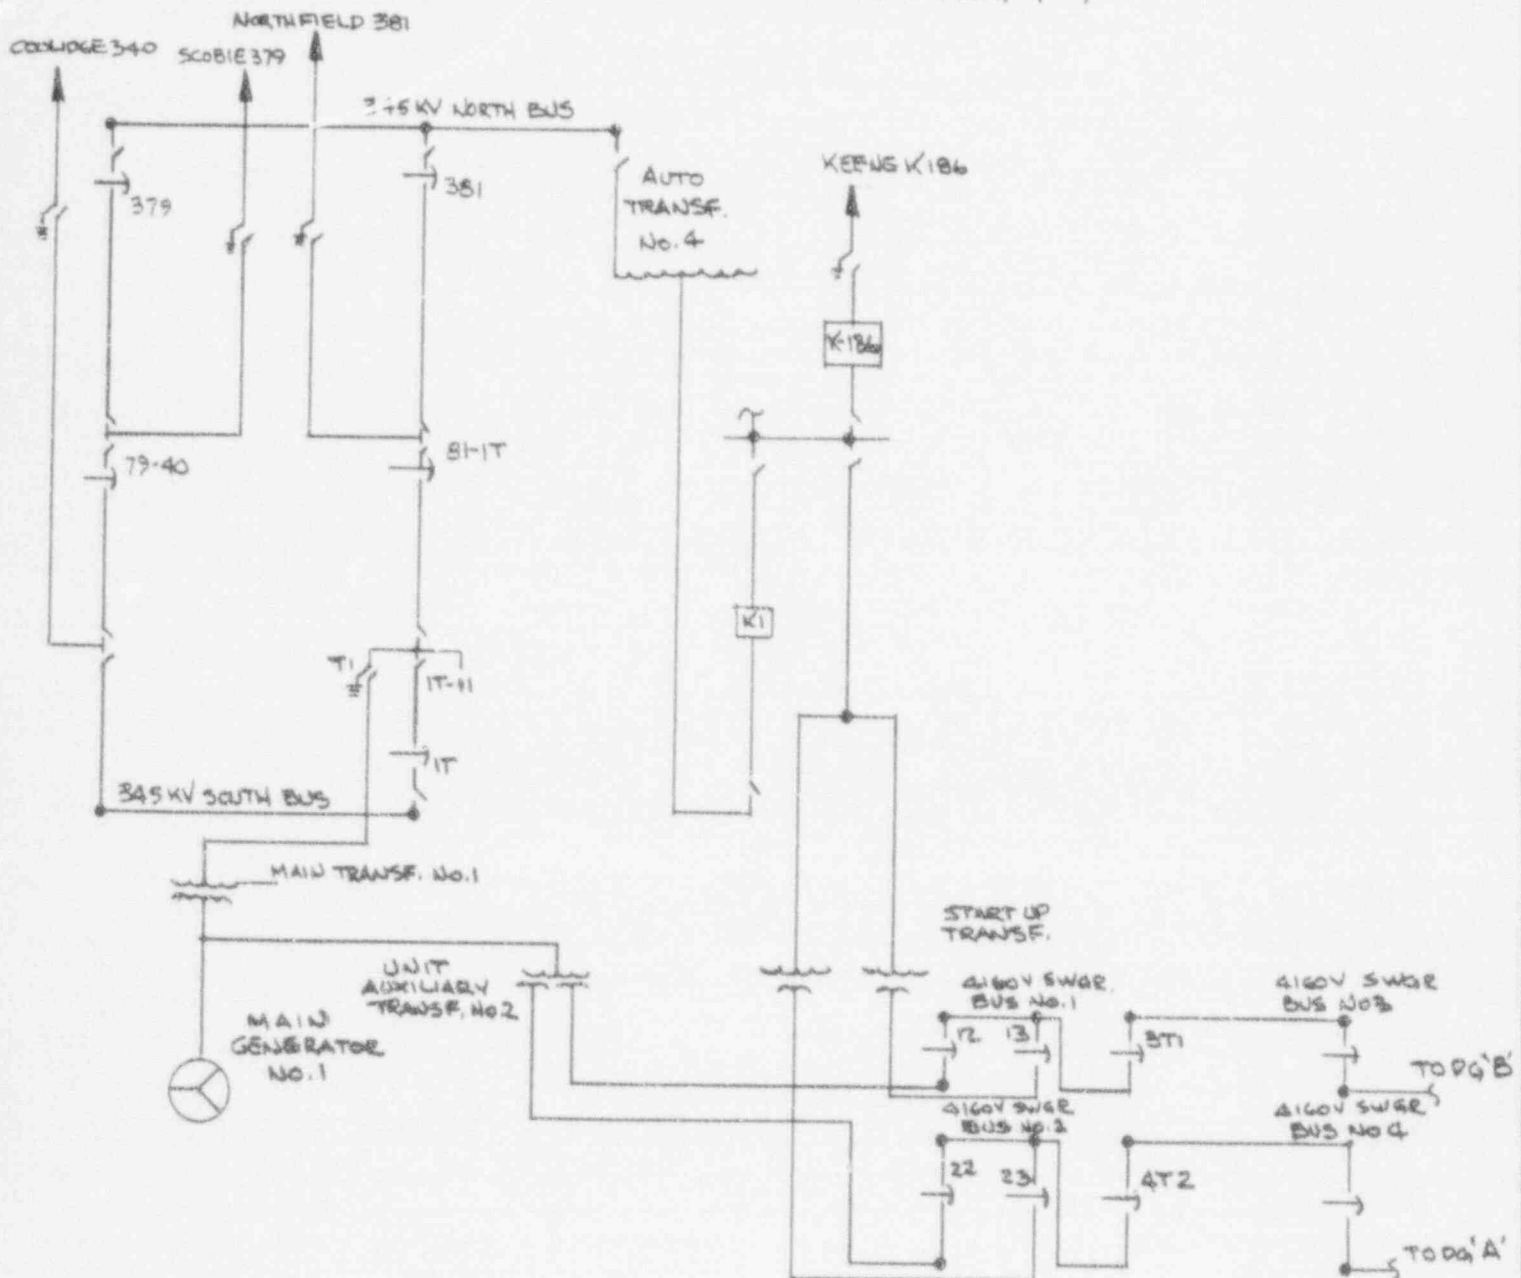
SWITCHYARD DISTRIBUTION

On 04/23/91 at 1448 hours, during normal operation with Reactor power at 100%, a Reactor scram occurred as a result of a Generator/Turbine trip on Generator Load Reject due to the receipt of a 345KV Breaker Failure Signal. The 345KV Breaker Failure Signal was received as a result of Breaker Failure Interlock (BFI) signals that occurred simultaneously in the 345KV Breaker 81-1T and 115 KV Breaker K-1 control circuitry.

The (BFI) signal from 115KV Breaker K-1 initiated the following automatic system responses:

- Opening of 115KV Breaker K-186
- Opening of 345KV Breakers 379 and 381

The loss of 381 and 379 breakers removed all power sources to the Auto Transformer which in conjunction with the K186 trip resulted in a total loss of 115KV power.

The (BFI) signal from 345KV Breaker 81-1T initiated the following automatic system responses:

- Generation of 345KV Breaker Failure Signal
- Opening of 345KV Breakers 381 and 1T
- Lockout of Main Generator 86GP and 86GB relays, causing the Main Generator and Exciter Field breakers to open

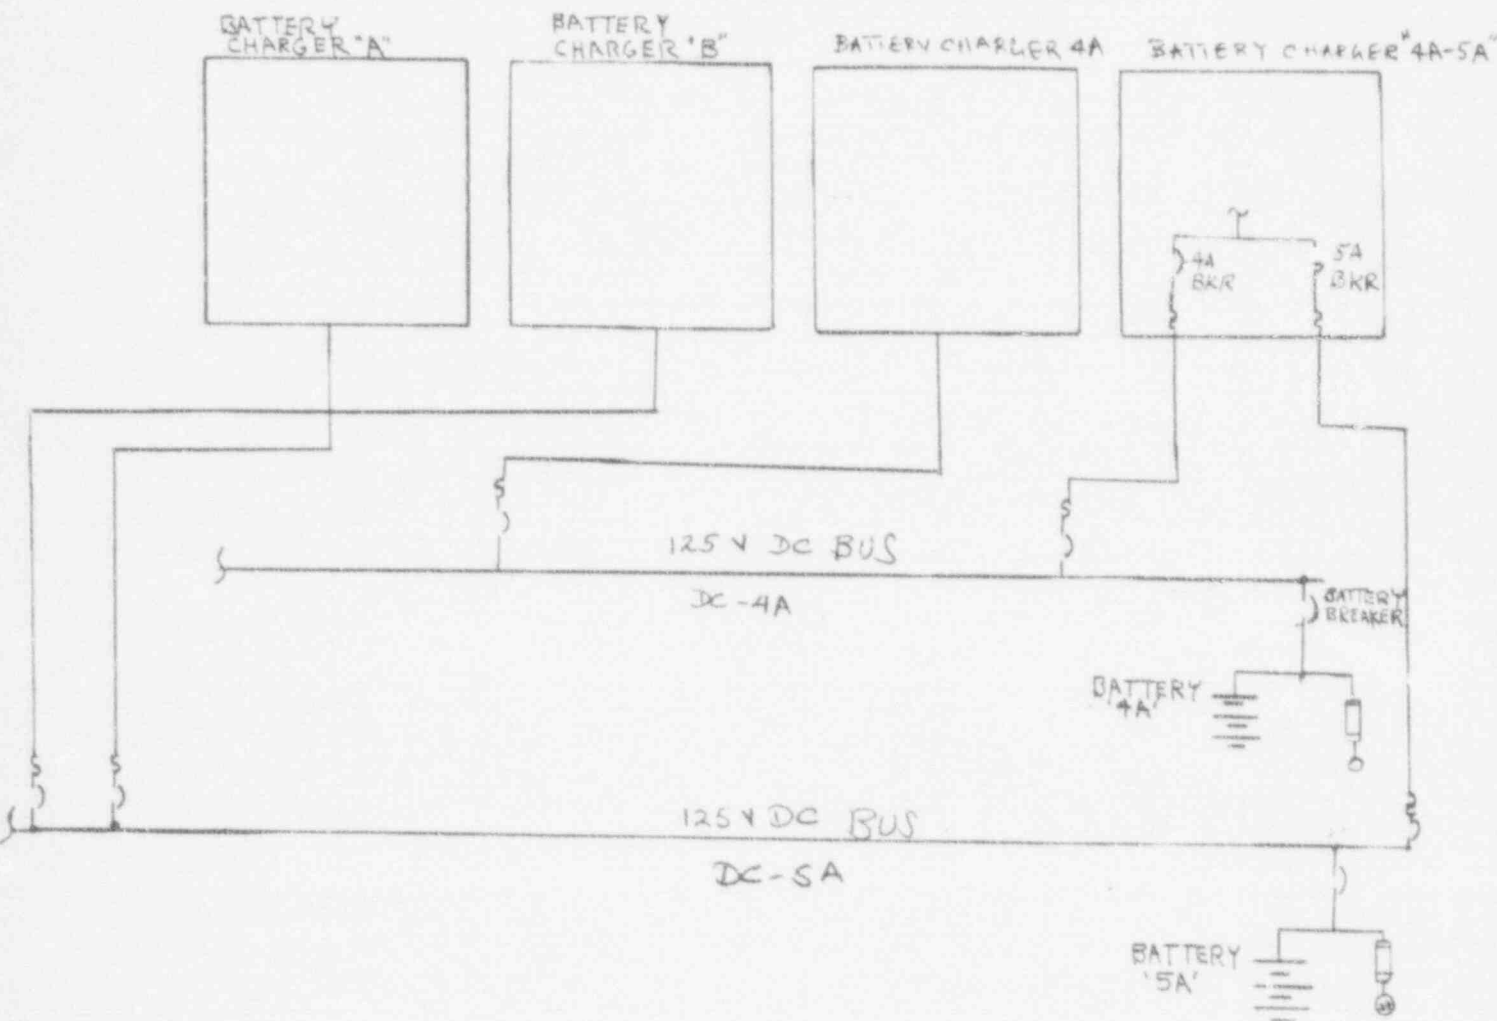
SWITCHYARD DC BUS SYSTEM

Prior to the event, the plant was in the process of completing the replacement of Switchyard Battery Bank 4A in accordance with a Maintenance Department guideline. All work with the exception of restoring the connection of the battery bank to the DC 4A bus, was completed without incident. While performing the final sequence of actions necessary to reconnect the battery bank to DC Bus 4A, a DC voltage transient occurred on the bus which initiated the event.

- The voltage transient on the DC 4A bus occurred when battery charger 4A-5A was disconnected from the DC-5A bus which rendered bus DC 4A susceptible to voltage spikes due to the absence of a battery bank.
- The specific cause of the zener diode failures which resulted in the 81-1T and K1 breaker (BFI) signals is attributed to the voltage transient which occurred on Bus DC 4A.
- A portion of the additional problems found with DC Bus 4A and 5A battery chargers which ranged from shorted diodes/SCRs and blown surge suppressor fuses, were concluded to be pre-existing and were responsible for the voltage transient.

The Root Cause of this event is the failure of the repair department personnel to recognize the consequences of operating a DC bus without a connected battery bank. The Maintenance Guideline, an internal Maintenance Department document prepared by the department Electrical Engineering staff, was inadequate in that it did not take into consideration all battery charger failure modes when floating a DC bus without a battery bank. The consequences of losing battery charger power while the bus is energized without a battery connected were considered during the revision of the Guideline, but not the potential of the battery chargers to fail high or induce a high voltage spike on the bus, both which have the potential to damage electronic circuitry.

batteries was completed without incident. Recovery of the battery required the closure of the battery output breaker first, essentially paralleling the two battery banks until the 4A/5A charger output breaker was opened. In June 1990, the Guideline was revised due to Operations Department concern with paralleling batteries. The new revision required that the cross connection between bus 4A and 5A provided by battery charger 4A/5A be opened prior to the reclosure of the bus 4A battery breaker. This configuration rendered bus 4A without a battery and susceptible to voltage excursions from either the 4A or 4A/5A battery chargers.

1. 345KV and 115KV breaker failure relays were susceptible to false initiation due to control voltage transients.
2. The switchyard battery chargers were in a degraded mode such that they created DC bus control voltage disturbance when the chargers were disconnected from associated batteries.
3. Lack of Switchyard battery charger and overall Switchyard preventative maintenance.

Discussions with the manufacturer indicated that the zener diodes are no longer employed on newer revision trip cards and have recommended the removal of the zener diodes based on their vulnerability to voltage transients. Based on this recommendation, the Maintenance Dept. has removed the zener diodes from these units in accordance with written direction from the vendor.

1. Immediate corrective actions included recovering from the reactor scram, restoration of off-site power, and Switchyard and reactor stabilization utilizing appropriate plant procedures.
2. The current revision of the Maintenance Dept. Guideline has been cancelled and the previous revision reinstated with an additional requirement that a review be performed prior to its use for dealing with any evolution requiring switchyard battery removal.
3. Review all other plant guidelines and Procedures pertaining to battery switching operations.
