# NORTHEAST UTILITIES

MP-91-471

Reference: Facility Operating License No. NPF-49  
Docket No. 50-423  
Licensee Event Report 90-030-02

I. Description of Event

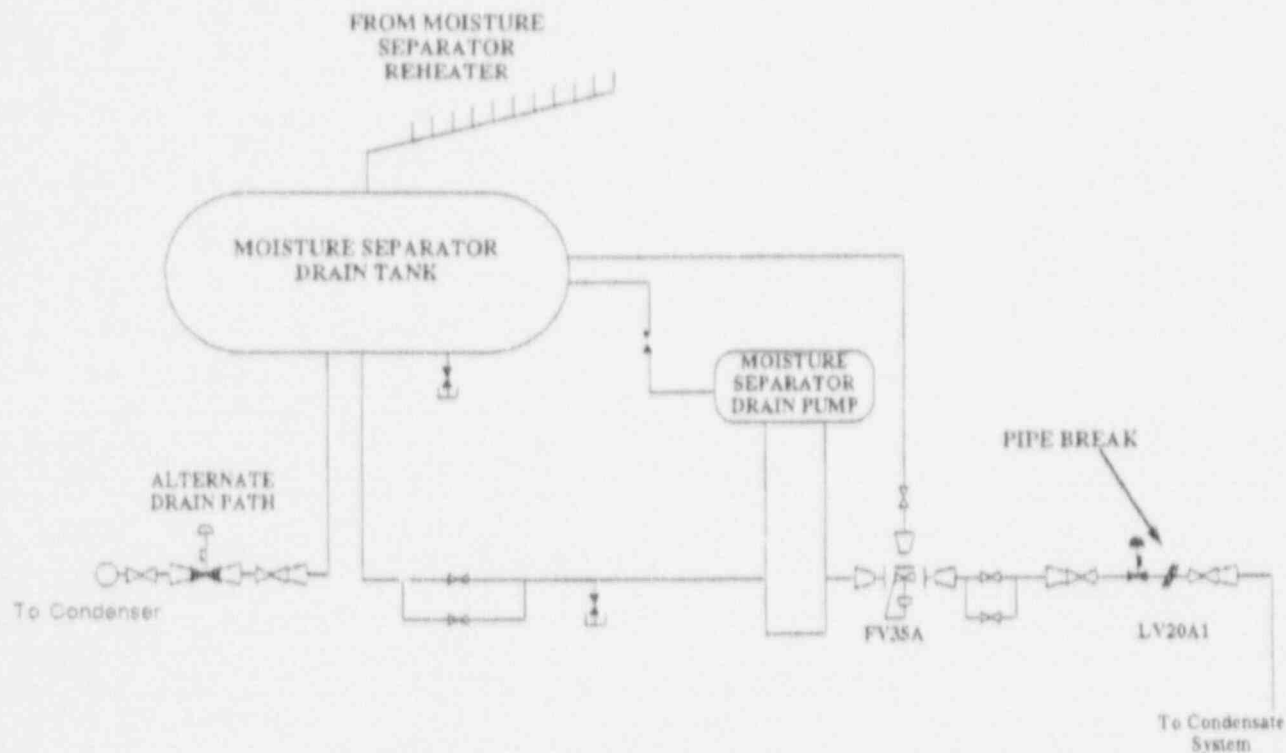
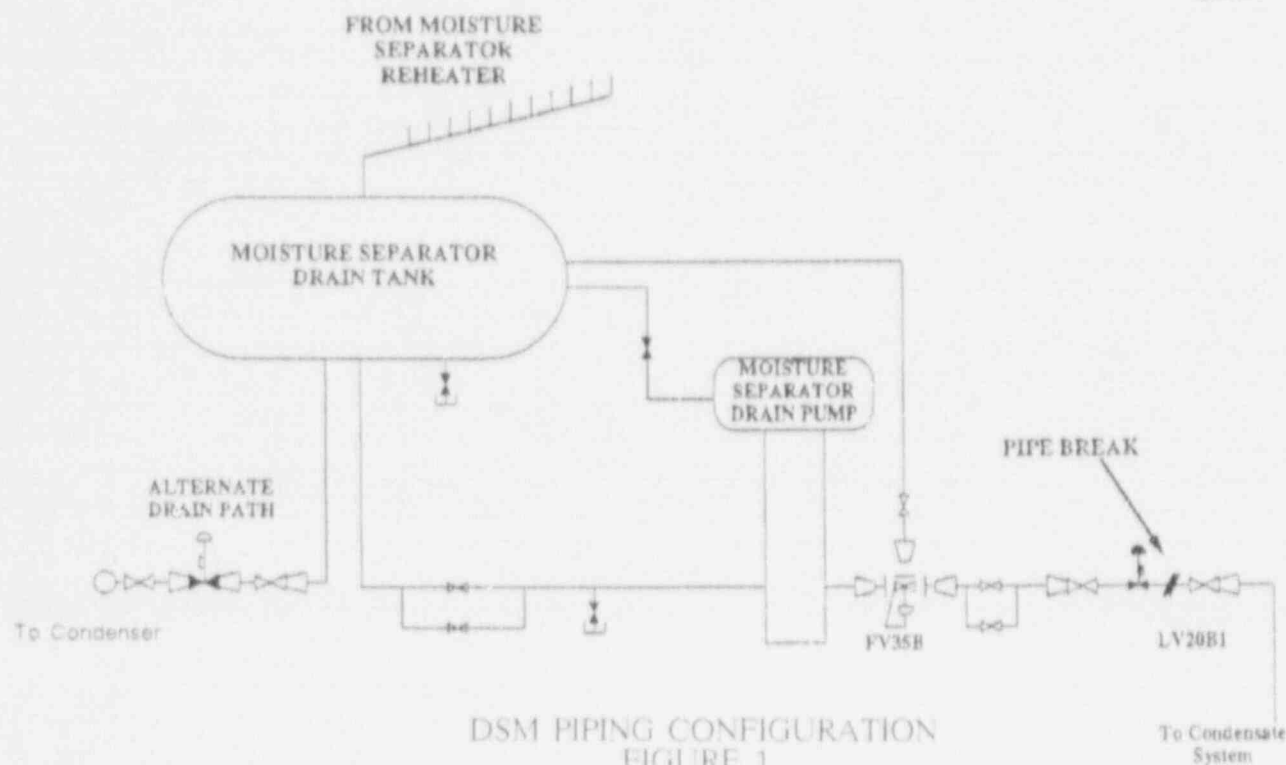
DSM PIPING CONFIGURATION  
FIGURE 1

The configuration of the failed piping was a horizontal run of 10" piping which reduced to 6" piping upstream of a 6" control valve. The 6" piping extended up to a 6" manual isolation valve, then expanded to 10" piping, before tying into the Condensate System. While it is normal to reduce the line size of piping directly upstream of a control valve, in typical piping designs, the piping is increased to the original line size immediately downstream of the associated control valve (see Figure 2). The fluid velocity in the piping downstream of the control valves has been calculated to be in the range of 17 ft/sec, which when coupled with the low oxygen levels produces a high erosion rate.

The damaged sections of pipe were removed. Temporary pipe caps of a material consistent with the original system design were installed. The plant returned to power utilizing the Moisture Separator drain system alternate drain lines. (See Figure 1). During the third refueling outage (RFO3), which began on February 2, 1991, the six-inch diameter piping upstream and downstream of the level control valves was replaced with six-inch piping having greater erosion/corrosion resistant properties (i.e., 5% chrome-moly, schedule 40 pipe (A-335, grade P5)). The existing piping configuration was determined to be acceptable with the change in piping material.
