Nebraska Public Power District

LICENSEE EVENT REPORT (LER)

Cooper Nuclear Station

TITLE (4) Unplanned Startup Of Diesel Generator Number 2 Due To An Equipment Deficiency That Occurred During Plant Startup While Transferring Loads To The Normal Transformer

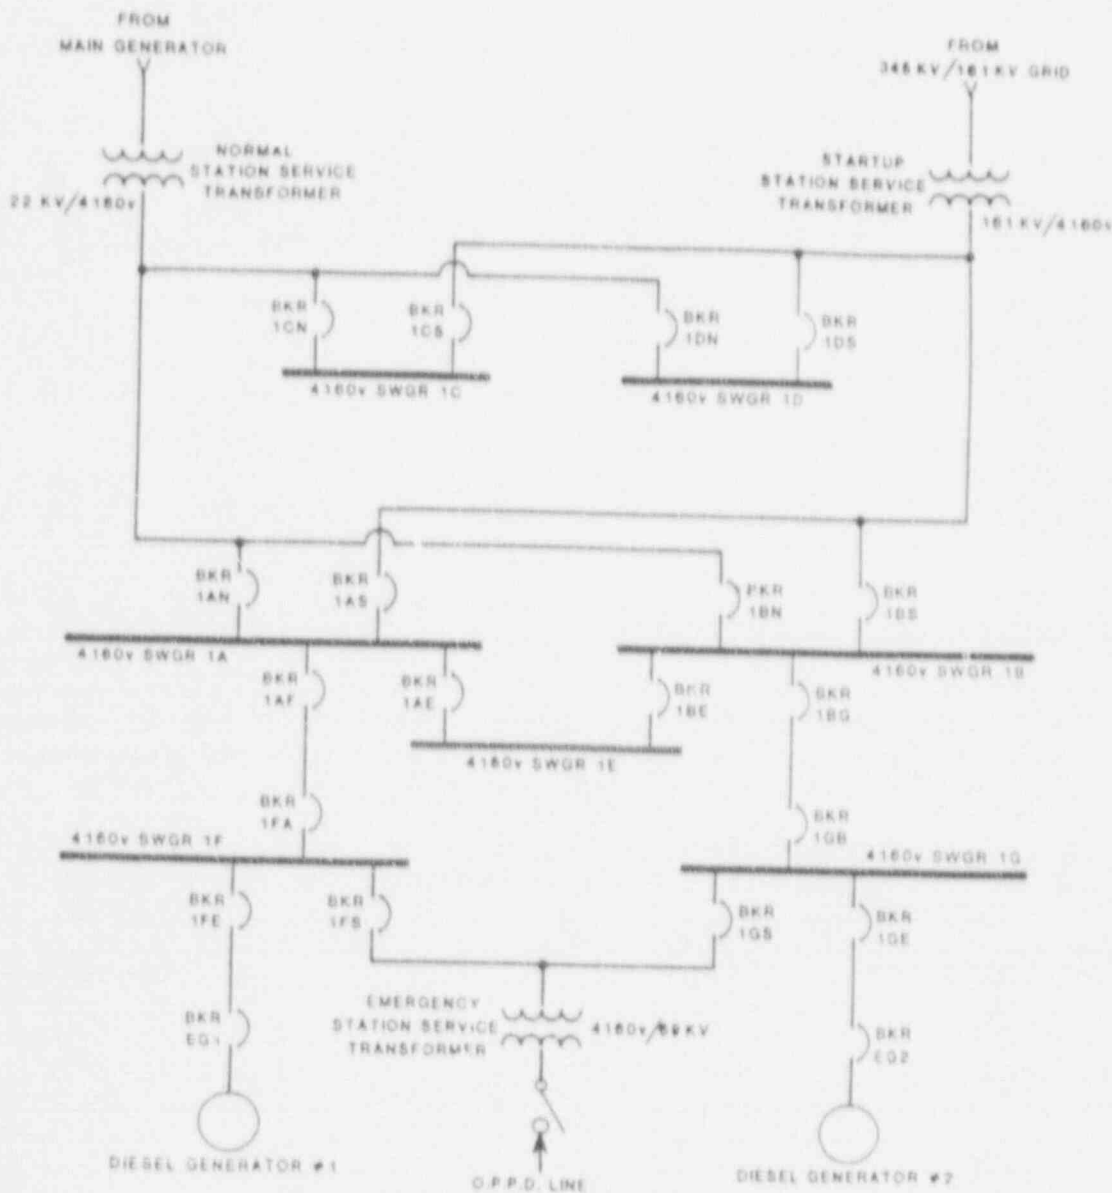
FIGURE 4 REV. 5

4160v DISTRIBUTION SYSTEM
