VERMONT YANKEE NUCLEAR POWER CORPORATION

December 30, 1994
BVY 94 - 130

Subject: Temporary Non-Code Repair of Service Water Piping

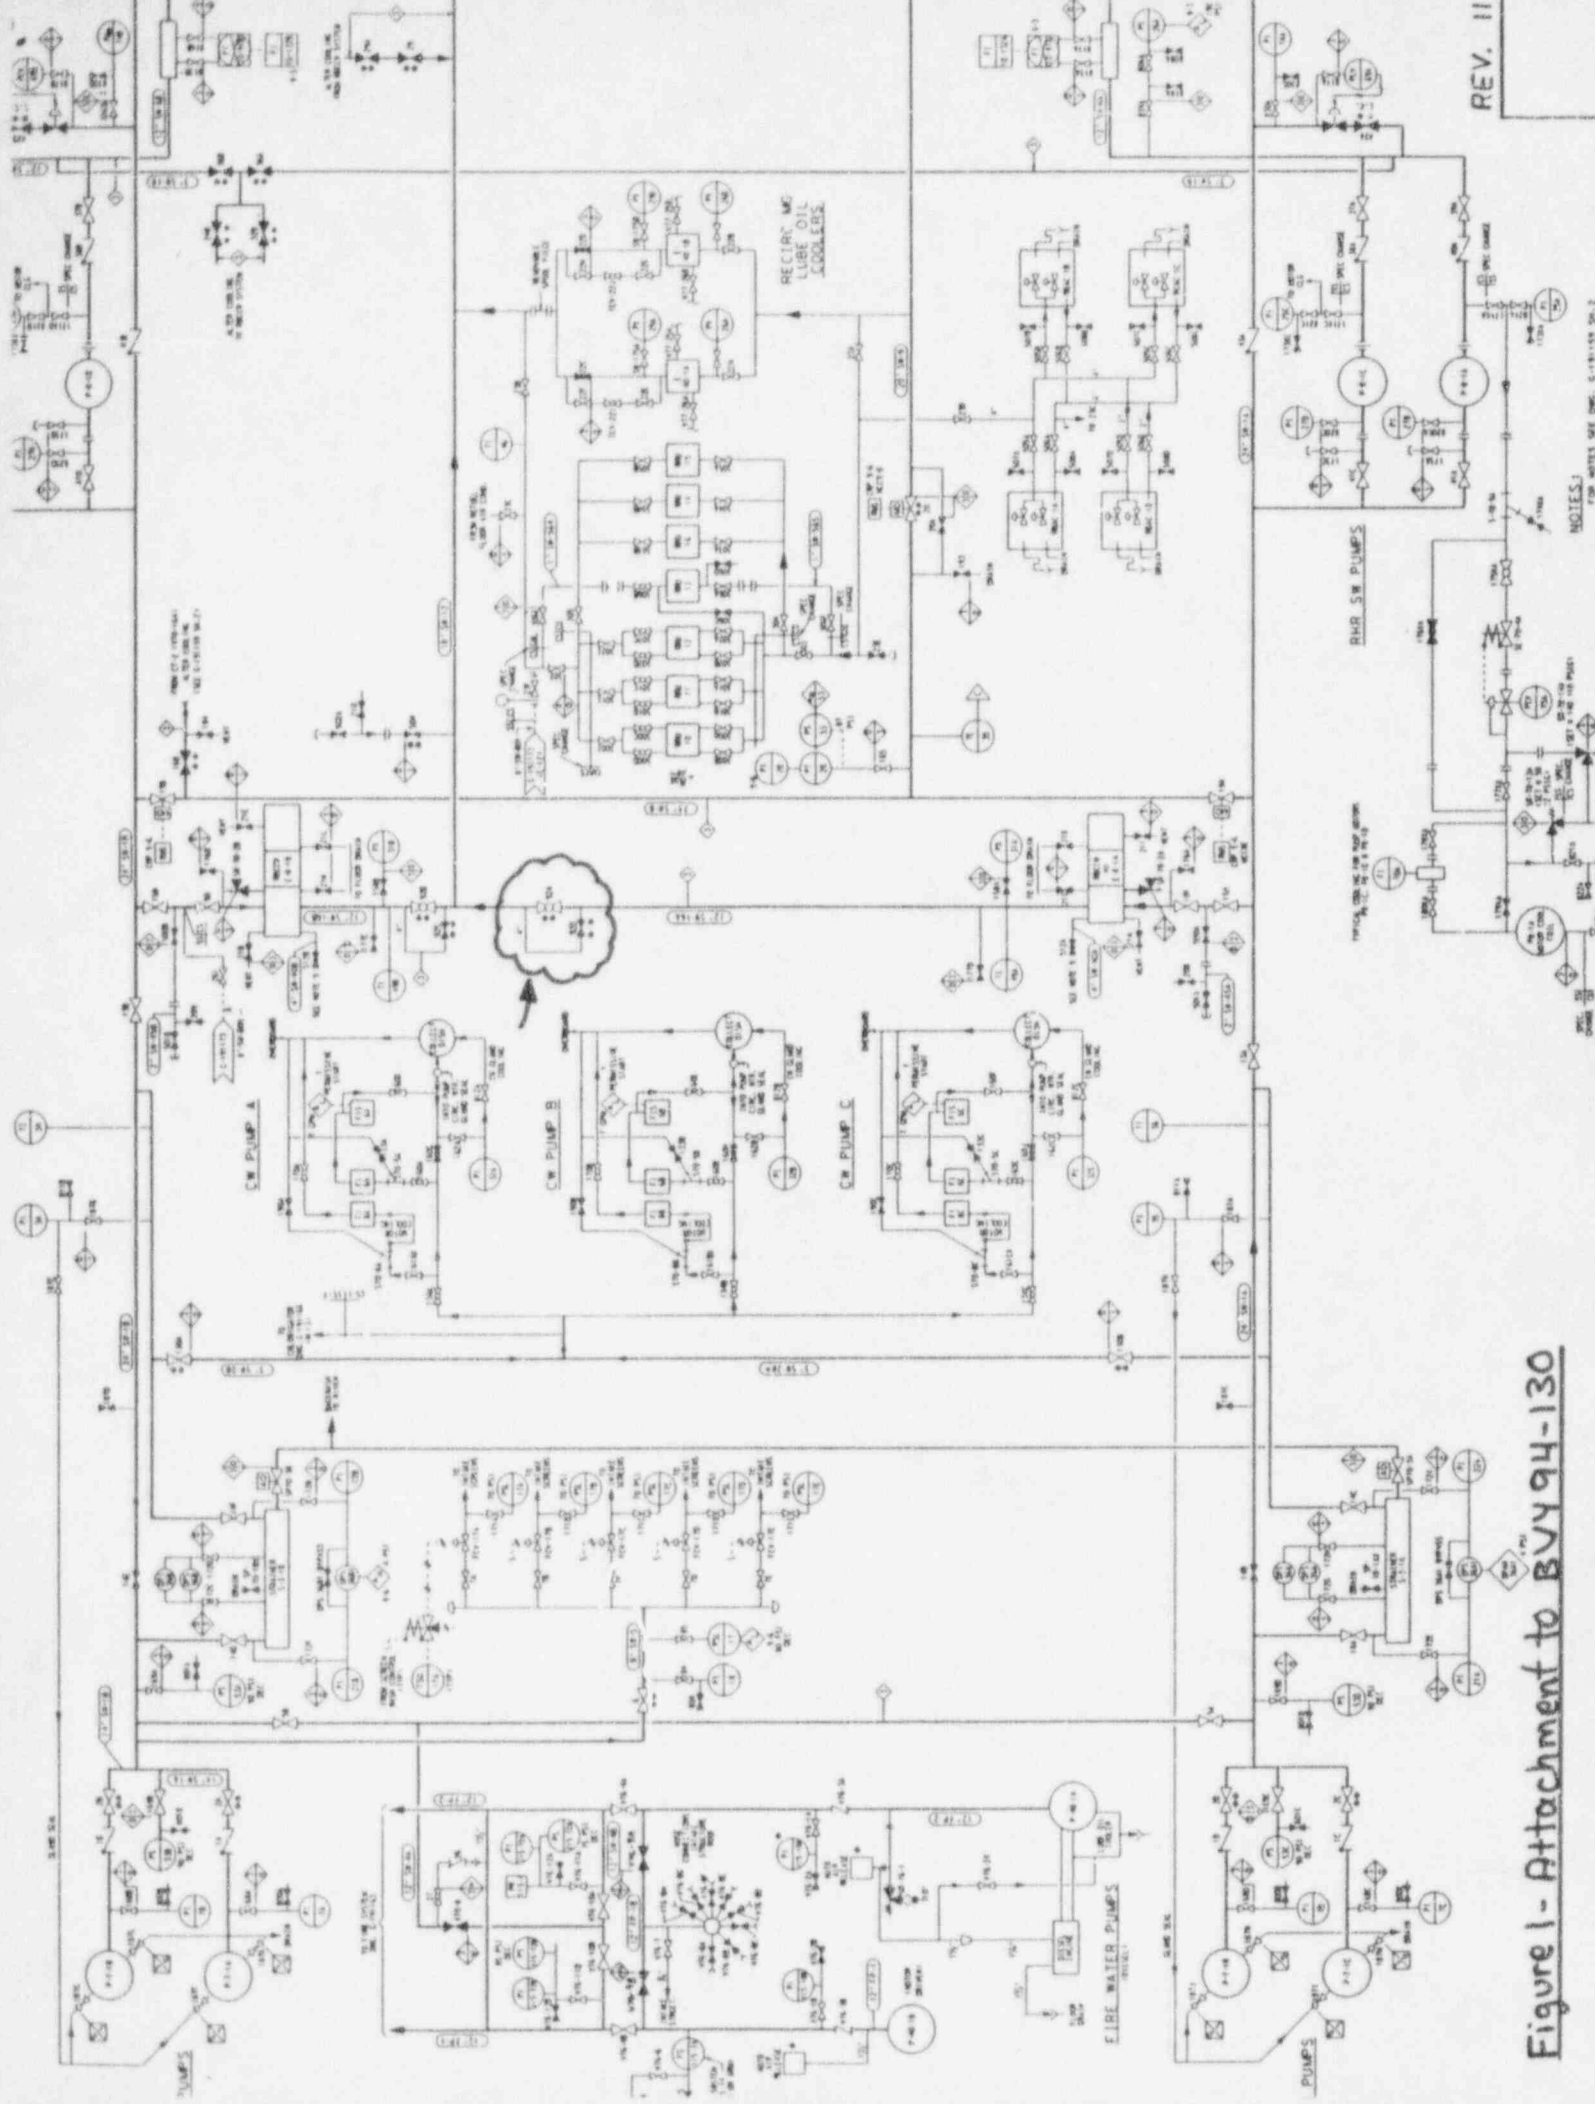
Figure 1 - Attachment to Bv94-130

On November 30, 1994, during a routine Operations Department tour of the plant, leakage was detected originating from a 4-inch schedule 40 Service Water (SW) pipe at the outlet of the "A" Reactor Building Closed Cooling Water System (RBCCW) heat exchanger (E-8-1A). The pipe contains a 4-inch globe valve (V70-92D), which is used as a bypass for 12-inch valve (V70-92A). The bypass is used for throttling of service water flow from the RBCCW heat exchanger under conditions of low heat load. Refer to Figure 1 attached and FSAR Figure 10.6-1a for the flow diagram and arrangement of these components.

Upon inspection, the leak originated from a pinhole perforation in the branch connection where the 4-inch bypass line returns to the 12-inch line. The perforation is located in the weld between the 4-inch weldolet and the 12-inch pipe. The leak consists of a light spray of water less than 1/64-inch in diameter. Nominal wall thickness of the 4-inch pipe is 0.237 inches, and nominal wall thickness for the 12-inch pipe is 0.375 inches. Required minimum wall thicknesses are 0.019 inches and 0.053 inches, respectively.

During post-maintenance testing of an RHRSW pump on December 1, 1994, a second leak was identified in a weld approximately two feet upstream of the first leak on the 4-inch pipe section. This second leak is located in the weld between the weld neck flange and the 4-inch pipe immediately downstream of valve V70-92D. This is attributed to the increase in system pressure resulting from operation of the RHRSW pump.

Ultrasonic examination of both locations was performed. No significant wall loss was observed in either the welds or the adjacent piping. There were no indications observed except at the locations of the leaks. The locations of the leaks are characterized as rounded in nature (much like porosity). Neither indication appears crack-like. When under pressure, both indications emit a pinhole stream of water no greater than 1/64 inch.

Although the exact root cause of these failures is unknown, the root cause of the first leak appears to be Microbiologically-Induced Corrosion (MIC). Due to the accelerated nature of the second leak (affected weld is less than two years old), MIC is not thought to be the root cause. It is possible that the flaw was a result of fabrication flaws combined with vibration.

Throttled operation of valve V70-92D appeared to be causing significant vibration in the adjacent piping. Vibration measurements were taken at the locations of the flaws and adjacent piping. Cyclic stresses at the flaw locations were calculated based on these measurements. Crack growth analyses using ASME Section XI, Appendix A criteria were performed. This evaluation concluded that both flaws will remain significantly below critical flaw size for the duration of the present operating cycle (until the scheduled 1995 refueling outage).

code repair until the scheduled 1995 refueling outage, which is scheduled to begin on March 18, 1995. A code repair will be implemented prior to startup from the refueling outage. Vermont Yankee does not foresee the need to implement any leak-mitigating measures for this situation. For the interim period until a code repair can be implemented, Vermont Yankee plans to perform daily qualitative evaluation of leakage rate and monthly ultrasonic examination of the welds containing these flaws.
