NUCLEAR SAFETY-RELATED
CONTAINMENT COOLING SERVICE WATER
PUMP ROOM COOLER HEAT LOAD STUDY
DRESDEN STATION - UNITS 2 AND 3

Report Prepared for
Commonwealth Edison Company

Report SL-7120

Revision 1

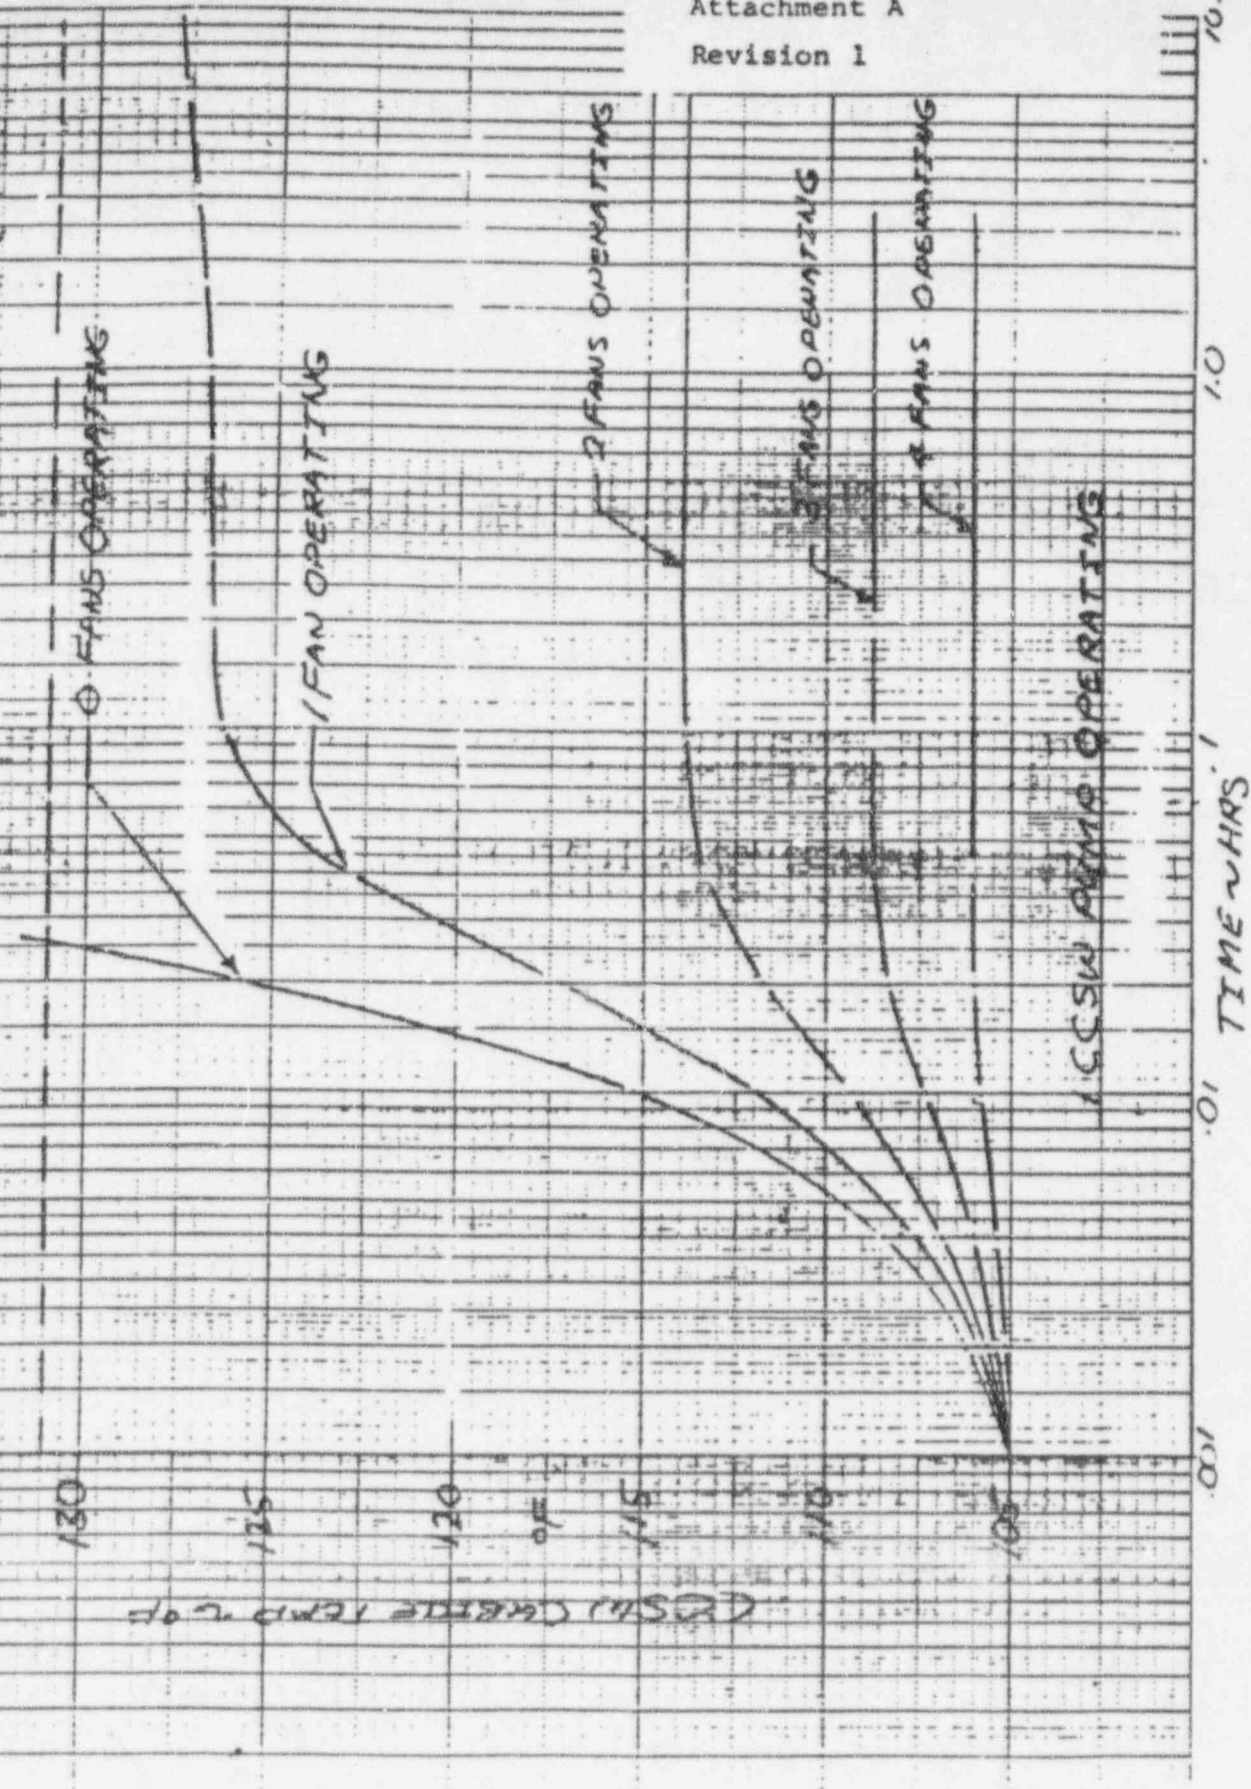
FIGURE 1 - CCSW PUMP ROOM TEMPERATURES - 0.5% INERT WATER TRAMP

Figures 1, 2 and 3 are plots of the transient CCSW cubicle temperature for 95°F, 85°F and 75°F entering cooling water temperature, respectively. Figure 1 presents five curves describing the transient temperature as a function of time with 0, 1, 2, 3 or 4 fans operating. From this figure it is seen that the CCSW cubicle will reach a temperature of 131°F in less than 2 minutes when no fans operate. Although not shown in this figure the CCSW cubicle temperature would exceed 160°F in 6 minutes with no fans operating. When 1 fan operates, the temperature at 10'

hours as shown in the figure is approximately 128°F. At 100 hours the additional temperature increase in the cubicle is less than 2 degrees above the 10-hour value. Efforts to qualify the CCSW pump motors to temperatures greater than 131°F would have marginal success because our results indicate that only a marginal increase in the operating time could be justified. The cubicle remains below 115°F for a 10-hour period for the conditions of 2, 3 or 4 operating fans. Also, the temperature rate of increase, at 10 hours, is minimal.

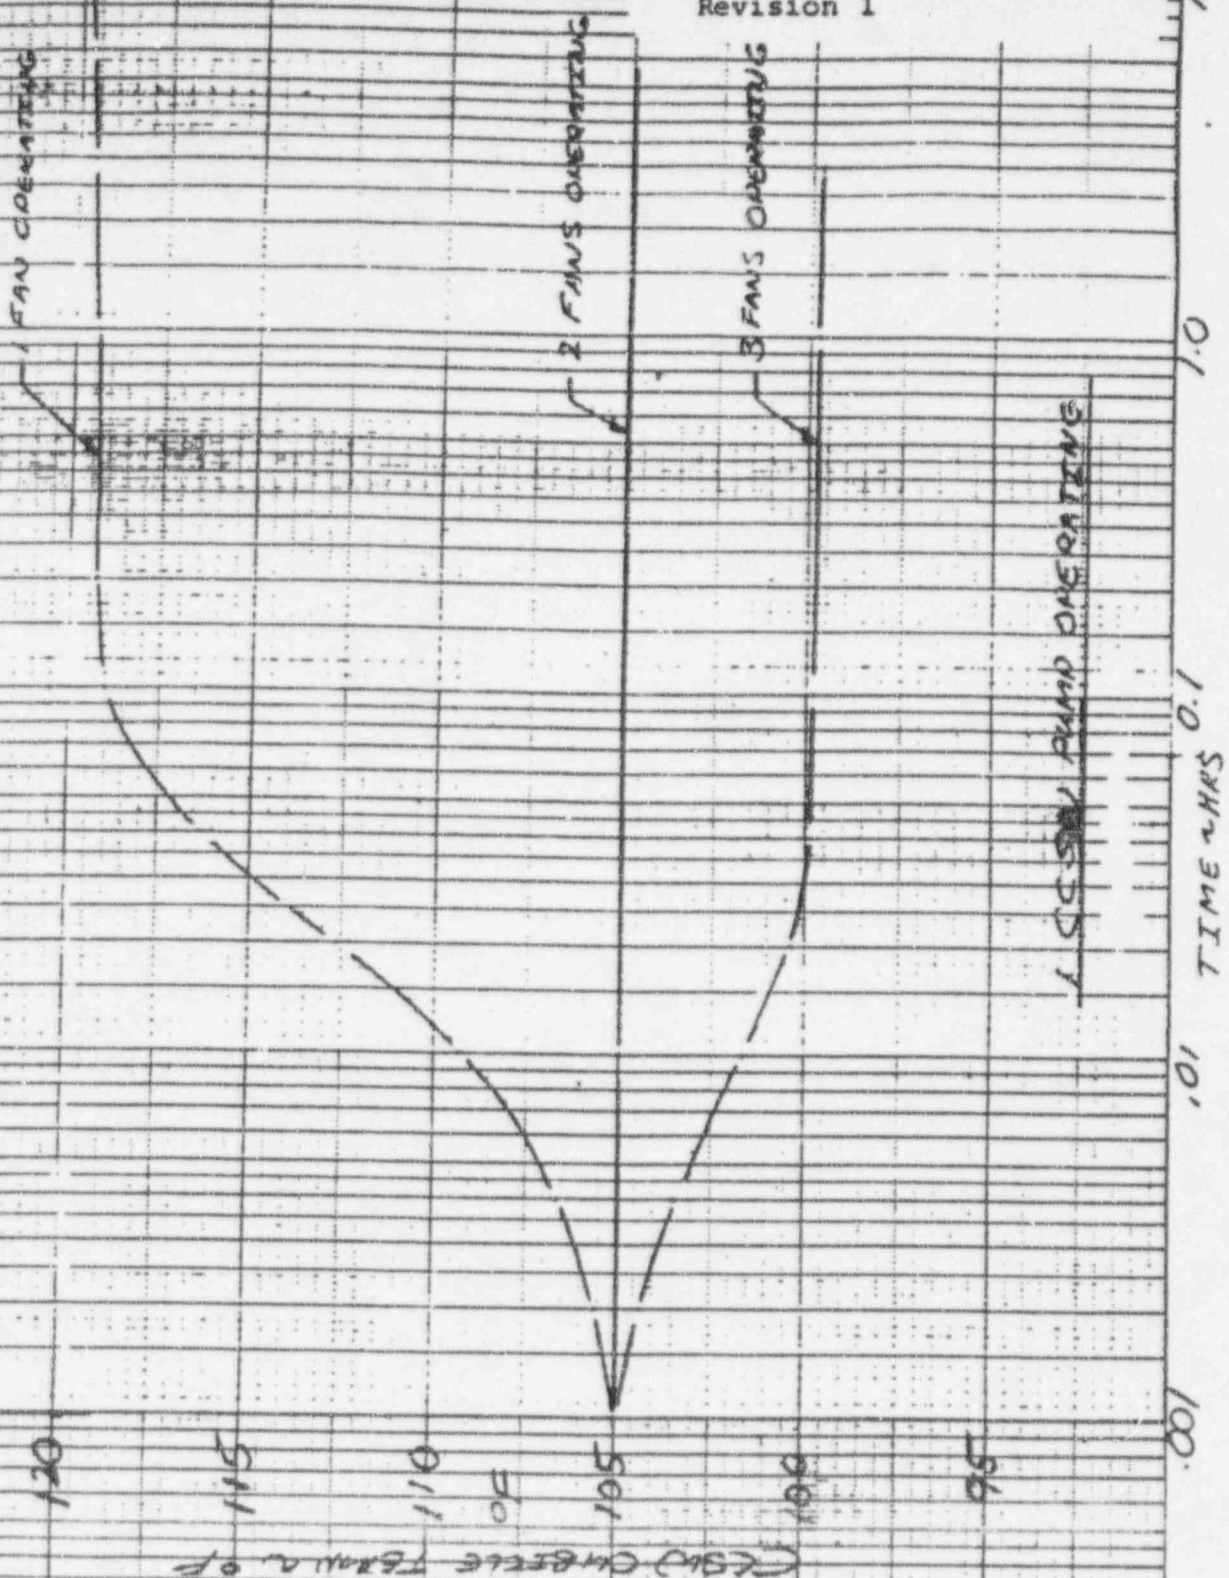
FIGURE 2 - CCSW PUMP ROOM TEMPERATURE - 85°F INLET WATER TEMPERATURE

The 85°F inlet cooling water results are presented in Figure 2 and they indicate that the cubicle temperature will reach 120°F in approximately 10 hours with 1 fan operating. The heat removal rate in the 2 fan case balances the heat load in the room and the 3 fan case causes the cubicle temperature to decrease.

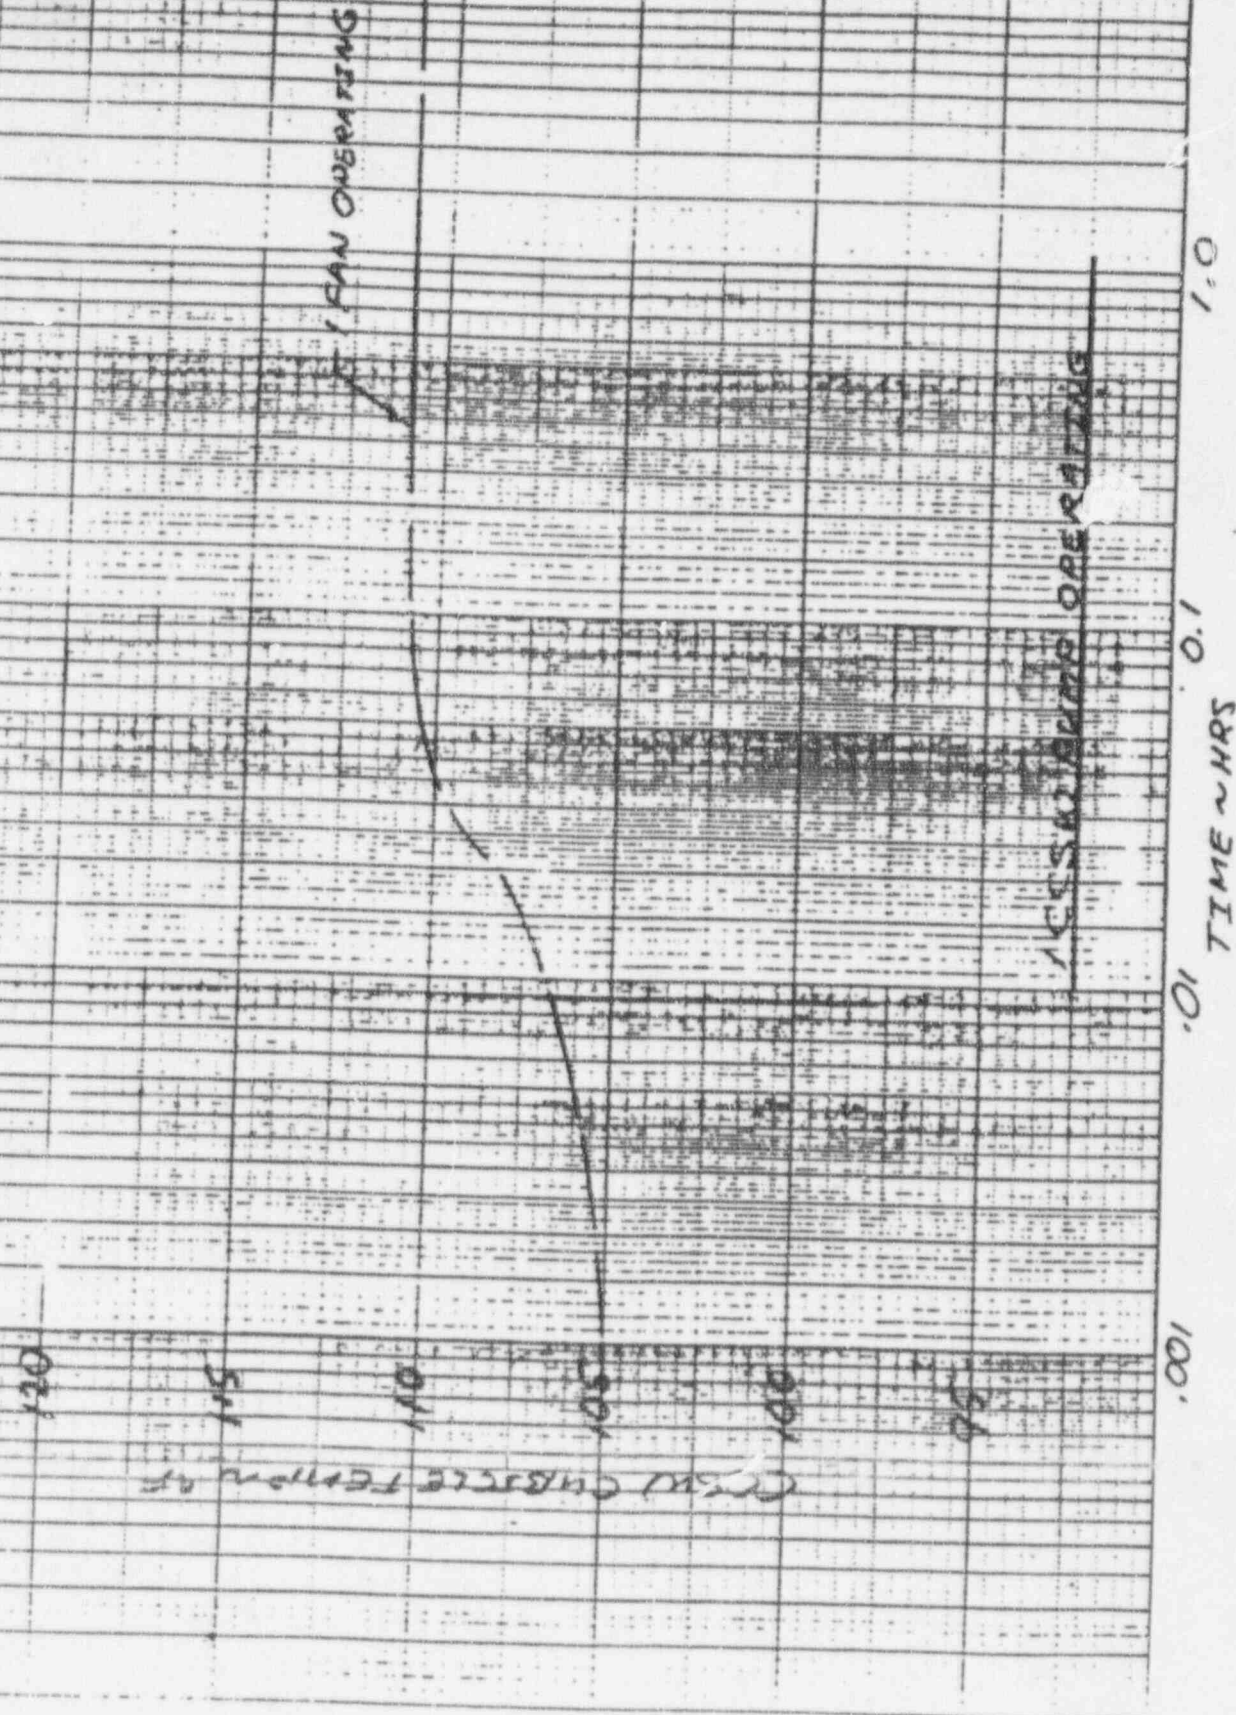
FIGURE 3 - CCSW PUMP ROOM TEMPERATURE + 75°F INLET WATER TEMP

Figure 3 presents the case of one fan operating with 75°F inlet water temperature. In this case, the CCSW temperature is approximately 112°F after 10 hours and is increasing slowly.

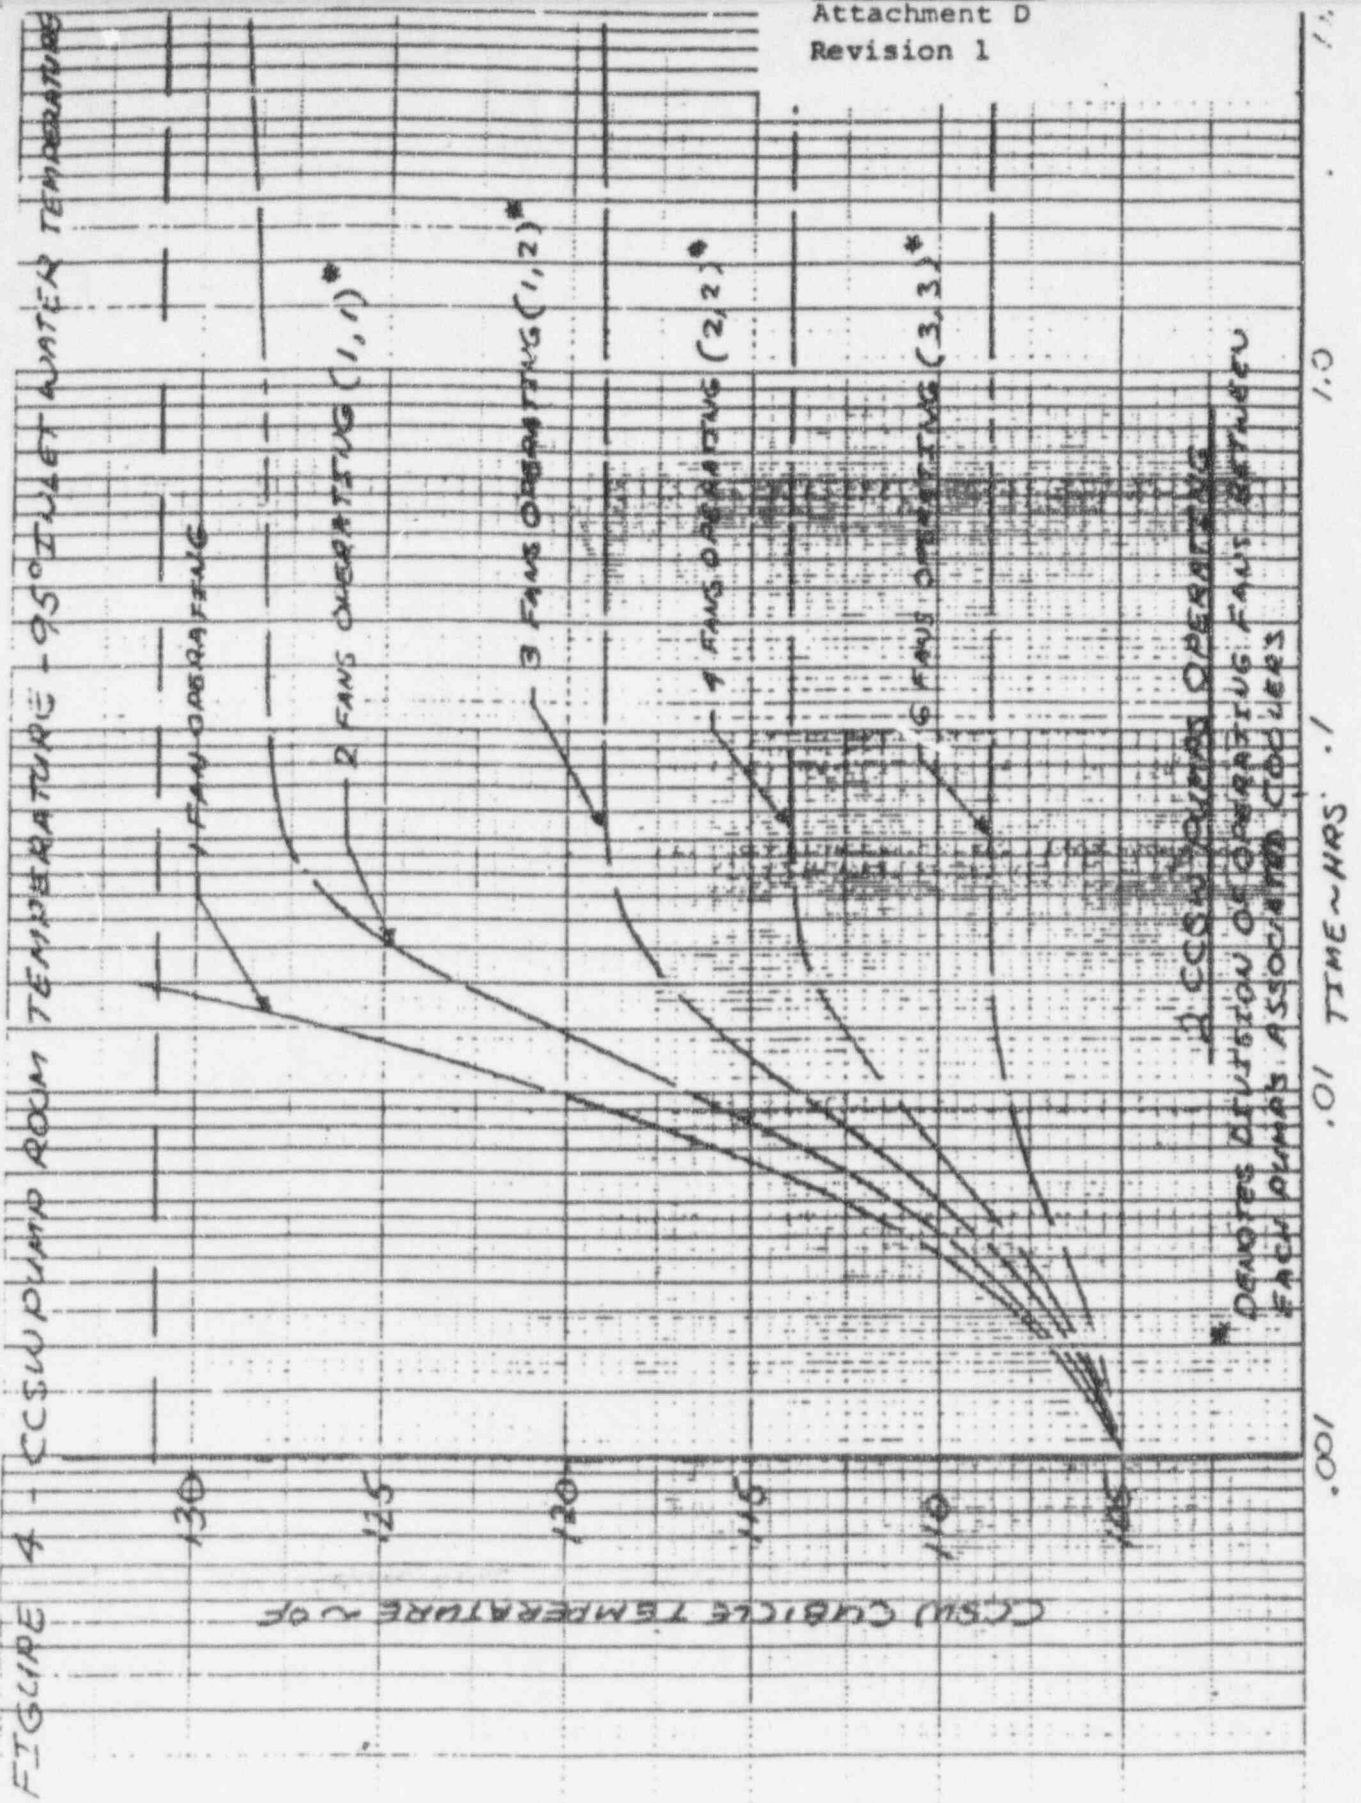
Figures 4, 5 and 6 present CCSW cubicle temperature transients for 95°F, 85°F and 75°F entering cooling water temperature with two CCSW pumps operating. Figure 4 presents five curves describing transient temperature as a function of time with 1, 2, 3, 4 or 6 fans operating. From this figure it is seen that the CCSW cubicle will reach a temperature of 131°F in less than 2 minutes when only 1 fan operates. When 2 fans operate, the temperature at 10 hours as shown in the figure is approximately 129°F. At 100 hours the additional temperature increase in the cubicle is less than 1 degree above the 10-hour value. For the condition of 3, 4 or 6

fans operating, the cubicle remains below 120°F for a 10-hour period and the temperature rate of increase after 10-hours is minimal.

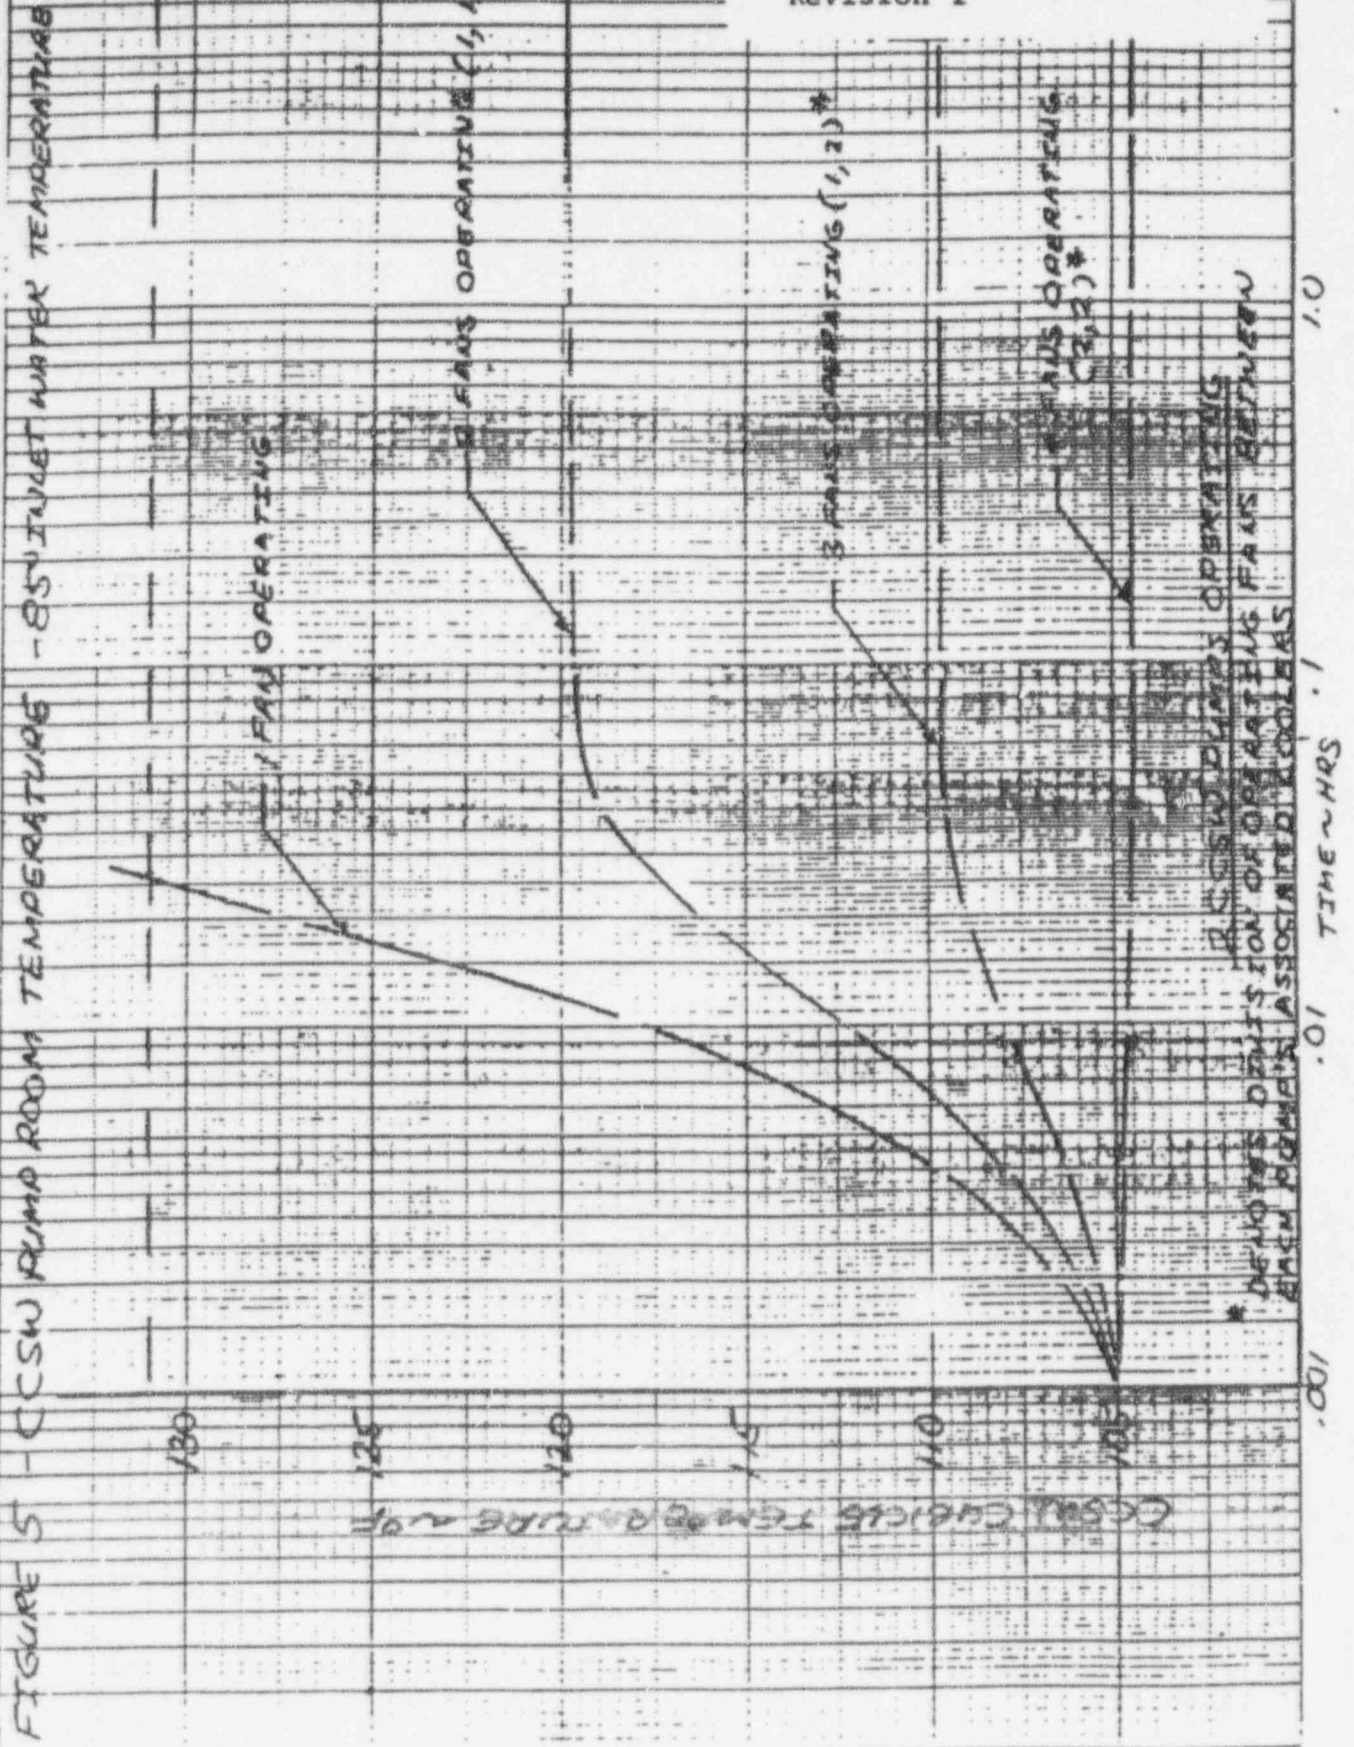
The 85°F inlet water results are presented in Figure 5 and they indicate with only one fan operating the cubicle temperature will also exceed 131°F in less than 2 minutes. With 2 fans operating the cubicle temperature will reach 120°F in approximately 10 hours. With 3 fans operating, the cubicle temperature remains below 110°F. The heat removal rate slightly exceeds the heat load with 4 fans operating.

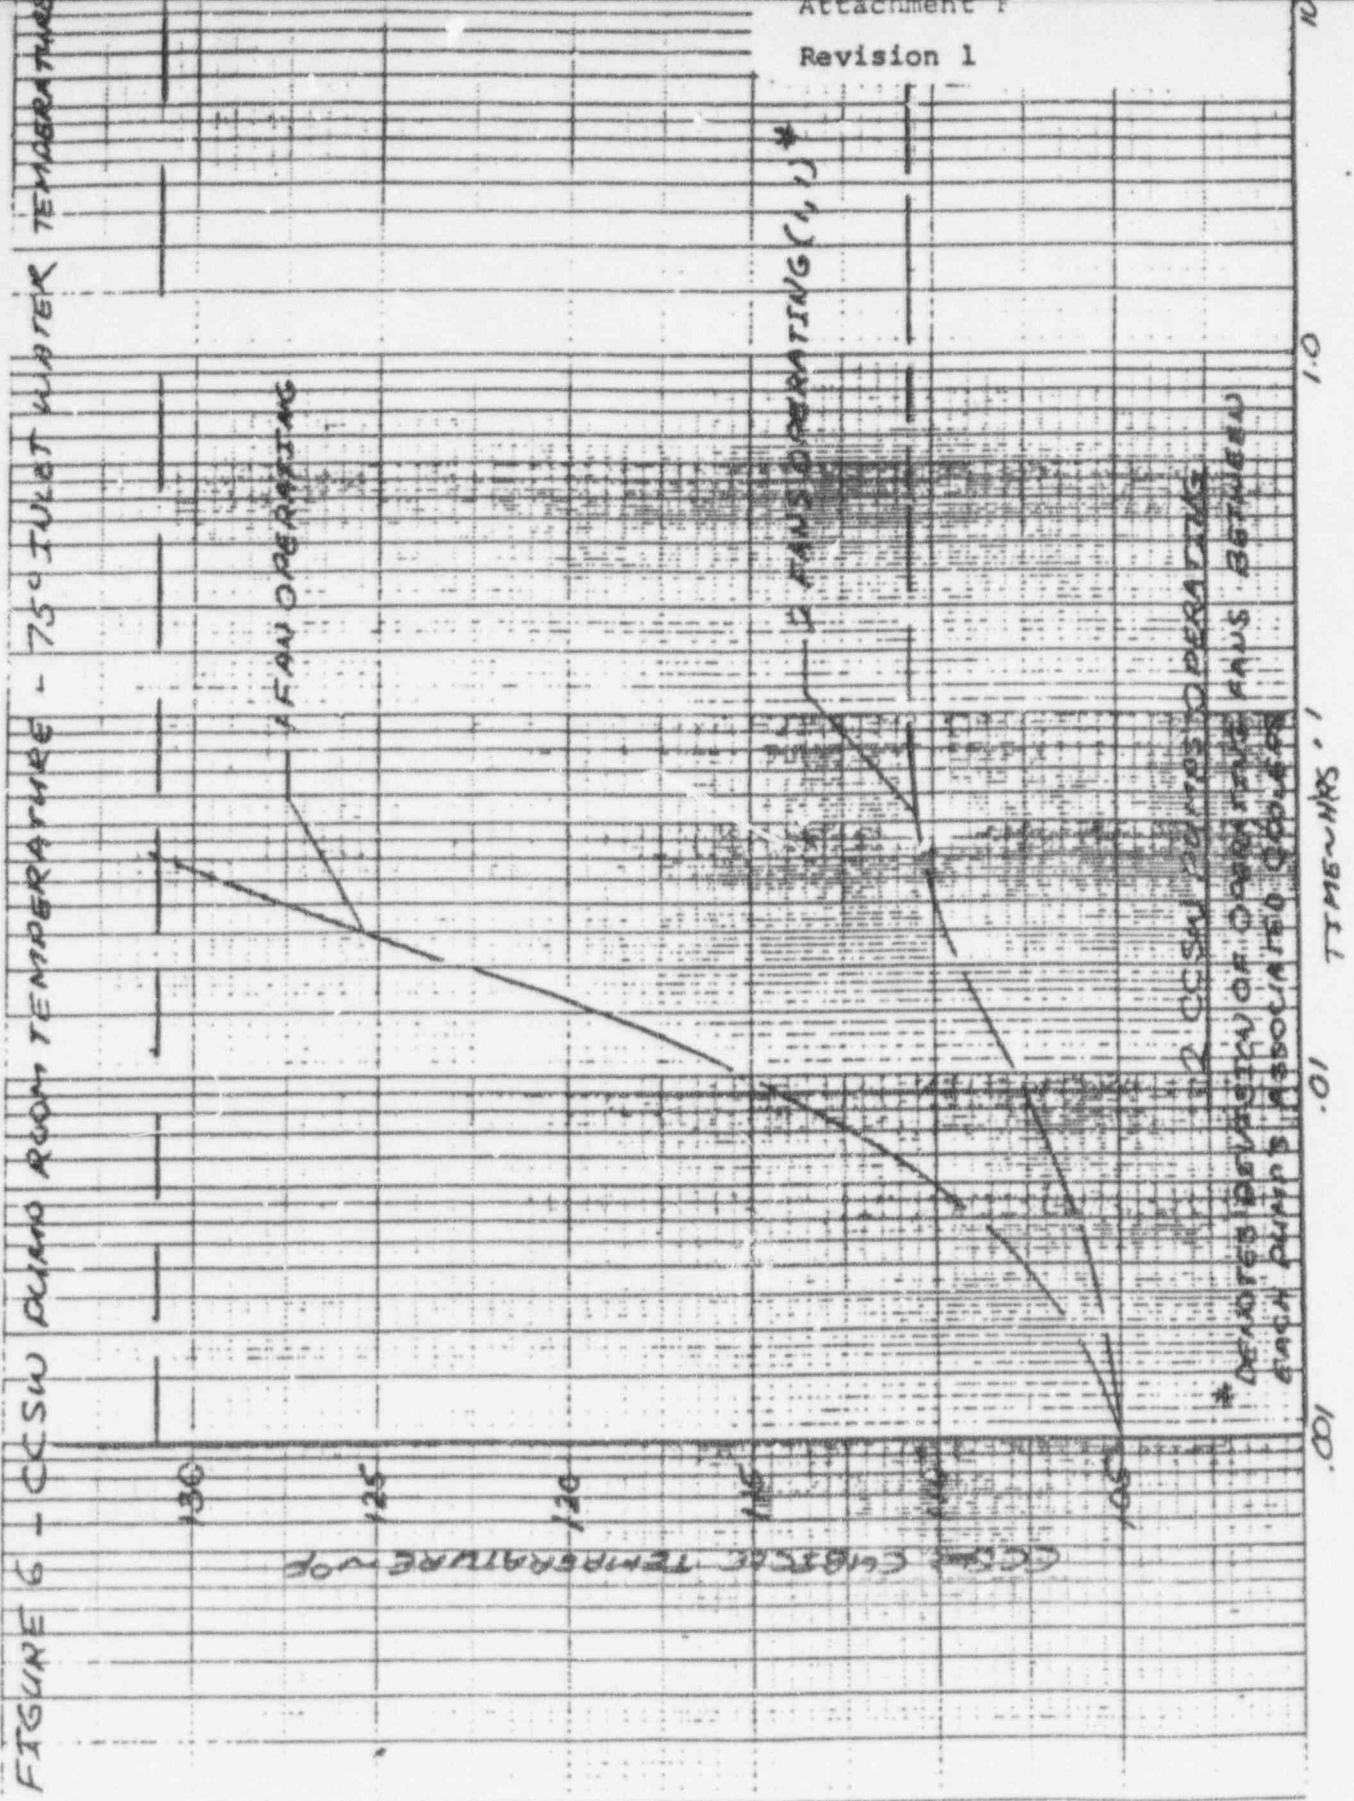
Figure 6 indicates that even with 75°F entering water temperature and 1 fan operating the qualification temperature for the CCSW pump motors is exceeded in less than 3 minutes. With 2 fans operating the temperature in the cubicle is less than 111°F after 10 hours.
