Subject: NUCLEAR PROJECT NO. 3
POTENTIAL 10CFR50.55(E) DEFICIENCY
WESTINGHOUSE POWER CENTER DRY TYPE
TRANSFORMER INSULATOR CRACKING

INTERIM REPORT

WESTINGHOUSE POWER CENTER
DRY TYPE TRANSFORMER INSULATOR CRACKING

DEVIATION/NONCOMPLIANCE NO. 067

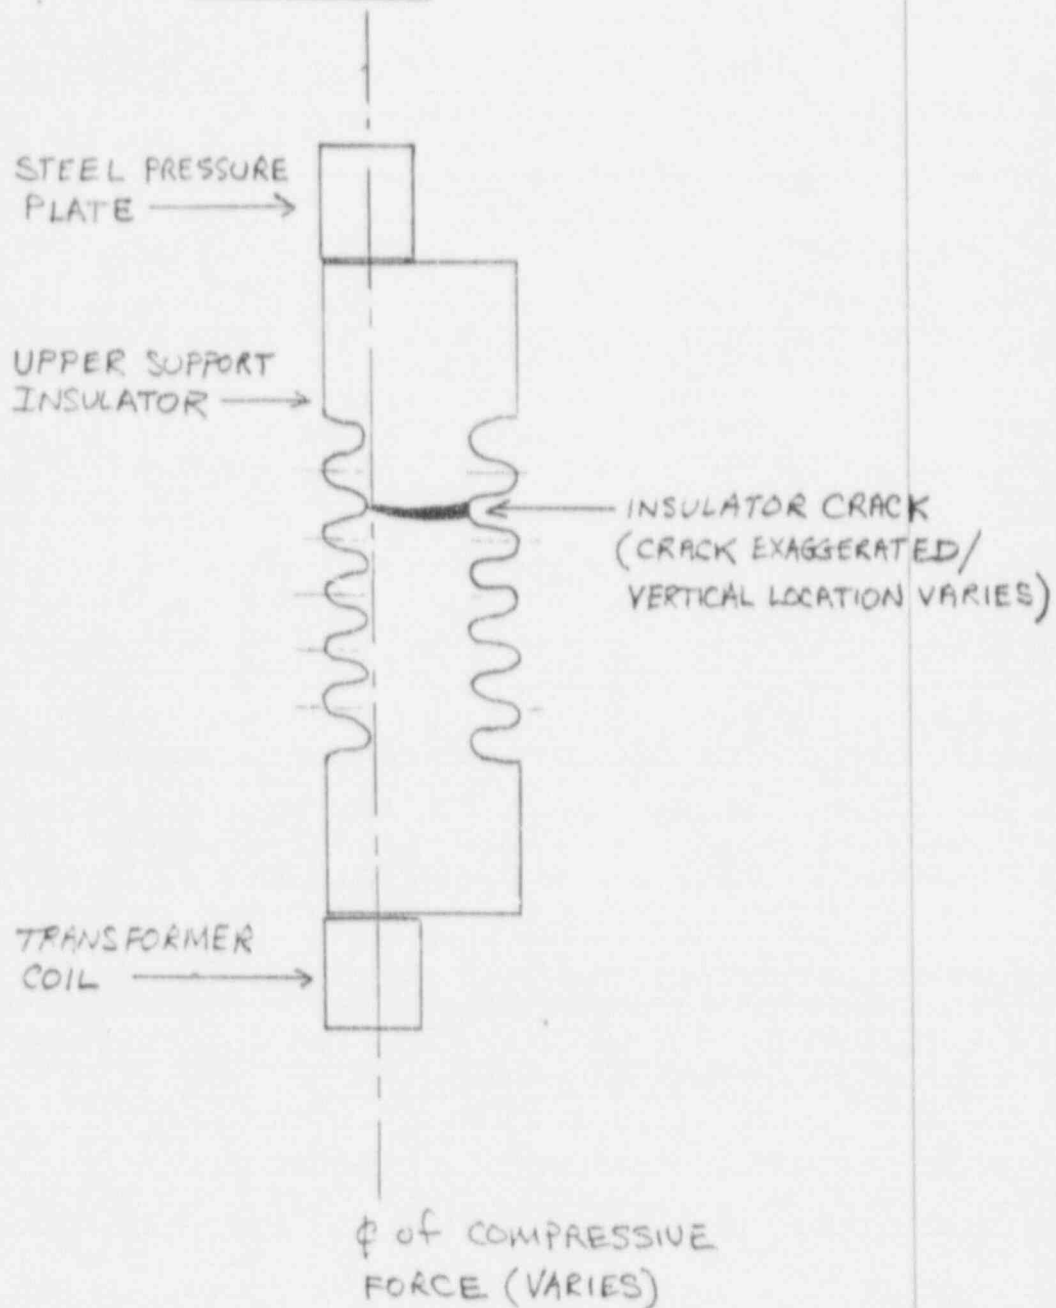
SKETCH A

In September 1987, an insulator that supports the C-phase coil of a Westinghouse supplied (Contract 3240-48) dry type air ventilated 2000KVA Non Class IE transformer (A22-NA) was discovered to be cracked and this problem was documented on a work request. Then in January 1990, three (3) cracked insulators were discovered in Non Class IE transformer A21-NA purchased under the same contract. The latter discovery resulted in an engineering inspection of transformers A21-NA and A22-NA. The inspection confirmed the insulator cracking and also identified the off-center positioning of the insulators between the coil and the pressure plate. Preliminary assessments indicated that the cracks resulted from the stress caused by the compressive force acting through the side of each insulator (see Sketch A). Both these transformers were energized prior to the discovery of the cracked insulators. As a result of this discovery, a letter was sent to Westinghouse in February 1990 notifying them of the problem and requesting their technical assistance.

Due to the above, Engineering initiated an additional work request to open the Plant's six (6) Class IE power center transformers, purchased under the same contract, for inspection. The transformers, which have not yet been energized, were inspected in November 1990. This inspection found that the Class IE transformers had the same off center positioning of the insulators between the transformer coil and the pressure plate. In addition, cracked insulators were found in two of the six transformers (A33-SA and B33-SB). Westinghouse was advised of this subsequent discovery. No information or assistance was provided by them and on April 11, 1991, NCR 15525 was initiated to document and track resolution of the problem and the open work requests were closed. The problem was deemed potentially significant since it is unknown at this time what effect the insulator's off center position and subsequent cracking would have on the Class IE qualification of the transformers. This evaluation will begin when information requested from Westinghouse, in our letter of April 30, 1991 and earlier correspondence referenced therein, is received.

The Project has tracked this problem from an isolated finding to what appears to be a generic problem. After it was determined that the problem affected our Class IE transformers, NCR 15525 was written to document the deficiency and track resolution. As part of the NCR's interim disposition and evaluation, the finding was deemed potentially significant since the potential for common mode failure exists and potentially reportable to the NRC under 10CFR50.55(e) as required by Procedure C3-N-23WP when significance could not be evaluated within 14 days. When the requested technical information is received from Westinghouse, significance will be determined and a final disposition will be made on the NCR to resolve this problem.
