Duke Power Company
McGuire Nuclear Station
12700 Hagers Ferry Road
Huntersville, NC 28078-8985

Subject: McGuire Nuclear Station Unit 1
Docket No. 50-369
Licensee Event Report 369/91-07

FACILITY NAME (1) McGuire Nuclear Station, Unit 1										DOCKET NUMBER (2) 0 5 0 0 0 3 6 9										PAGE (3) 1 OF 1					
TITLE (4) Train B Of The Residual Heat Removal System Was Inoperable Due To Inappropriate Actions And An Unknown Possible Installation Deficiency																									
EVENT DATE (5)						LER NUMBER (6)						REPORT DATE (7)						OTHER FACILITIES INVOLVED (8)							
MONTH		DAY		YEAR		YEAR		SEQUENTIAL NUMBER		REVISION NUMBER		MONTH		DAY		YEAR		FACILITY NAMES N/A							
0 5		2 0		9 1		9 1		1 - 0 0 7		- 0 0		0 6		1 8		9 1		DOCKET NUMBER (9) 0 5 0 0 0							
0 5		2 0		9 1		9 1		1 - 0 0 7		- 0 0		0 6		1 8		9 1		DOCKET NUMBER (9) 0 5 0 0 0							
OPERATING MODE (9)		1		THIS REPORT IS SUBMITTED PURSUANT TO THE REQUIREMENTS OF 10 CFR 5. (Check one or more of the following) (11)																					
POWER LEVEL (10)		1 0 0		20.402(b)						20.405(e)						50.73(a)(2)(iv)						73.71(b)

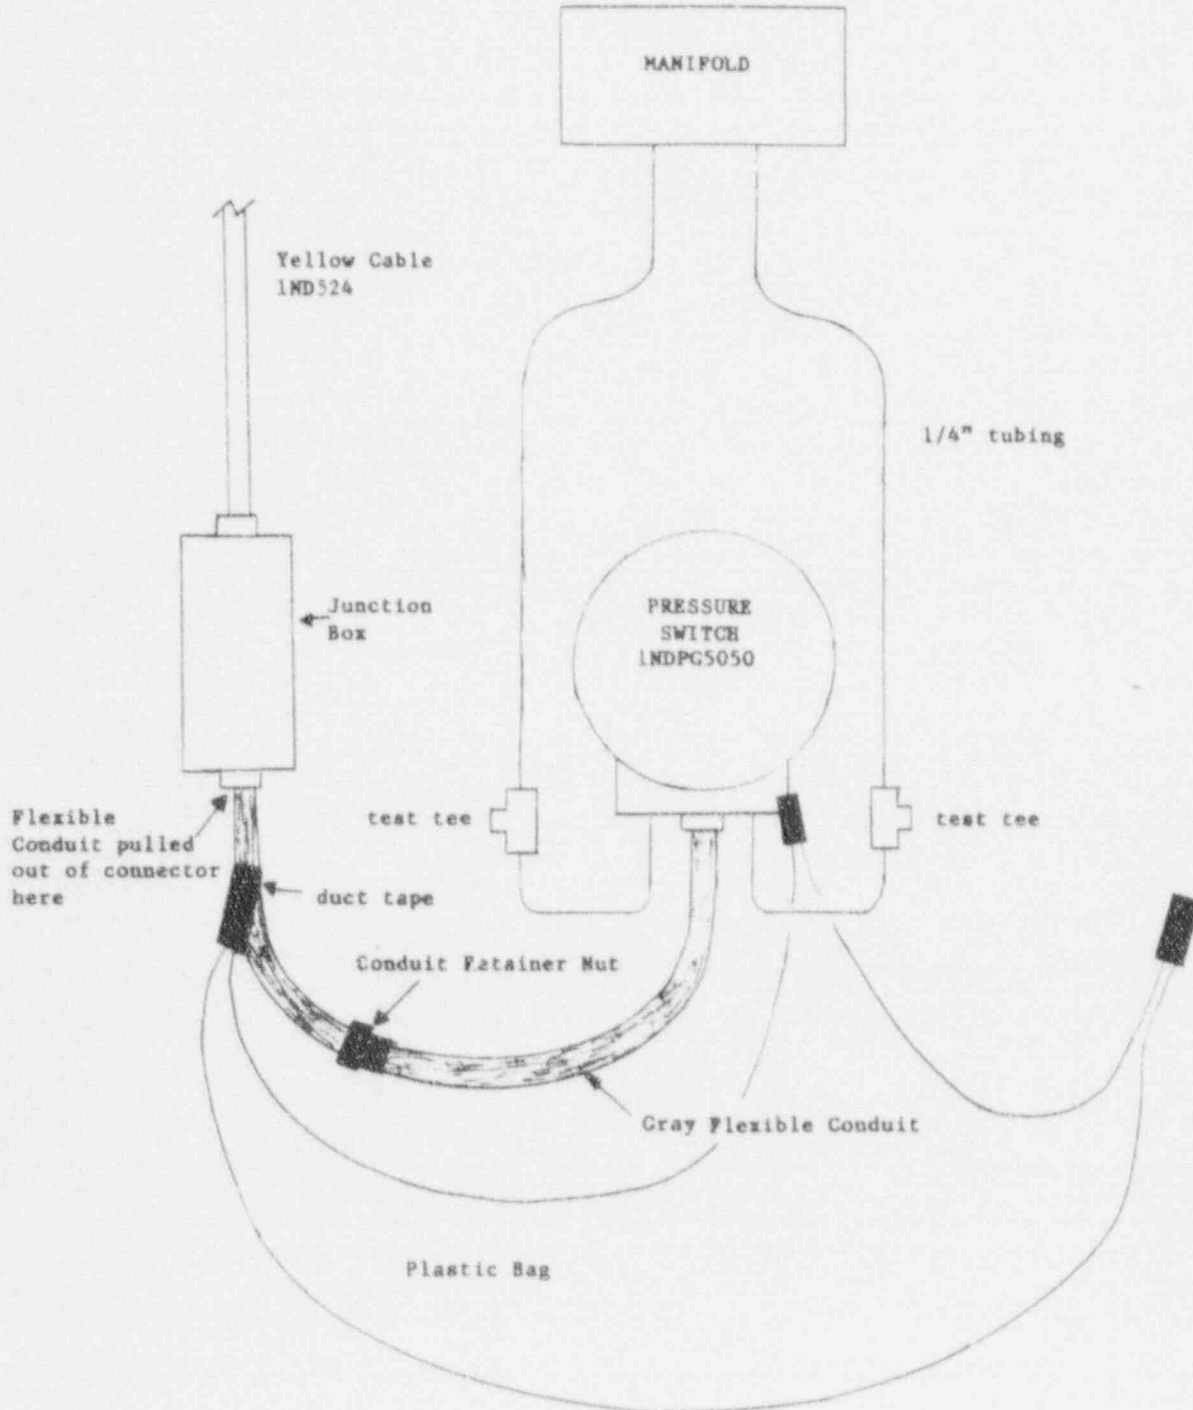
FIGURE 1
EQUIPMENT ARRANGEMENT

A cause of Inappropriate Action is assigned to PRF Technician A due to inattention to detail. The Yellow cable (1ND524) and junction box are mounted at eye level (See Figure 1, page 10 of 10). PRF Technician A should have observed this during installation or removal of the plastic bag under pressure switch 1NDPG5050. Since pressure switch 1NDPG5050 was fed by a Yellow cable, Technician A should have realized that it was nuclear safety related and should have informed his supervisor.

This event is also assigned a cause of Unknown due to the separated liquid tight flexible metal conduit which originated in a nearby junction box and terminated in pressure switch 1NDPG5050. The flexible conduit pulled out of its connector at the junction box when PRF Technician A removed the plastic bag and duct tape from under pressure switch 1NDPG5050. PRF Technician A then noticed that the flexible conduit retaining nut was not screwed on the junction box connector. The retaining nut had slid down the flexible conduit. The weight of the plastic bag and its contents was negligible and should not have caused the cable to pull out of the connector. The retaining nut may have been loose or completely off prior to this event. However, no problems were noted with this particular flexible conduit section when a material condition inspection of 695' elevation of the Auxiliary building (which addressed and corrected improperly installed and broken conduit) was performed during November and December, 1990. The connector is designed to provide strain relief from external forces applied to the cable. One possible cause for this was an installation deficiency. Had the flexible conduit been properly installed, it should not have pulled apart from the force applied by PRF Technician A to the cable. A search of equipment history files revealed that the junction box wiring was last repaired in February 1986. This repair was documented on work request 1222170PS. This work request documented, among other items, the repair of a loose crimp on a butt splice connector on the wiring inside the junction box. The junction box contained wiring that was electrically continuous and did not pull apart until an external force was applied to the cable assembly. However, IAE personnel believe existing installation procedures and calibrated crimping tools are adequate.

- Subsequent:
- 1) The wiring and conduit feeding pressure switch 1NDGP5050 was repaired as directed by work request 144977OPS.
 - 2) This event was reviewed with the personnel involved.
 - 3) ND Pump 1B was successfully tested by PRF personnel on 6/6/91.

- 3) PRF Management personnel will initiate action to upgrade the labeling on flow switches 1NDPG5040, 1NDPG5050, 2NDPG5040, and 2NDPG5050. The new labels will be color coded to indicate these instruments are train related.
