ANALYSIS OF CHECK VALVE SWING ARMS

Task 1 Evaluation of Commercial Swing Arms FINAL REPORT

SwRI Project No. 06-3893-100

TU Electric Co.
Comanche Peak S.E.S.
P.O. Box 1002
Glen Rose, TX 76043

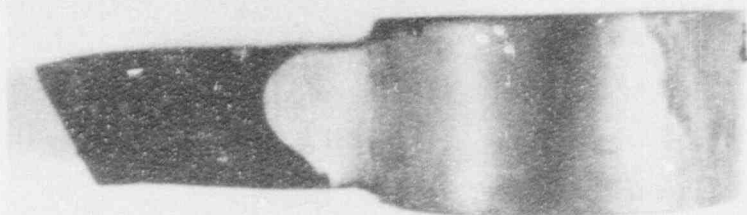
(a) Sample No. 244 (6 in.).

Weld repairs were evident on most of the large arms and in several cases considerable weld repair had been performed on the disk attachment bosses. The etching response of the weld deposits suggested that the filler material was an austenitic stainless steel (Type 308 or similar). A summary of the observed weld repairs is presented in Table 2-1 and photographs of representative examples are shown in Figures 2-1 and 2-2. In the case of the two 16-inch swing arms, the weld repairs in the disk attachment boss were such that, after final machining, the weld deposit extended completely through the radial thickness of the boss [Figure 2-1(a)]. Metallographic examinations established that the depths of all other weld repairs were on the order of 0.06-inch.

FIGURE 2-2. WELD REPAIRS IN SWING ARMS.
Immersion etched in Fry's reagent.

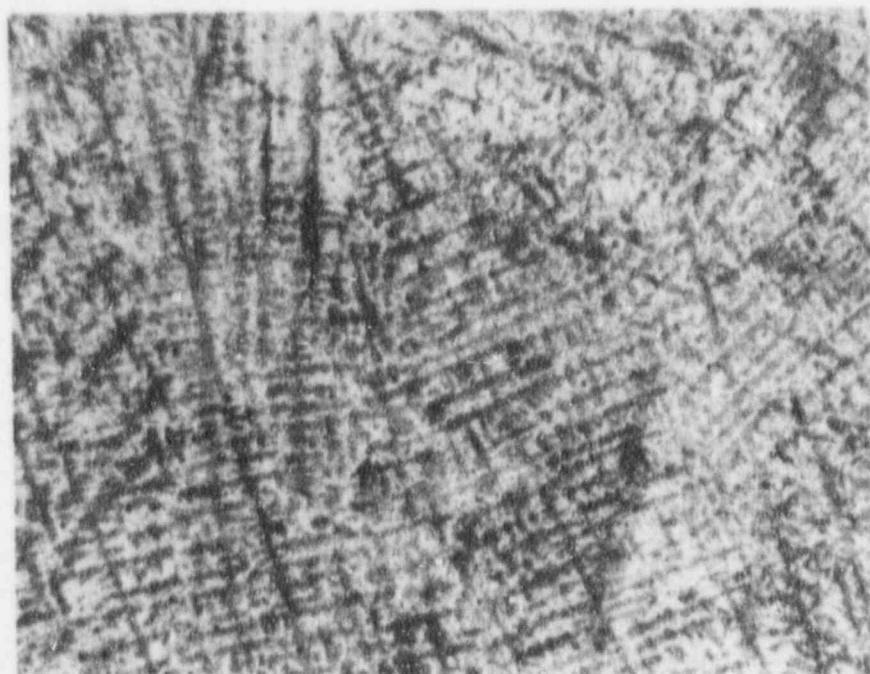
The hardness of Sample No. 260 was measured as HRC 21-HRB 96 (BHN 224). This value is substantially below the range of values for the other 15 samples and below the specified minimum hardness for CB7Cu-1 (H1100) material. The corresponding approximate ultimate strength for this hardness level is 106 ksi. It is of interest to note that the metallographic examination established that Sample No. 260 was improperly heat treated (see Section 4.1).

FIGURE 4-7. MICROSTRUCTURE OF SAMPLE NO. 260 (4-in.)
Etchant: Vilella's reagent

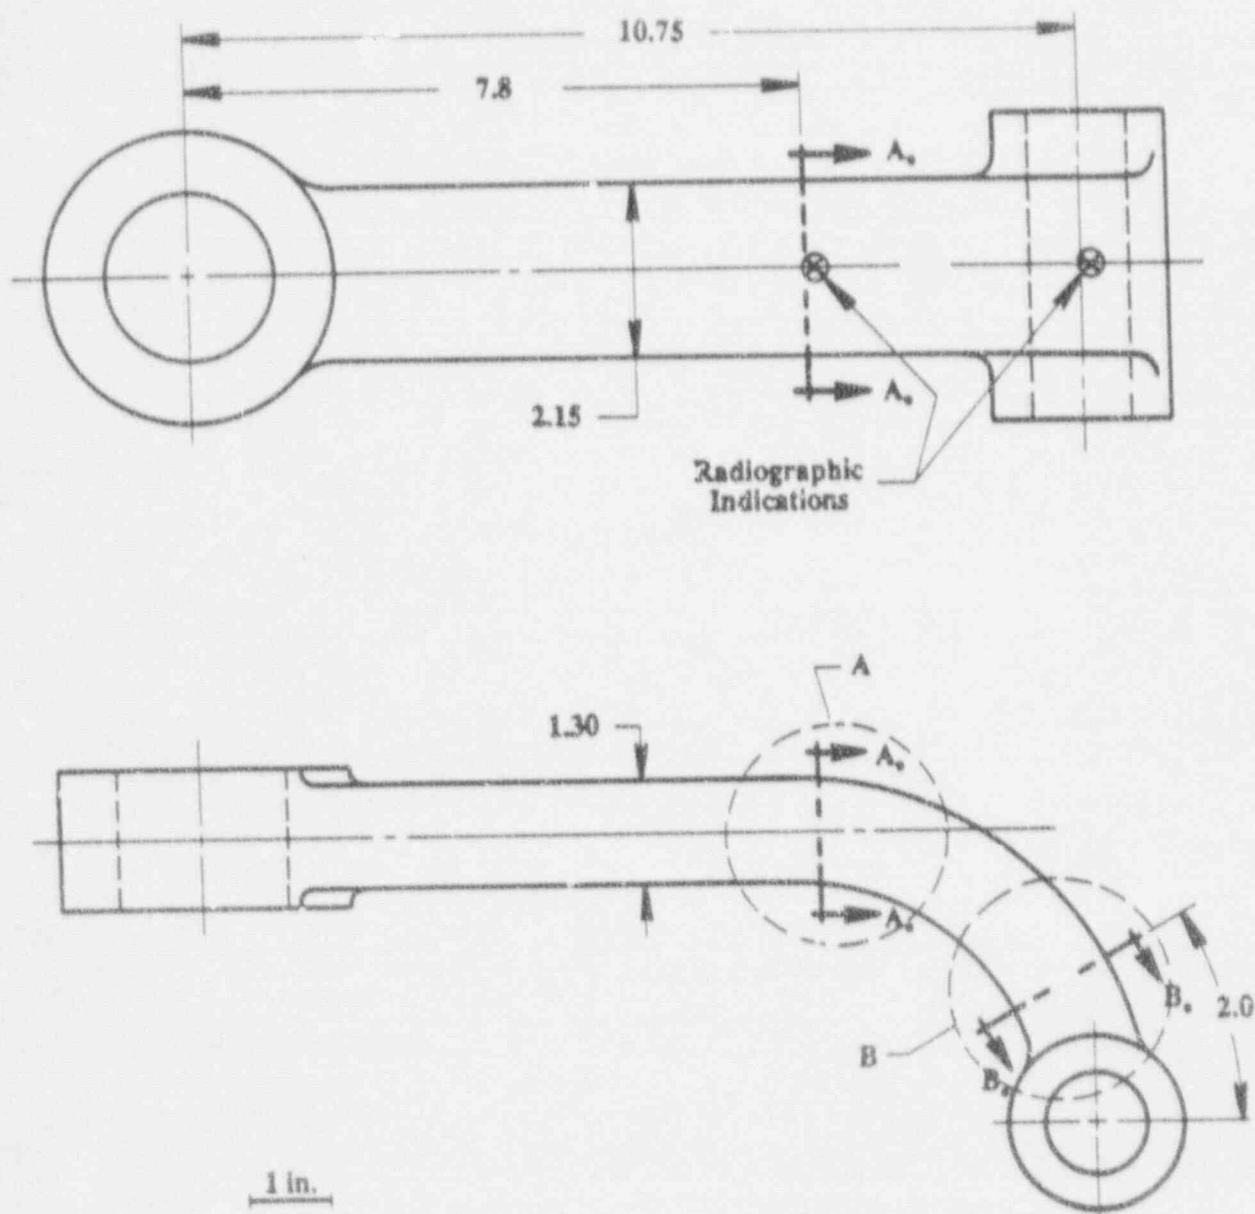
FIGURE 5-1. LOCATIONS OF RADIOGRAPHIC INDICATIONS IN SAMPLE NO. 240 (16-in.). Scale is approximate.

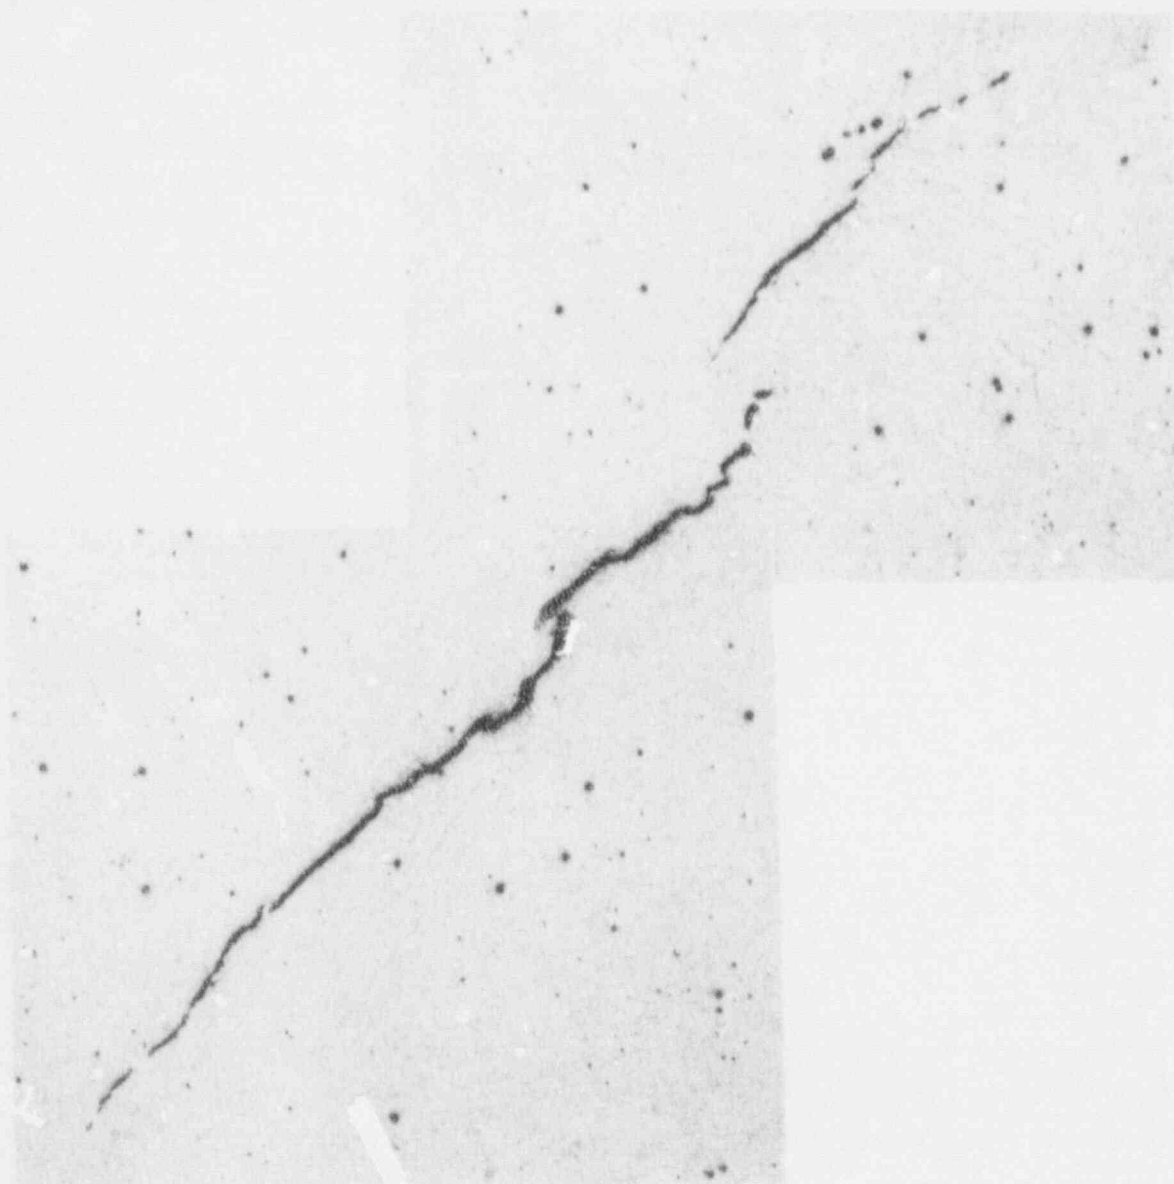
FIGURE 5-2. INTERNAL FISSURE IN SAMPLE NO. 240.
Transverse section of arm at location of radiographic
flaw indication. Section $A_0-A_0 + 0.10$ -in., see
Figure 5-1. Etchant: Vilella's reagent.

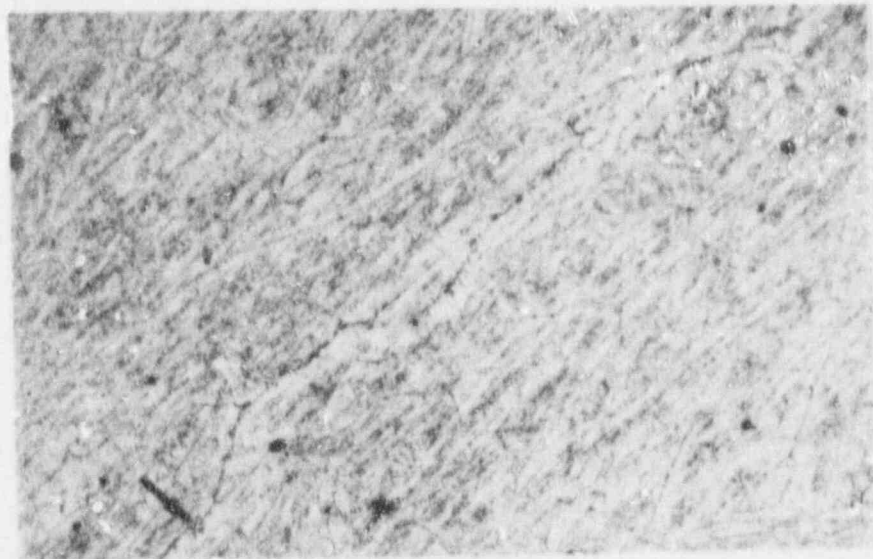
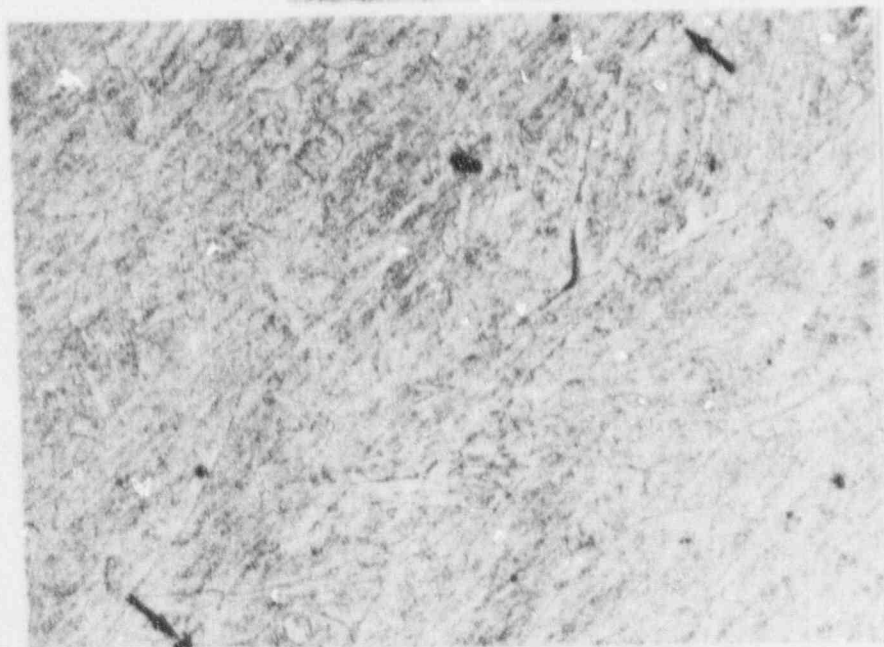
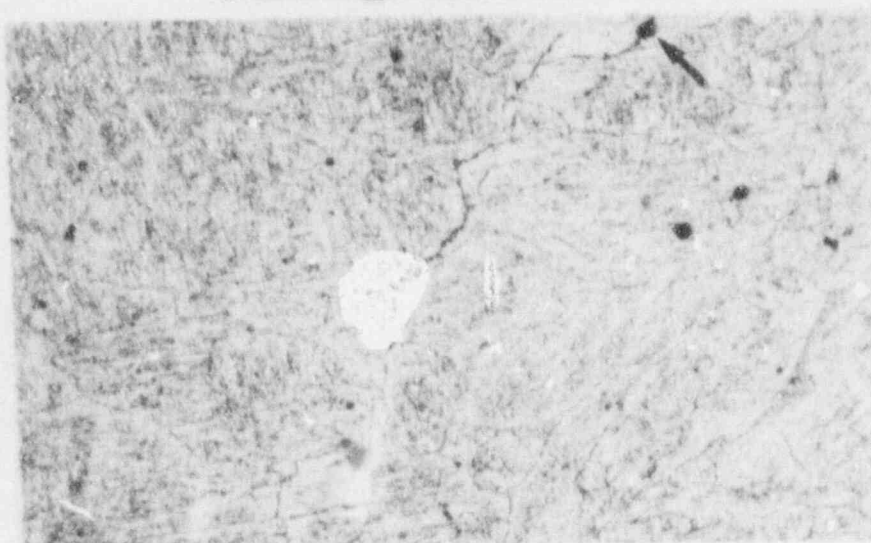
FIGURE 5-3. MICROFISSURE IN SAMPLE NO. 240 (16-in.). Transverse section 0.006 inch beyond section of Figure 5-2. Three matching photomicrographs. The upper two are displaced to the left to fit the single page format. Arrows mark matchpoints in each photomicrograph. Etchant: Vilella's reagent

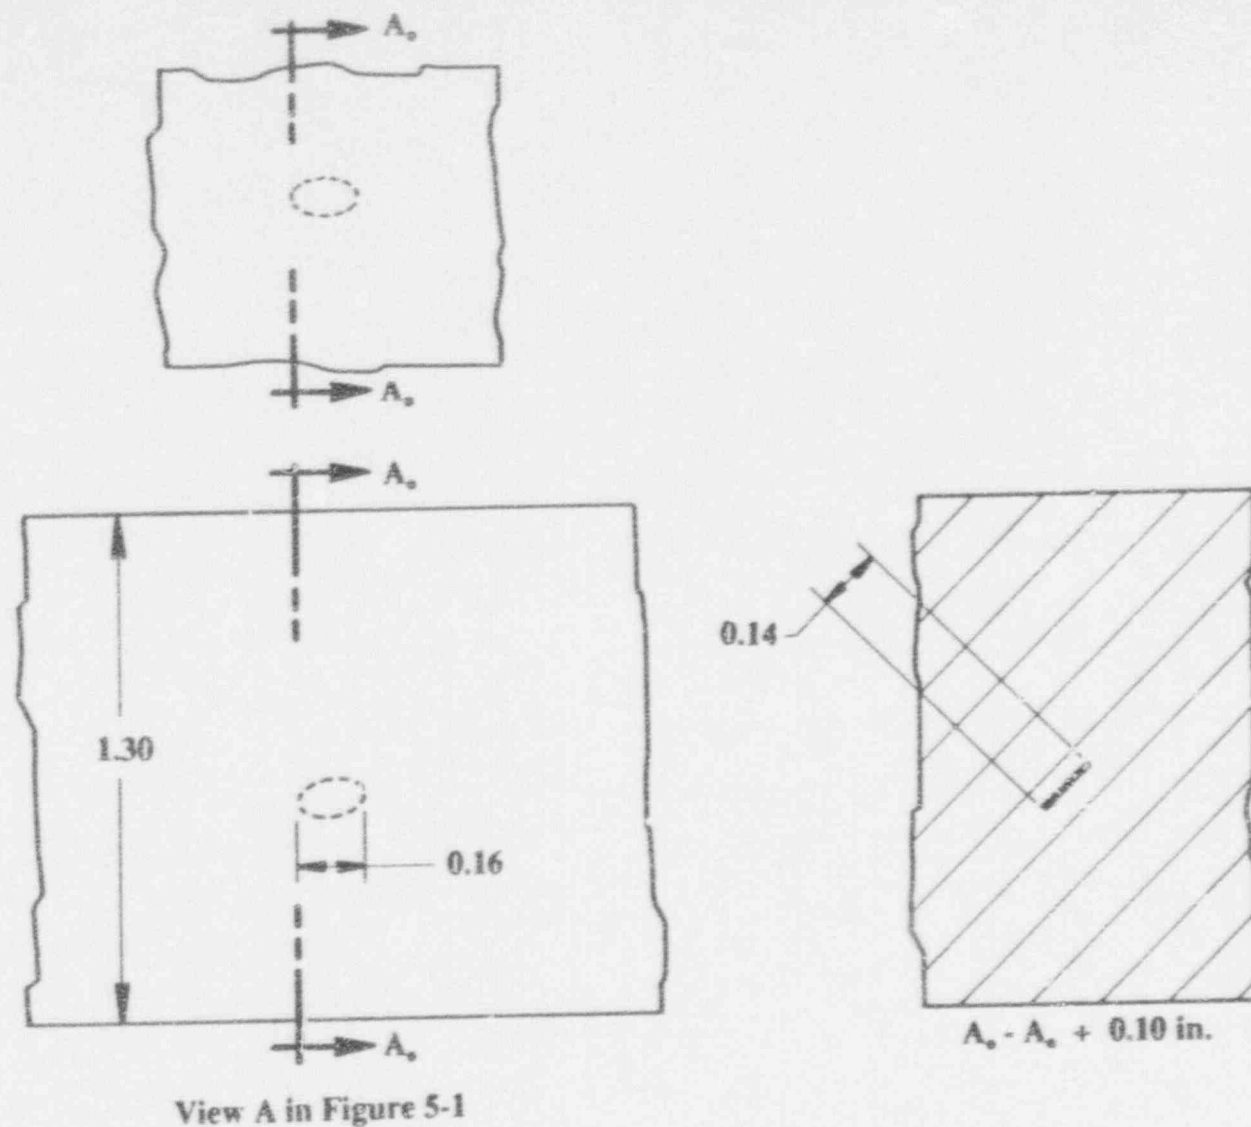
FIGURE 5-4. DIAGRAM OF INTERNAL FISSURE IN SAMPLE NO. 240 (16-in.). See Figure 5-1 for location. Twice size. Dimensions in inches.

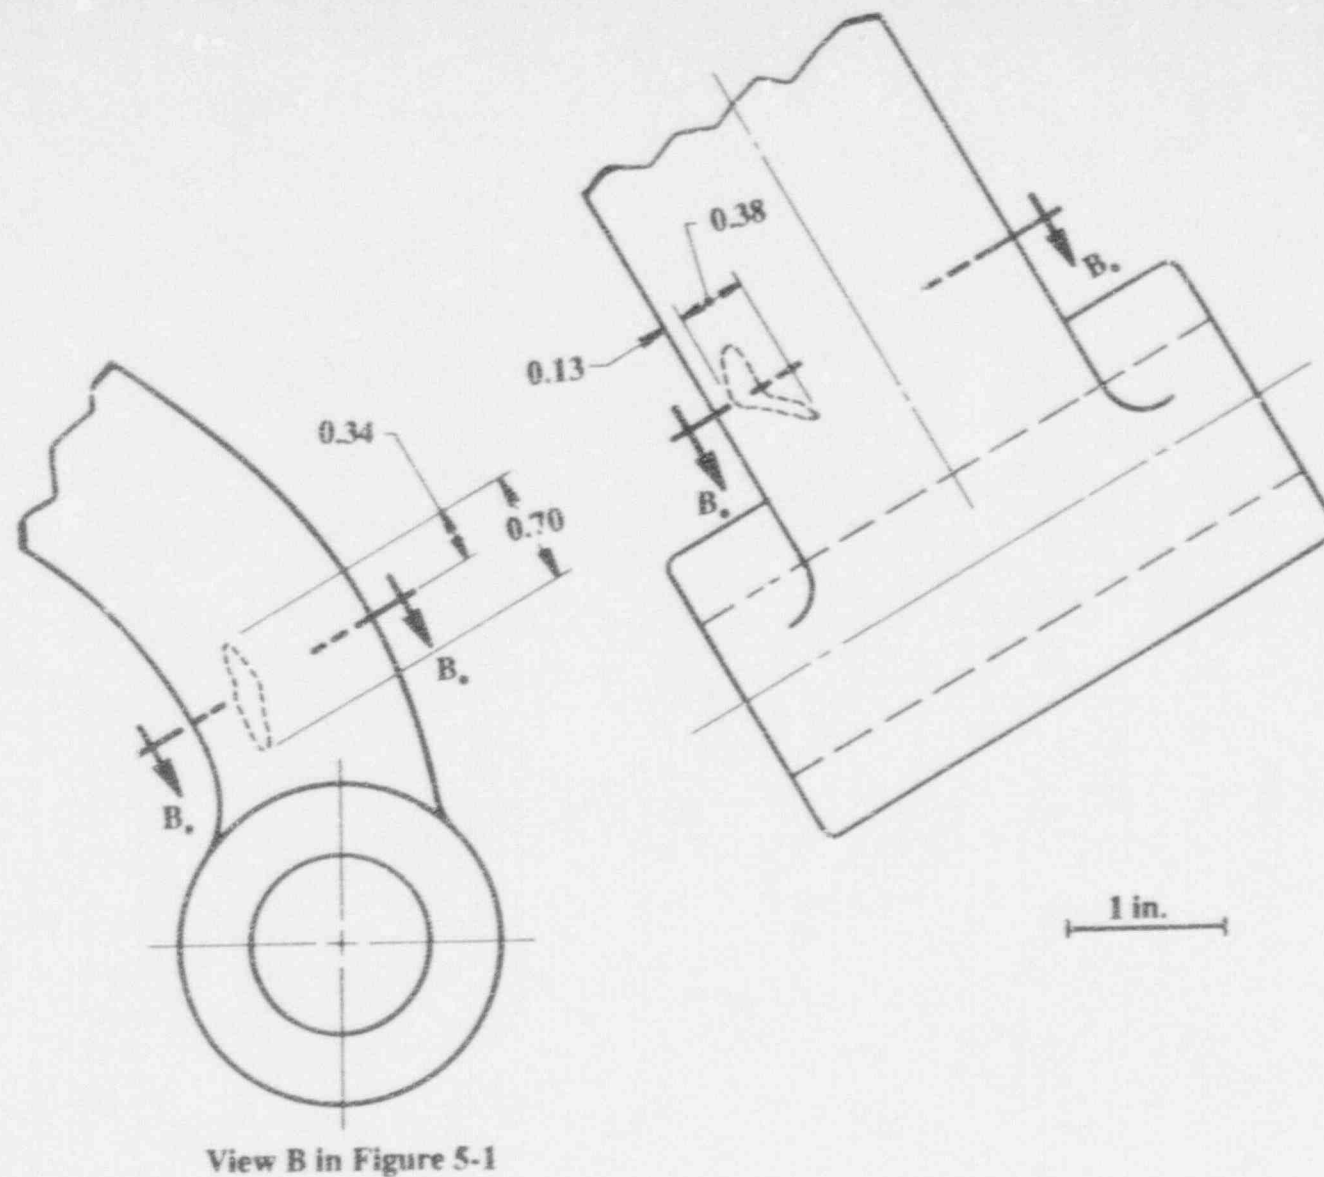
FIGURE 5-7. DIAGRAM OF INTERNAL FLAW IN SAMPLE NO. 240 (16-in.). Outlined areas represent volume containing concentration of small voids. See Figures 5-5 and 5-6. Scale is approximate.

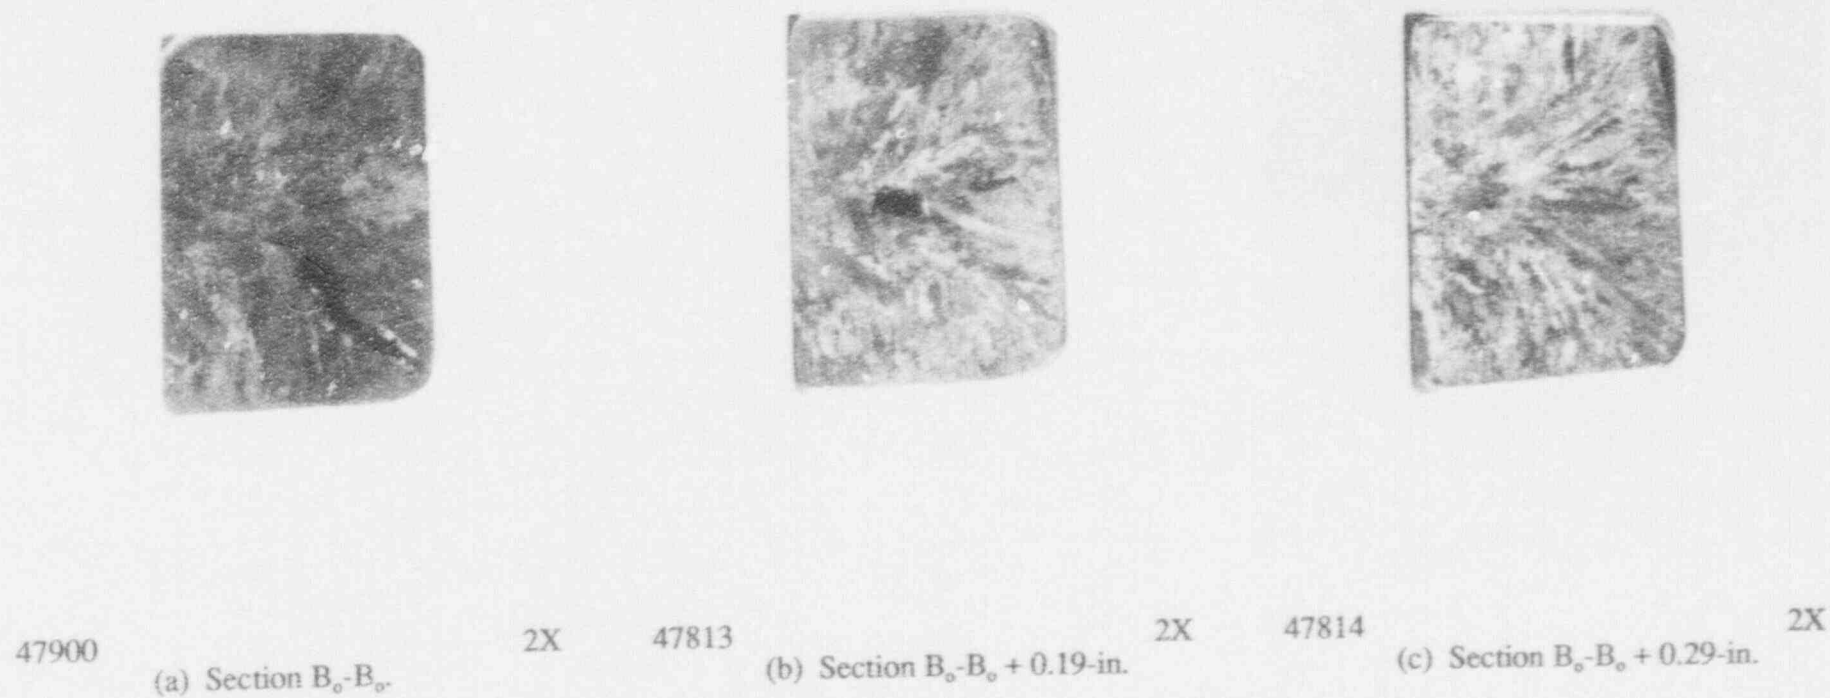
Note: Grinding to $B_0-B_0 + 0.40$ -in. removed flaw.

FIGURE 5-10. TRANSVERSE SECTION FROM SAMPLE NO. 255 (10-in.) See Figure 5-11. Etchant: Vilella's reagent

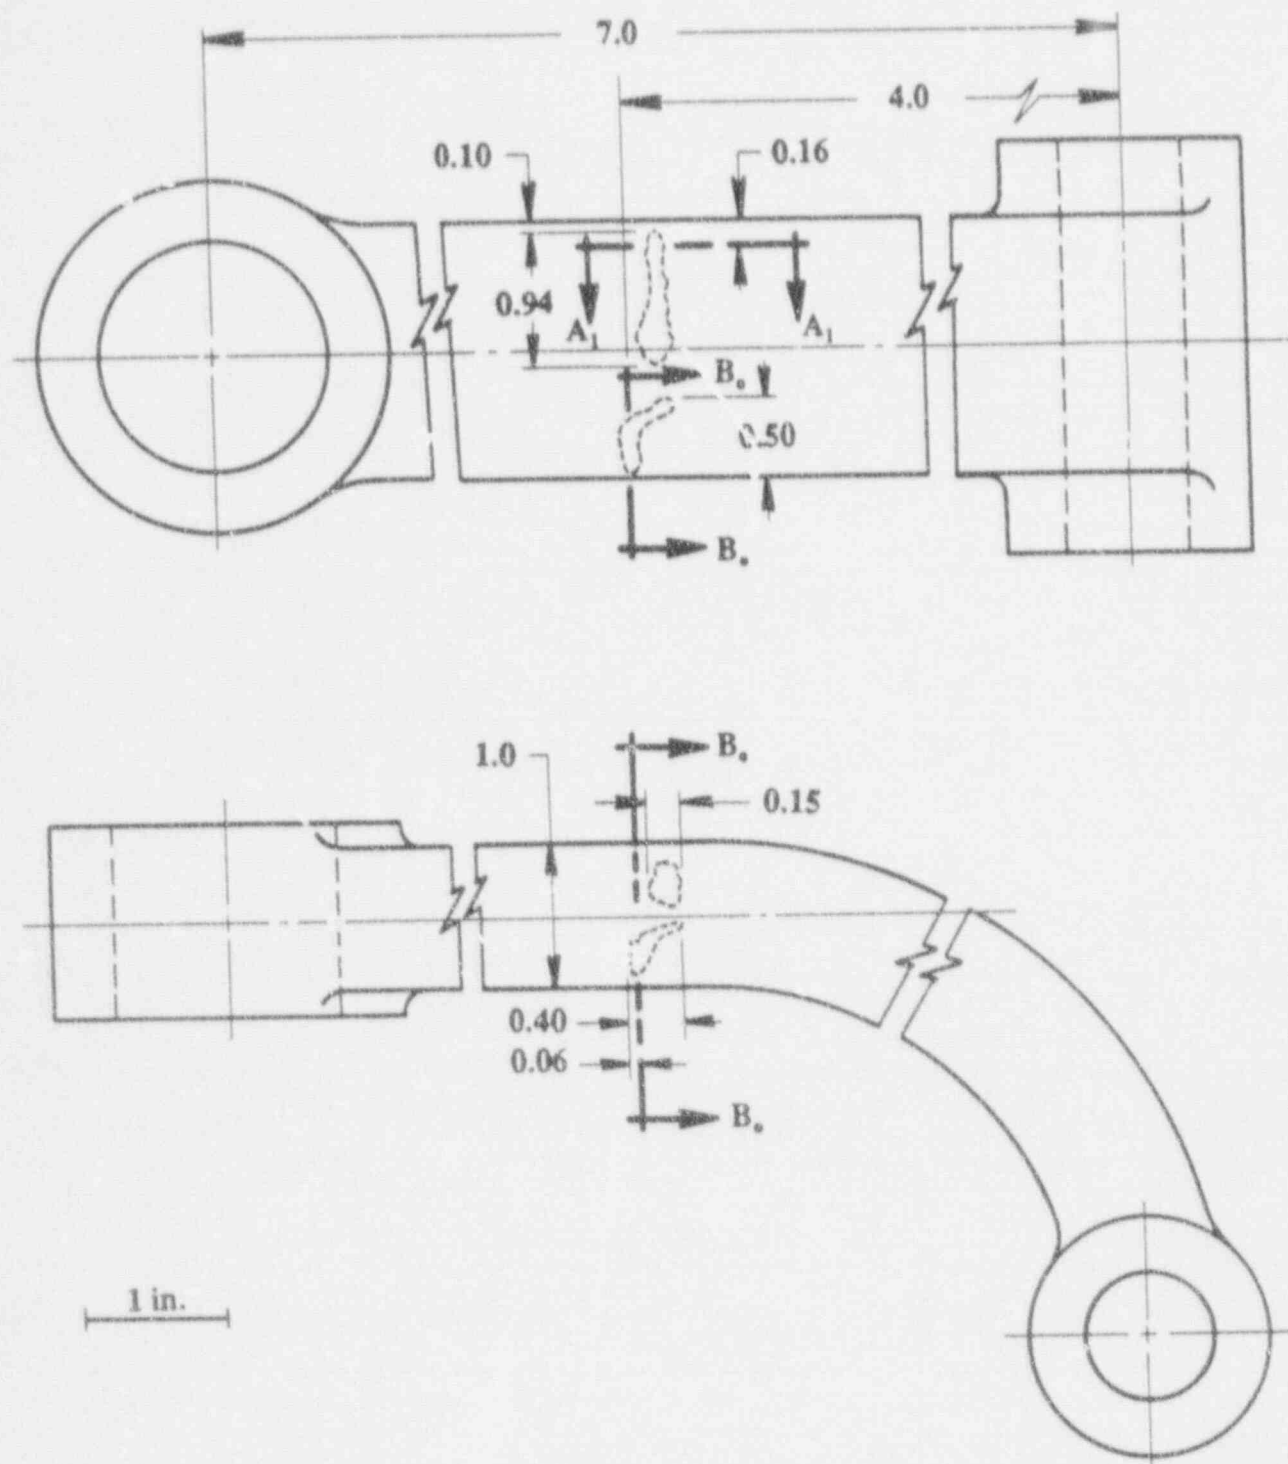
FIGURE 5-11. DIAGRAM OF INTERNAL VOIDS IN SAMPLE NO. 255 (10-in.). See Figures 5-8, 5-9 and 5-10.

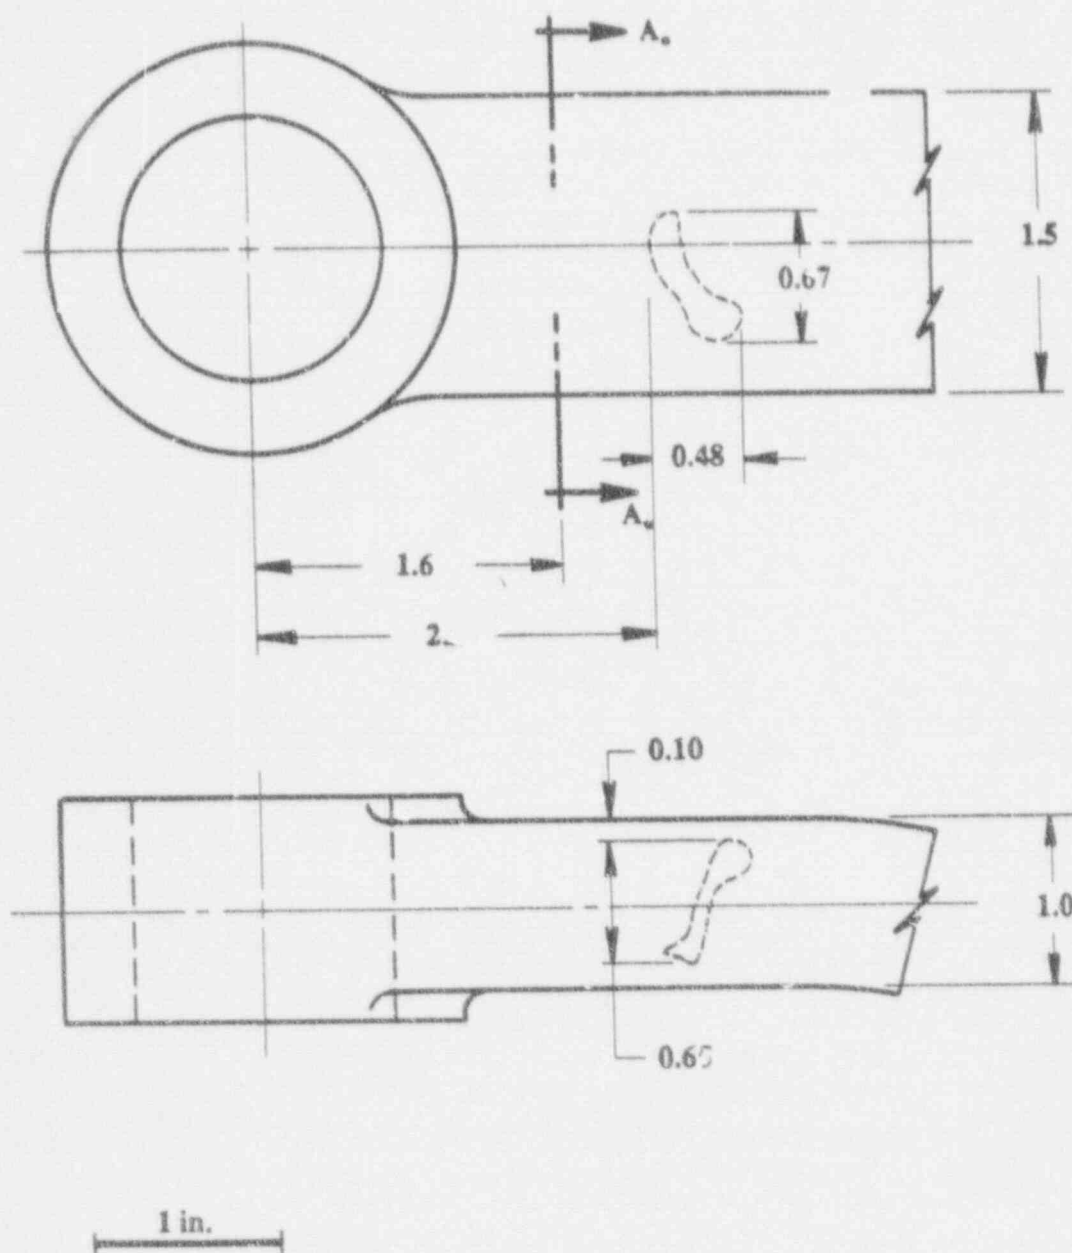
FIGURE 5-16. DIAGRAM OF INTERNAL FLAW IN SAMPLE NO. 242 (8-in.)
 Outlined areas represent volume containing concentration of small voids. See Figures 5-12 through 5-15. Scale is approximate.

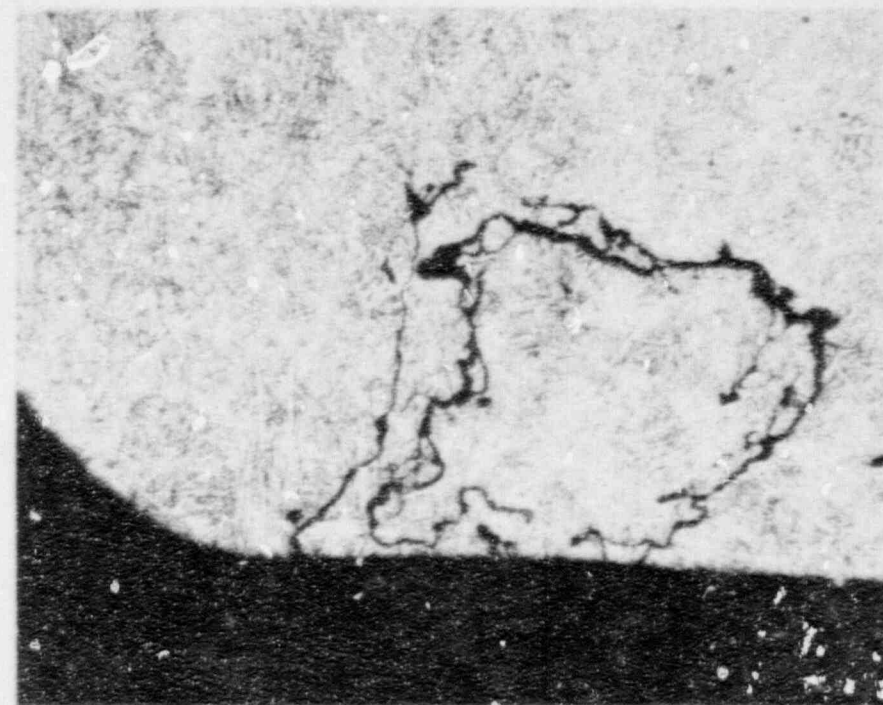
- (b) Sample No. 263 (3-in.).
Section C-C, Figure 4-1.

FIGURE 5-19. MICROFISSURES IN 4-in. AND 3-in. SWING ARMS. Etchant: Vilella's reagent

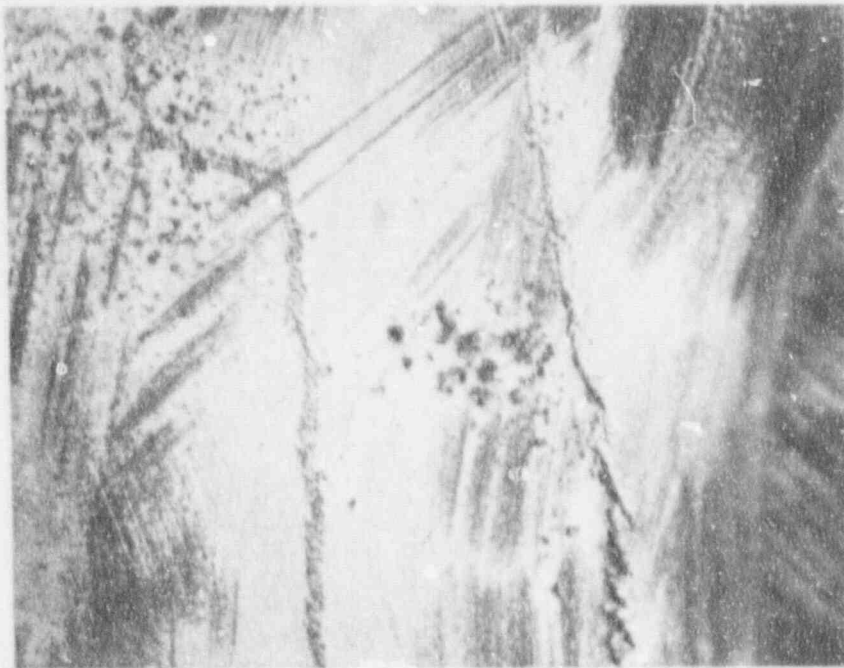
FIGURE 5-20. SURFACE CONNECTED VOIDS IN SAMPLE NO. 243 (8-in.). Location in arm-to-disk boss transition.
