TVA - BROWNS FERRY NUCLEAR PLANT (BFN) UNIT 1 - DOCKET NO. 50-259 -
FACILITY OPERATING LICENSE DFR-33 - REPORTABLE OCCURRENCE REPORT
BFRO-50-259/91007

FACILITY NAME (1) Browns Ferry Unit 1										DOCKET NUMBER (2) PAGE (3) 015101012 15 19 11 OF 014									
TITLE (4) Emergency Diesel Generators Auto-Started Due to a Degraded Voltage Condition on 4kV Shutdown Board																			
EVENT DAY (5)					LER NUMBER (6)					REPORT DATE (7)					OTHER FACILITIES INVOLVED (8)				
					SEQUENTIAL REVISION					FACILITY NAMES DOCKET NUMBER(5)									
MONTH DAY YEAR YEAR					NUMBER NUMBER					MONTH DAY YEAR					01510101				
0 5 3 1 9 1 9 1					0 0 7					0 0 7 0 1 9 1					01510101				
OPERATING THIS REPORT IS SUBMITTED PURSUANT TO THE REQUIREMENTS OF 10 CFR 5:																			
MODE (Check one or more of the following)(11)

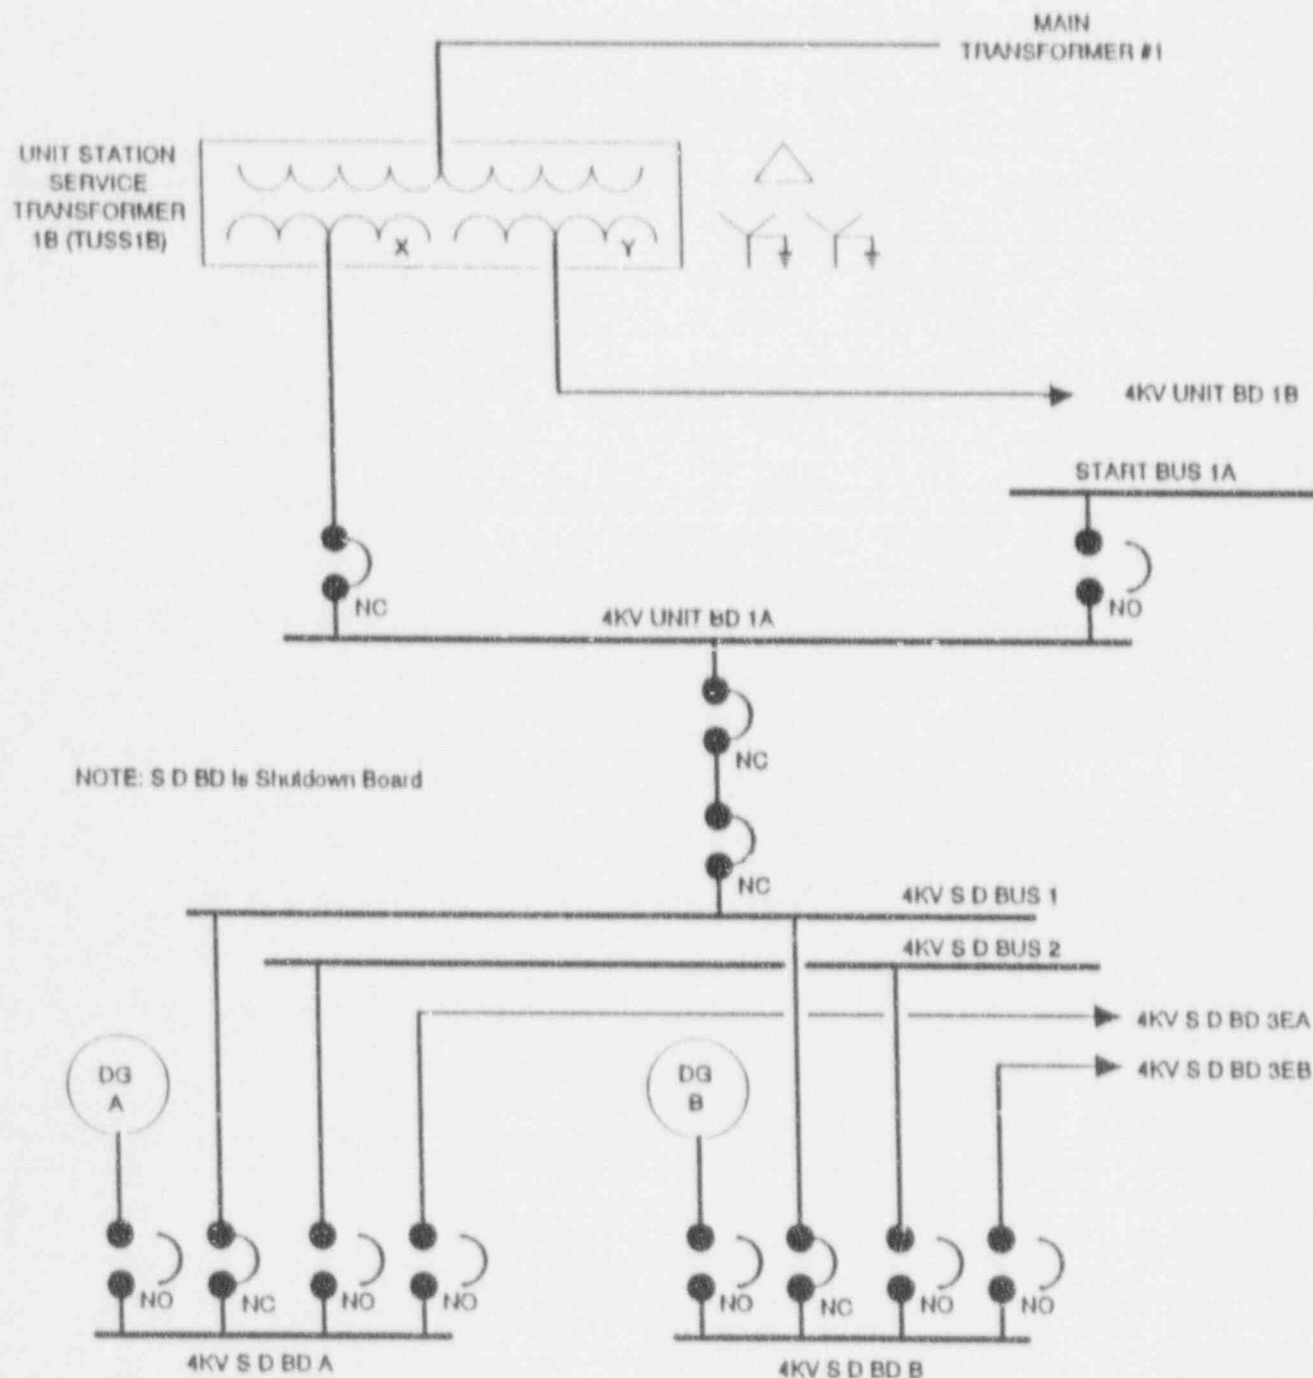
Figure 1

At the time of this event, both 4kV shutdown boards A and B were aligned to their normal feeds from 4kV shutdown bus 1 (see Figure 1). Shutdown bus 1 was being fed by its normal supply, 4kV unit board 1A. This unit board in turn was being fed from the X winding of the unit station service transformer (USST) 1B. The USST 1B load tap changer was set on automatic, with the X/Y winding selector switch of USST 1B set to monitor the lightly loaded Y winding.

However, in this event the selector switch was set to the lightly loaded Y winding of USST 1B (the Y winding supplied the lightly loaded Unit 1, while the X winding supplied the heavily loaded Unit 2 and 4kV shutdown bus 1). The voltage on the heavily loaded X winding may have been as much as 200 volts lower than that of the Y winding. Therefore, when the voltage changed sufficiently on the Y winding to require a tap change, an overshoot of one tap could easily cause voltage on the X winding to dip below the degraded voltage setpoint of the 4kV shutdown boards for the automatic start of EDGs A and B.

The procedure that governs the operation of the USST is the Switchyard Operating Procedure (SOP 6055). This procedure is not routinely used by plant personnel. SOP 6055 does specify that the most loaded winding should be the one being monitored. After reviewing the SOP, the USST 1B selector switch was reset to monitor the more heavily loaded X winding.

To ensure that the heavily loaded windings of USSTs are monitored, the Assistant Shift Operations Supervisor's daily electrical log of the Operations Routine Sheets (O-GOI-300-1) has been revised to include a note informing personnel to set the X/Y winding selector switch to monitor the heavier loaded winding.
