BOSTON EDISON

Pilgrim Nuclear Power Station
Rocky Hill Road
Plymouth, Massachusetts 02360

The enclosed Licensee Event Report (LER) 91-012-00, "Automatic Start of Diesel Generator During Surveillance Testing Due to Non-Licensed Personnel Error", is submitted in accordance with 10 CFR Part 50.73.

TITLE (4): Automatic Start of Diesel Generator During Surveillance Testing Due to Non-Licensed Personnel Error

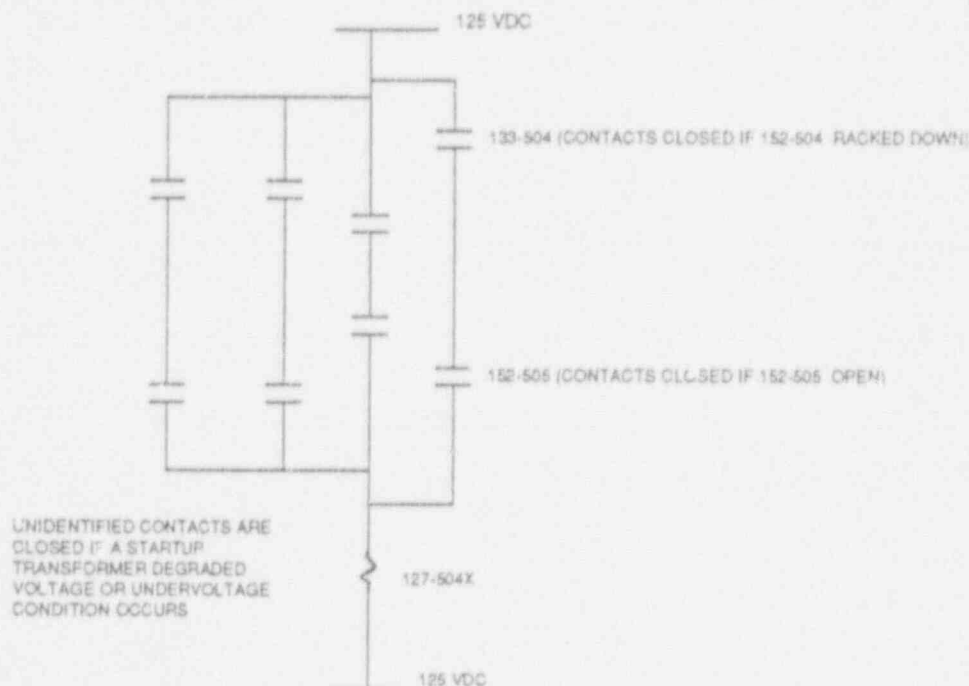
SIMPLIFIED DRAWING OF BUS A5 RELAY 127-504X CIRCUIT

Located at the end of this report are figures depicting simplified drawings of the circuitry for Bus A5 relay 127-504X and the EDG 'A' relay EMSR that are discussed in the following paragraph.

The event occurred at step [28](d) because step [28](c) was not performed. At step [28](d), a wire that was disconnected at step [16] was reconnected. The wire is part of the circuitry that energizes the Bus A5 auxiliary relay 127-504X if breaker 152-504 is not racked up and breaker 152-505 is open. When the wire was reconnected, breaker 152-504 was not racked up because it was placed in the TEST position at step [12](e) and is to be racked up at step [28](c). In addition, breaker 152-504 was in the OPEN position because it is tripped at step [28](a). Moreover, when the wire was reconnected, breaker 152-505 was in the OPEN position from step [6]. This configuration caused relay 127-504X to become energized and resulted in the actuation of the EDG 'A' emergency start relay (EMSR) and the start of EDG 'A'.
