TENNESSEE VALLEY AUTHORITY - SEQUOYAH NUCLEAR PLANT UNIT 1 - DOCKET
NO. 50-327 - FACILITY OPERATING LICENSE DPR-77 - LICENSEE EVENT REPORT
(LER) 50-327/91012

LICENSEE EVENT REPORT (LER)

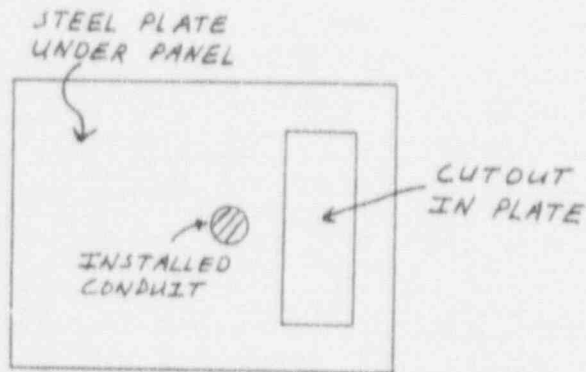
TOP VIEW OF CABINET
III FLOOR

The craft inadvertently proceeded to breach the foam insulation in the bottom of Cabinet III to support the conduit installation. While removing the foam insulation the subject breach (hole in foam insulation to spreading room) was made. A simplified sketch of the breach is attached. It appears that the craft were not aware that they had inadvertently breached the ECRPB through the foam insulation. The craft proceeded to install the conduit in the bottom of the panel and prepared to install the cable.

A contributing factor to this inappropriate action is that the breach of the pressurization boundary through the foam may not have been recognized by the foreman. The breach through the foam is not easily identified (it is not a straight vertical hole). The plugging of the conduit may have been considered adequate. This was the

Upon discovery of the breach on June 12, 1991, steps were initiated to comply with the action provisions of LCO 3.7.12. A work request was initiated to seal the breach. Documentation of the repair was completed, and LCO 3.7.12 exited at 1327 EDT on June 13, 1991.
