LIMERICK GENERATING STATION

SUBJECT: Licensee Event Report
Limerick Generating Station - Unit 1

FACILITY NAME (1) Limerick Generating Station, Unit 1										DOCKET NUMBER (2) 0 5 0 0 0 3 5 2					PAGE (3) 1 OF 0 5										
TITLE (4) Condition Prohibited by Technical Specifications in that Surveillance Requirements were not performed for a Fire Rated Barrier due to Procedural Deficiency.																									
EVENT DATE (5)			LER NUMBER (6)				REPORT DATE (7)			OTHER FACILITIES INVOLVED (8)															
MONTH	DAY	YEAR	YEAR	SEQUENTIAL NUMBER	REVISION NUMBER	MONTH	DAY	YEAR	FACILITY NAMES				DOCKET NUMBER(S)												
0	2	26	9	1	9	1	0	0	7	0	1	0	7	2	6	9	1	0	5	0	0	0	0	0	0
OPERATING MODE (9)		THIS REPORT IS SUBMITTED PURSUANT TO THE REQUIREMENTS OF 10 CFR § (Check one or more of the following) (11)																							
1		20.402(b)				20.405(c)				50.73(a)(2)(iv)				73.71(b)											
POWER LEVEL (10)		20.406(a)(1)(i)				50.36(a)(1)				50.73(a)(2)(v)				73.71(c)											
1 0 0		20.406(a)(1)(ii)				50.36(a)(2)				50.73(a)(2)(vi)				OTHER (Specify in Abstract below and in Text, NRC Form 366A)

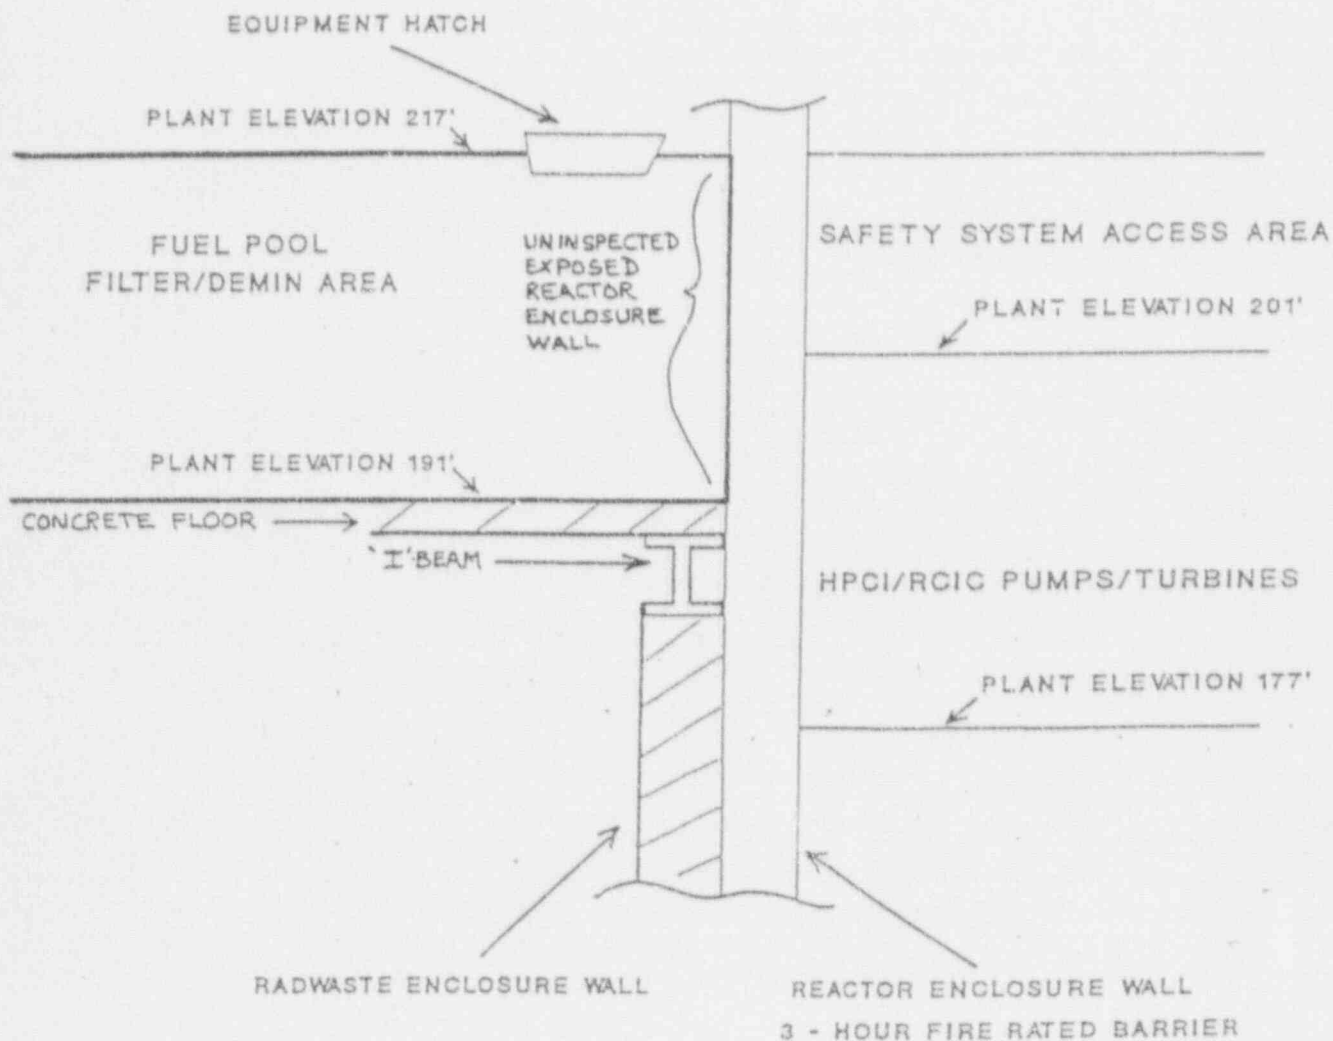
DIAGRAM 1

During the April, 1989 performance of the ST procedure, fire protection personnel implemented a Temporary Procedure Change (TPC) to remove the TS SR for a specific fire rated assembly. The TPC was implemented to remove the requirement to visually verify the structural integrity of an exposed section of the Reactor Enclosure wall (a 3-hour fire rated barrier) because of a misinterpretation of drawings. A difficulty in performing the inspection was created by various portable equipment covering the equipment hatch on plant elevation 217 feet (Diagram 1). This hatch had to be lifted open as part of the performance of the ST procedure.

In the event of a postulated fire in the area not inspected, combined with a deficiency/failure of the fire rated barrier, there is a potential for migration of the fire into the Reactor Enclosure. In the area not inspected (Diagram 1),

the combustible material consists of only cable insulation (166 pounds in a fuel pool filter/demineralizer compartment) and the combustible loading is relatively low (1.25 pounds per square foot). The equipment in this area is not safety related and a manually operated hose station comprises the total fire suppression capability in the area. No local detection for smoke or heat is available in the area.

On the opposite side of the fire rated barrier, in the Reactor Enclosure, is a safeguard system access area including safety related equipment. The combustible material again consists of only cable insulation (3578 pounds) with a combustible loading of 1.40 pounds per square foot. There is local smoke and heat detection instrumentation, as well as automatic suppression capability consisting of a preaction sprinkler system. The safety related equipment in the area consists of components of the High Pressure Coolant Injection (HPCI) system and the Reactor Core Isolation Cooling (RCIC) system.

Upon visual inspection of the involved fire rated barrier we determined that no degradation of the barrier existed and therefore, we have concluded that the barrier was capable of performing its intended function during the period in question. This, combined with the existing automatic detection and suppression capability on the opposite side, and the low combustible loading, lead us to conclude that the potential consequences of this event were minimal.
