VPNPD-91-238
NRC-91-070

DOCKETS 50-266 AND 50-301
LICENSEE EVENT REPORT 91-007-00
FIRE BARRIER INADVERTENTLY DISABLED
POINT BEACH NUCLEAR PLANT, UNITS 1 AND 2

FACILITY NAME (1) Point Beach Nuclear Plant, Unit 1										DOCKET NUMBER (2) 0 5 0 0 0 2 6 6				PAGE (3) 1 OF 16	
TITLE (4) Inoperable Fire Barrier Penetration Seals															
EVENT DATE (5)			LER NUMBER (6)				REPORT DATE (7)			OTHER #1					
MONTH	DAY	YEAR	YEAR	SEQUENTIAL NUMBER	REVISION NUMBER	MONTH	DAY	YEAR	FACILITY NAME: Point Beach, Unit 1						
0 6	2 6	9 1	9 1	0 0 7	0 0	0 7	2 6	9 1	0 5 0 0 0 2 6 6						
OPERATING MODE (8) N		THIS REPORT IS SUBMITTED PURSUANT TO THE REQUIREMENTS OF 10 CFR 5 (Check one or more of the following):													
POWER LEVEL (10) 1 0 0		20.402(b)				20.405(e)				50.73(a)(2)(iv)				73.71(b)

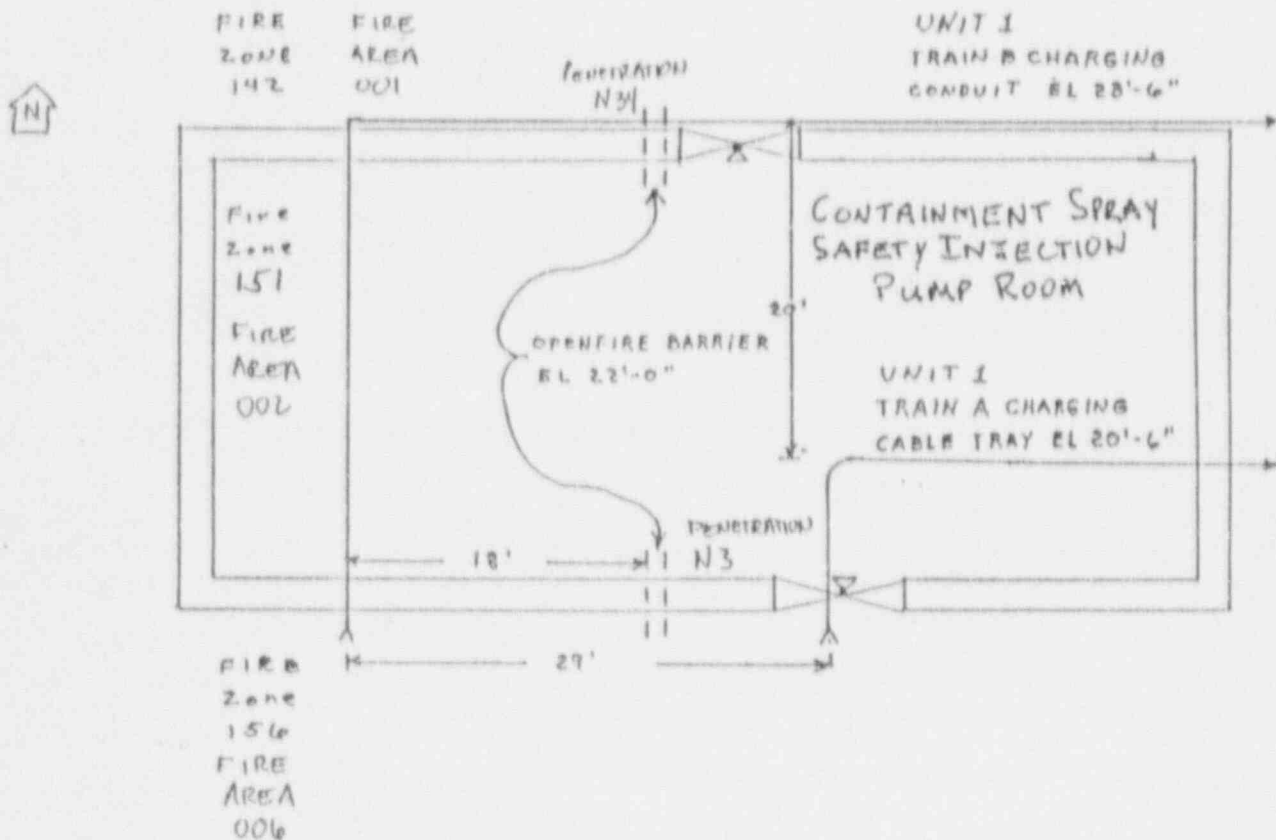
Figure 1

The open penetrations compromised the fire protection integrity of fire area 002, creating the potential for a fire to spread between area 002 and adjacent areas. Penetration N34 is located between fire area 002 and fire zone 142 of fire area 001 to the north. Penetration N3 is located between fire area 002 and fire zone 156, which makes up all of fire area 006, to the south. (See Figure 1.)

The open penetration in the south wall of fire area 002 (N3) degraded the fire barrier and provided a possible but unlikely combustible pathway between fire area 002 and fire area 006. The approximate six inch by twelve inch opening which had been made for new conduit installation was located approximately fourteen feet above the floor and above a cable tray which also penetrates the barrier. The hole was located in a manner which left sufficient seal material to provide a full height cable tray fire stop. The new conduit does not add exposed combustibles through the opening. In addition to fire detection and suppression capabilities, each side of the fire barrier is covered by transient combustible control which includes weekly housekeeping tours. These measures are considered adequate to prevent propagation of a fire through the opening. The location of the hole and the new conduit do not change the configuration of intervening combustibles within fire areas 002 and 006. Therefore, the opening in N3 had no adverse impact on the train separation of Unit 1 charging pumps.

The open penetration in the north wall of fire area 002 (N34) degraded the fire barrier and provided a possible but unlikely combustible pathway between fire area 002 and fire zone 142. The approximate six inch by fifteen inch opening which had been made for new conduit installation was located approximately fourteen feet above the floor and above a cable tray which also penetrates the barrier. The hole was located in a manner which left sufficient seal material to provide a full height cable tray fire stop. The new conduit does not add exposed combustibles through the opening. In addition to fire
