Subject: McGuire Nuclear Station Unit 2  
Docket No. 50-370  
Licensee Event Report 370/91-04

FACILITY NAME(1) McGuire Nuclear Station, Unit 2										DOCKET NUMBER(2) 05000 370		PAGE(3) 1 OF 10	
TITLE(4) The Auxiliary Feedwater System Turbine Driven Pump Was Past Inoperable Due To Erroneous Calibration Of Suction Pressure Switches Due To A Management And A Design Deficiency													
EVENT DATE(5)			LER NUMBER(6)			REPORT DATE(7)			OTHER FACILITIES INVOLVED(8)				
MONTH	DAY	YEAR	YEAR	SEQUENTIAL NUMBER	REVISION NUMBER	MONTH	DAY	YEAR	FACILITY NAMES			DOCKET NUMBER(S)	
04	22	91	91	04	0	07	29	91				05000	
OPERATING MODE(9)		1		THIS REPORT IS SUBMITTED PURSUANT TO REQUIREMENTS OF 10CFR (Check one or more of the following)(11)									
POWER LEVEL(10)		100%		20.402(b)		20.405(c)		50.73(a)(2)(iv)		73.71(b)

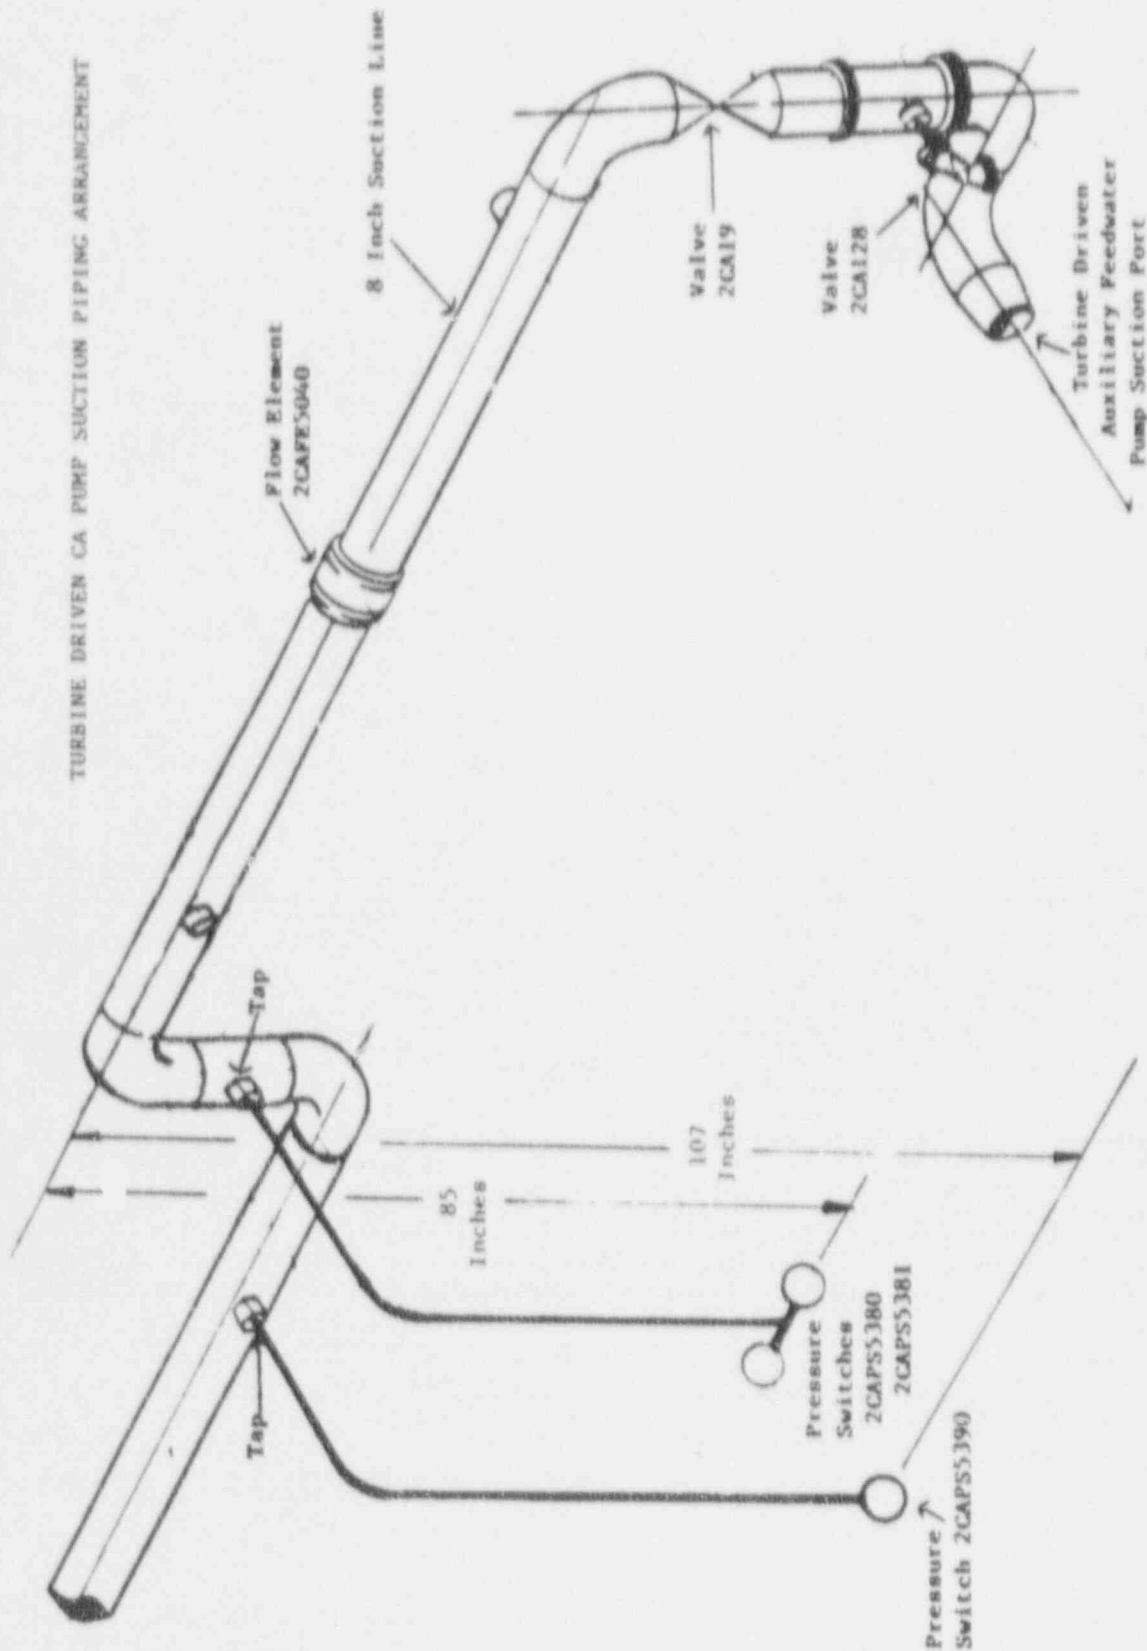
The tap location for pressure switches 2CAPS5380 and 2CAPS5381 is located approximately 33 inches below the centerline of the TD CA Pump suction piping (see page 10 of 10) flow element. The tap location for pressure switch 2CAPS5390 is located approximately 69 inches below the center line of the TD CA Pump suction piping at the flow element.
