DUKE POWER

September 27, 1991

Subject: McGuire Nuclear Station
Docket Nos. 50-369, -370
Inspection Report No. 50-369, -370/91-09
Electrical Distribution System Functional Inspection
Response to Finding on Breaker Miscoordination

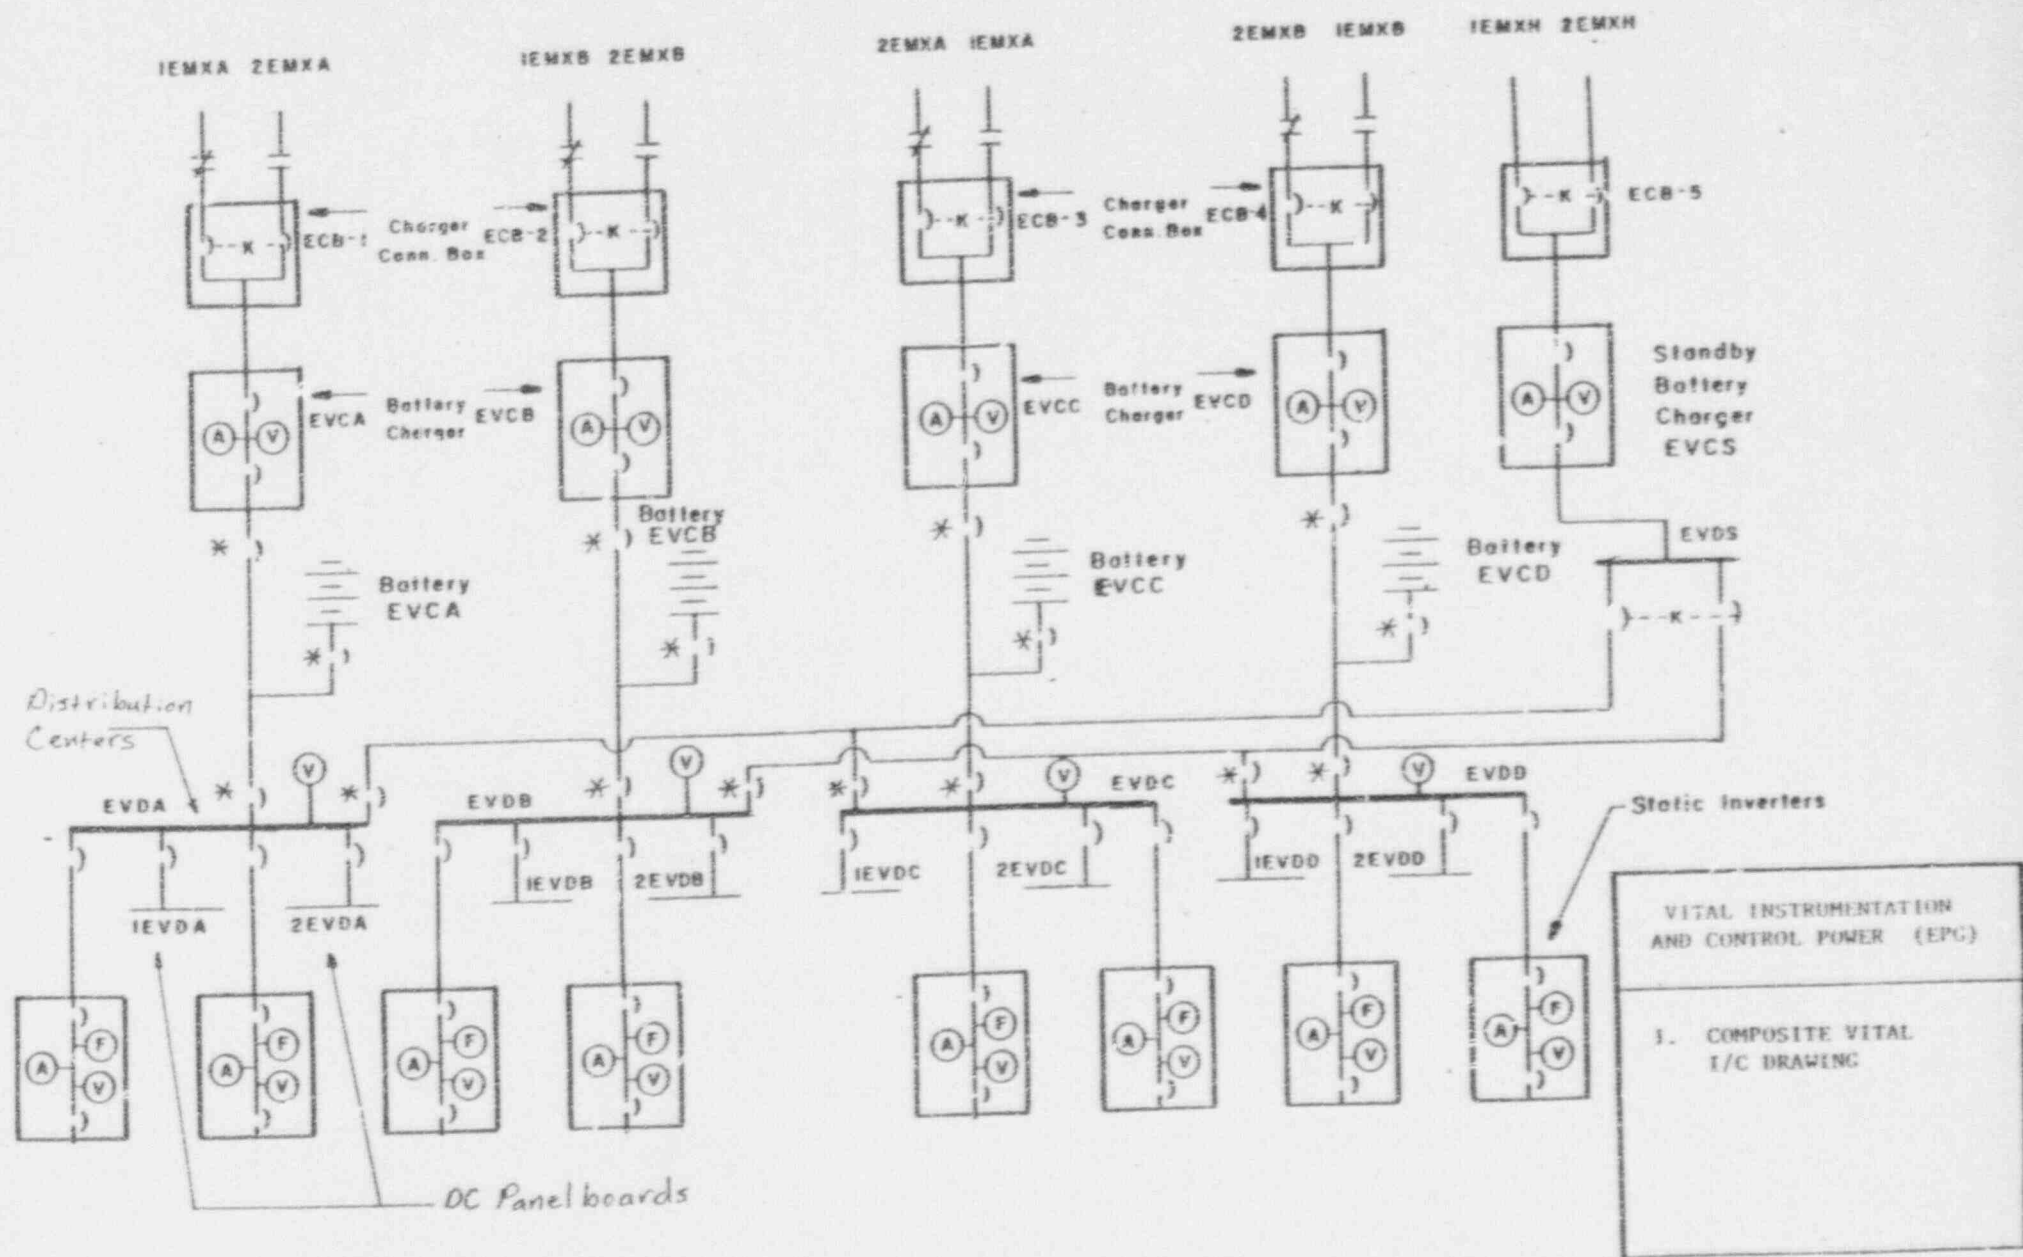
As noted in the NRC Inspection Report, the 125 VDC Vital Instrumentation and Control (EPL) system is not selectively coordinated above a certain level of fault current. Since the system is shared between units 1 and 2, this could potentially result in a trip of both units if this specific fault were to occur. Each of the four batteries supply one distribution center which in turn supplies one DC panelboard per unit. Coordination cannot be guaranteed in the instantaneous region of the molded case circuit breakers located in the distribution center and the panelboards. This characteristic may cause the battery circuit breaker to operate due to a fault in a panelboard.

Even with the replacement of the circuit breakers described above, one unit could trip as a result of a fault beyond one of the panelboard branch circuit breakers. Both the panelboard feeder circuit breaker and the branch circuit breakers have thermal-magnetic elements, so they will not coordinate during the instantaneous region. However, this is similar in consequence to the case postulated in the PSAR where the panelboard is lost and the other train is used.

The most feasible solution is to replace the charger circuit breaker, battery circuit breaker, main circuit breaker and cross-tie circuit breaker (indicated by an asterisk on the attached drawing) with non-fusible and fusible switches. The addition of fuses will allow the circuit breakers closest to the fault to clear before isolating the battery from the bus. This will decrease the possibility of a fault causing a loss of power which would trip both units. In the cross-tied configuration, the fuses will help insure that the bus without a battery will be cleared successfully under a fault condition without isolating the battery from the other bus.

It is preferable to replace this equipment while one unit is in an outage. The planned schedule is for two of the buses to be changed during unit 1 outage EOC-9 scheduled for March 1994, with the remaining two buses changed during the unit 2 outage EOC-9 scheduled for September 1994. This will provide adequate time to procure and qualify equipment, complete the design and address the details necessary to install the new equipment.

This time schedule considers the replacement of the charger, battery, main and cross-tie circuit breakers. The time schedule for the panelboard changes will be included in the succeeding response.
