Commonwealth Edison Company  
LaSalle County Station - Unit 1

REPORT ON UNIT 1 HIGH DRYWELL TEMPERATURE

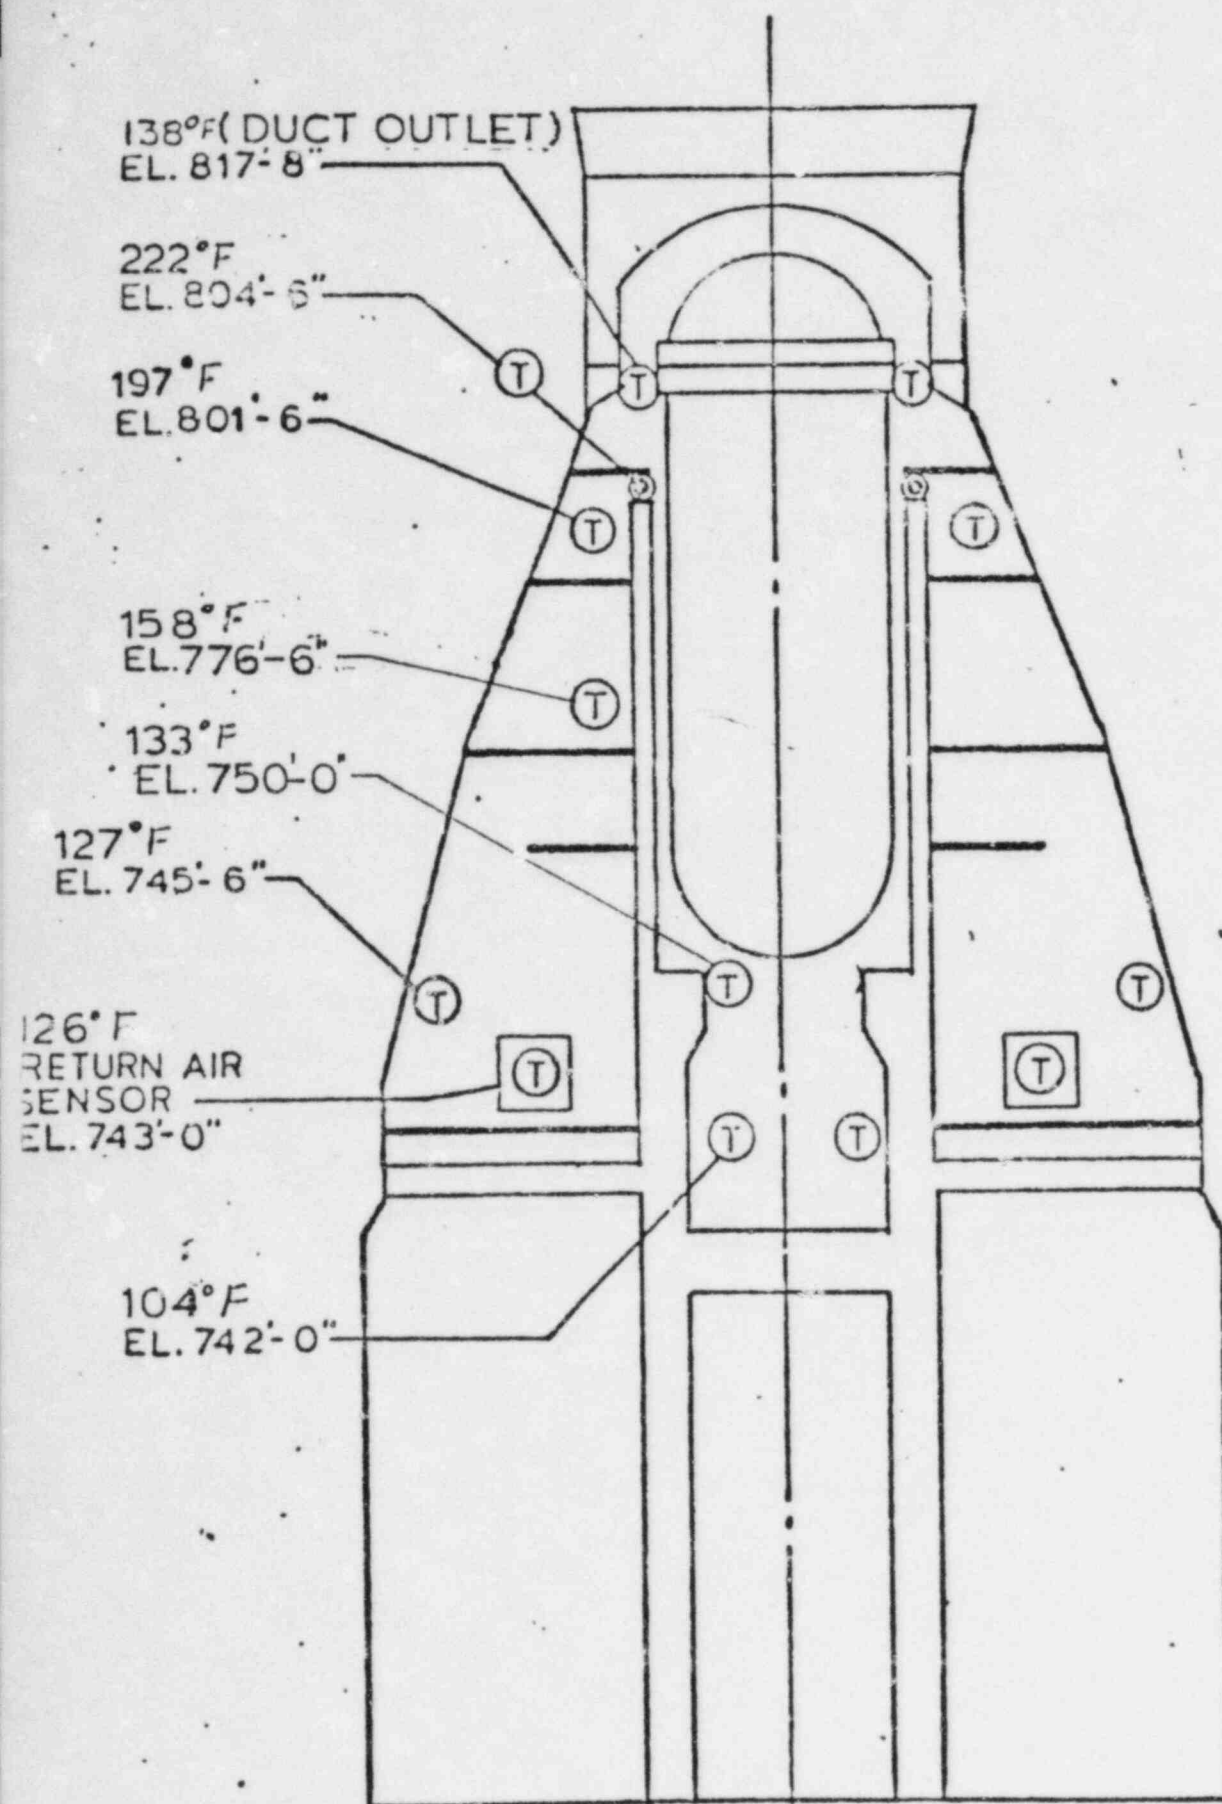
FIGURE 1  
AVERAGE VERTICAL TEMPERATURE PROFILE  
FROM TEMPERATURE SENSORS

The operating temperature reading from drywell monitors were used to establish a temperature profile for the drywell (See Figure 1). Some additional temporarily installed thermocouples around the safety relief valves were also utilized for temperature indications. A correlation was made of available temperature data and observed visual damage. The bulk high temperature effects appear to be limited to elevation 804 feet and above with some local problems below that level. The degradation problem is caused by excessive heat in the upper drywell regions and at localized hot spots. The local hot spots on some cables coincided with physical contacts on hot piping or high temperature surfaces. Only the upper area of the drywell had a volumetric or bulk overtemperature.
