SUPPLEMENTARY INFORMATION

REPORT NO.: 50-302/83-030/03X-1

FACILITY: Crystal River Unit 3

Subject: Crystal River Unit 3
Docket No. 50-302
Operating License No. DPR-72
Licensee Event Report No. 83-030, Revision 1

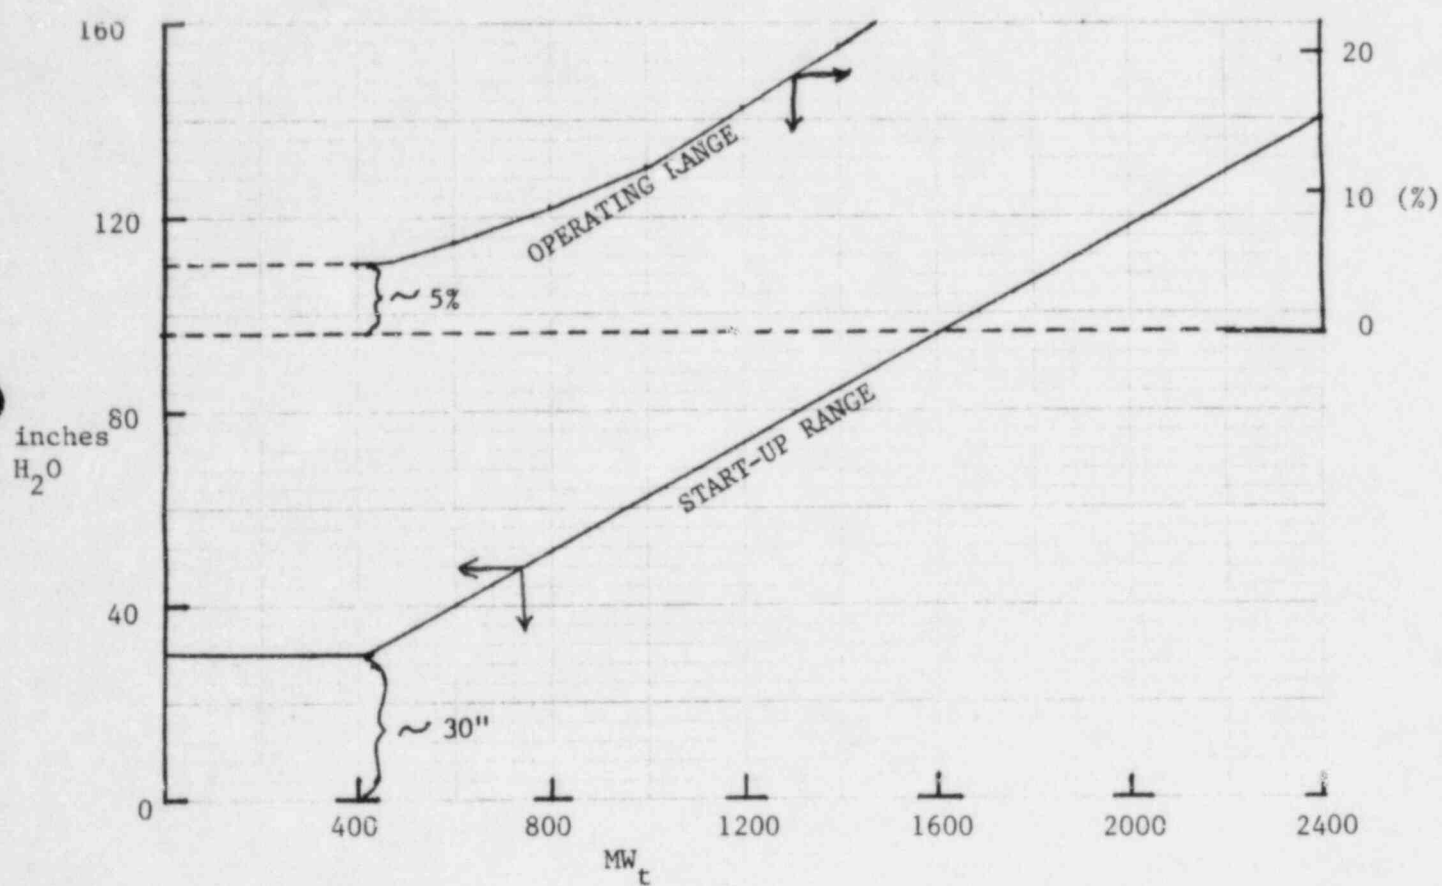
COMPARISON BETWEEN THE EXPECTED OTSG LEVEL INDICATIONS
ON THE START-UP AND OPERATING RANGE VERSUS MEGAWATTS (th)

As to the apparent mismatch noticed on July 23, 1983, the Steam Generator operating range level instrumentation is expected to read approximately 5% with 0% power. This indication is due to flow induced differential pressure across the OTSG support plates; the flow being the minimal steaming expected at this power level.

This expected level reading of approximately 5% at 0% power is supported by B&W's Limits and Precautions (1977) Figure 1.0-08.5, and Figure 1-8 of Florida Power Corporation's Plant Curve Book, OP-103. A comparison of the "expected" indication on both the start-up and operating range OTSG level instrumentation is attached.

The large difference in level indication between the startup and operating ranges is primarily due to temperature compensation on the operating range.

Hence, the observed reading was normal and not due to any instrumentation calibration problem. Thus, this channel was in fact operable.
