# MEMORANDUM

FROM J.M. McONAGHY, DPE DESIGN ENGR'S SUBJECT NCI 9092 - DOME PITTING

# TECHNICAL EVALUATION-INDIVIDUAL CONCERN

FIGURE 9092.1  
DOME PLATE SURFACE  
FLAW ACCEPTANCE  
CRITERIA

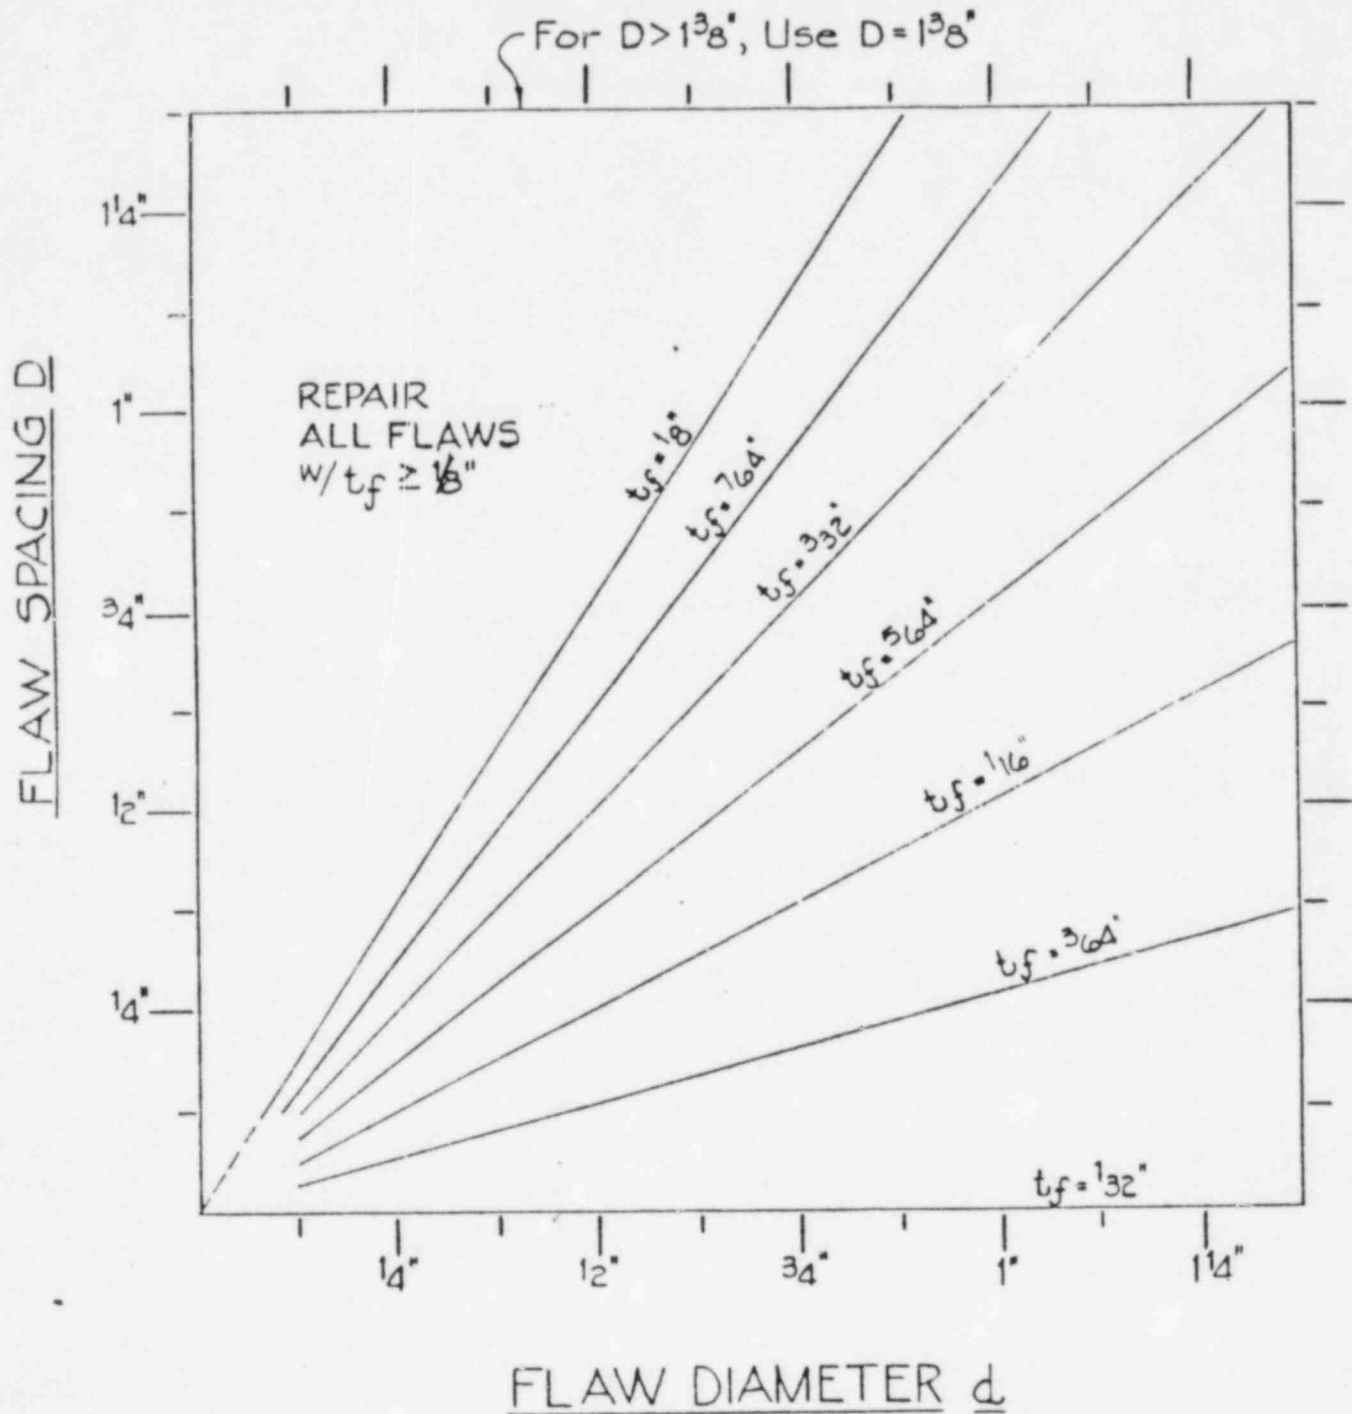
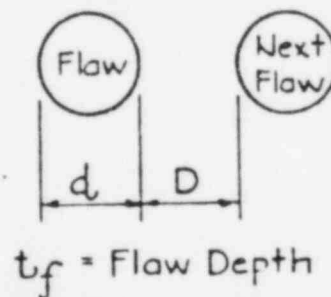
3. The remaining flaws shall be inspected to determine their acceptability using the attached Figure 9092.1. The acceptability of a given flaw will be determined by the size of the surface which it covers, the depth of the flaw, and the proximity of the flaw to other flaws. Surface defects failing this criteria shall be weld repaired according to ASME procedures.

1. Surface flaws with a depth of  $1/8$ " or greater shall be weld repaired according to ASME procedures.
2. Surface flaws with depth less than or equal to  $1/32$ " are acceptable if they do not interfere with other flaws as outlined below.

7. Surface flaws with a maximum dimension  $\underline{d}$  greater than  $1\ 3/8$ " shall be weld repaired according to ASME procedures except as noted in 2. above.

8. Surface flaws with a maximum dimension  $\underline{d}$  less than  $1/8$ " are not required to be repaired except as noted in 1. above.
9. Repairs are to be done in accordance with Section III, Subsection NE, of the ASME Code.

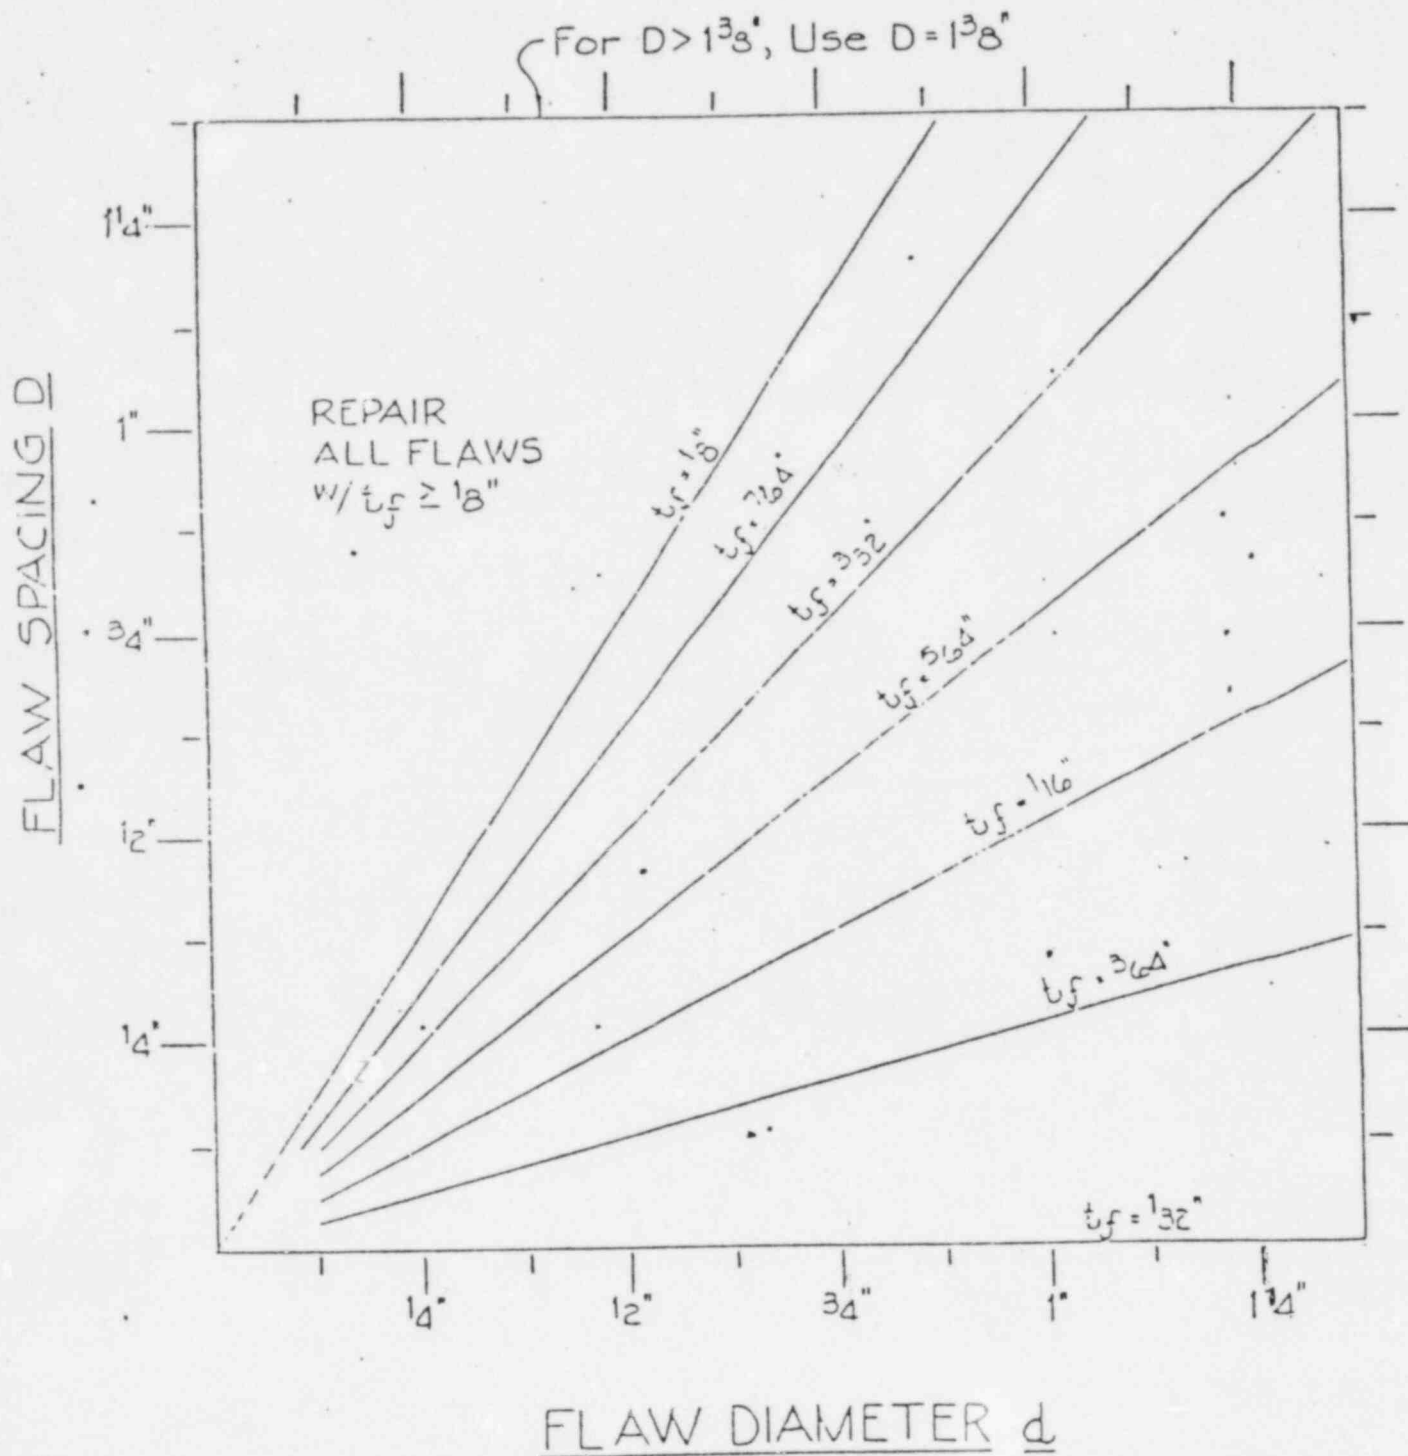
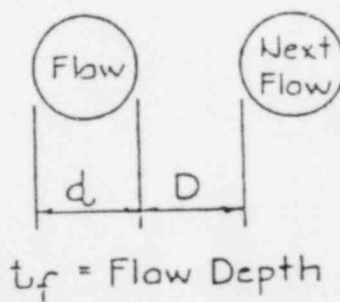
FIGURE 9092.1  
DOME PLATE SURFACE  
FLAW ACCEPTANCE  
CRITERIA

3. The remaining flaws shall be inspected to determine their acceptability using the attached Figure 9092.1. The acceptability of a given flaw will be determined by the size of the surface which it covers, the depth of the flaw, and the proximity of the flaw to other flaws. Surface defects failing this criteria shall be weld repaired according to ASME procedures.

7. Surface flaws with a maximum dimension  $\underline{d}$  greater than  $1\ 3/8"$  shall be weld repaired according to ASME procedures except as noted in 2. above.

8. Surface flaws with a maximum dimension  $\underline{d}$  less than  $1/8"$  are not required to be repaired except as noted in 1. above.
9. Repairs are to be done in accordance with Section III, Subsection NE, of the ASME Code.

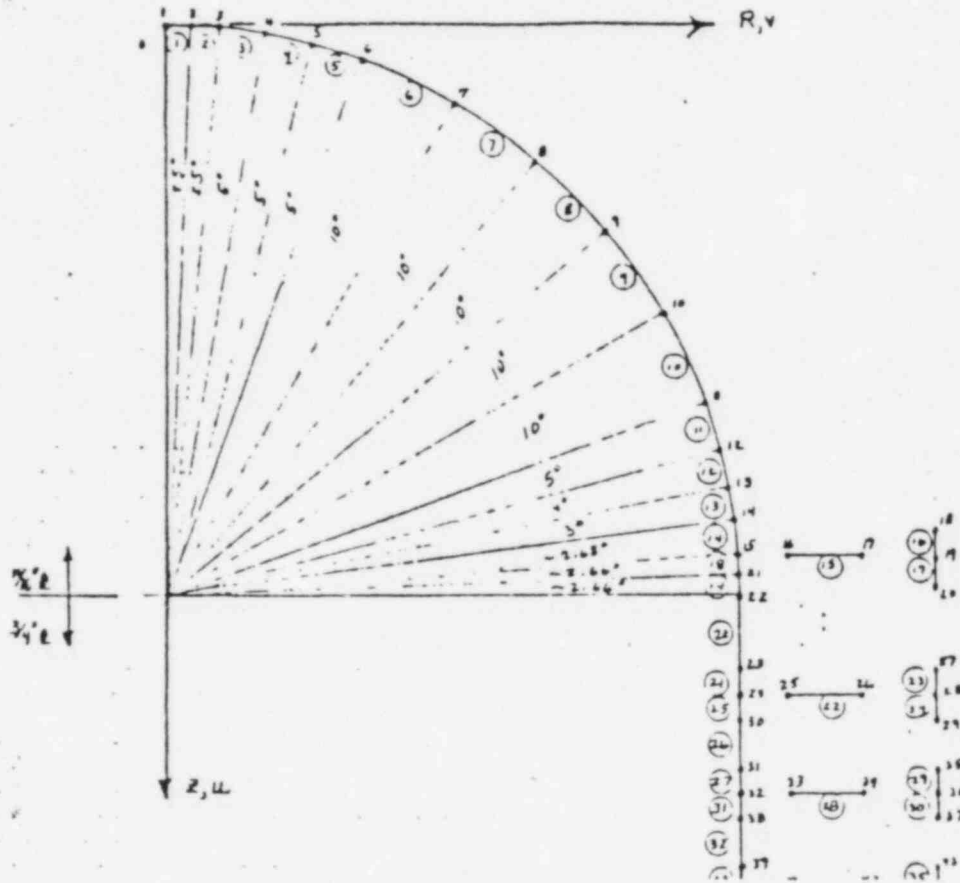
ULTIMATE CAPACITY MODEL OF DOME AREA  
(REF CNC-1144.09-01-0007)

→ DOME DEFECTS DO NOT AFFECT ULTIMATE CAPACITY IF REPAIRED SUCH THAT  $t_{\text{eff}} = 0.6''$  (ABOVE RING)

IF DOME DEFECTS ARE REPAIRED / INSPECTED AS REQUIRED ABOVE, NO DECREASE IN CONTAINMENT ULTIMATE CAPACITY WILL RESULT.

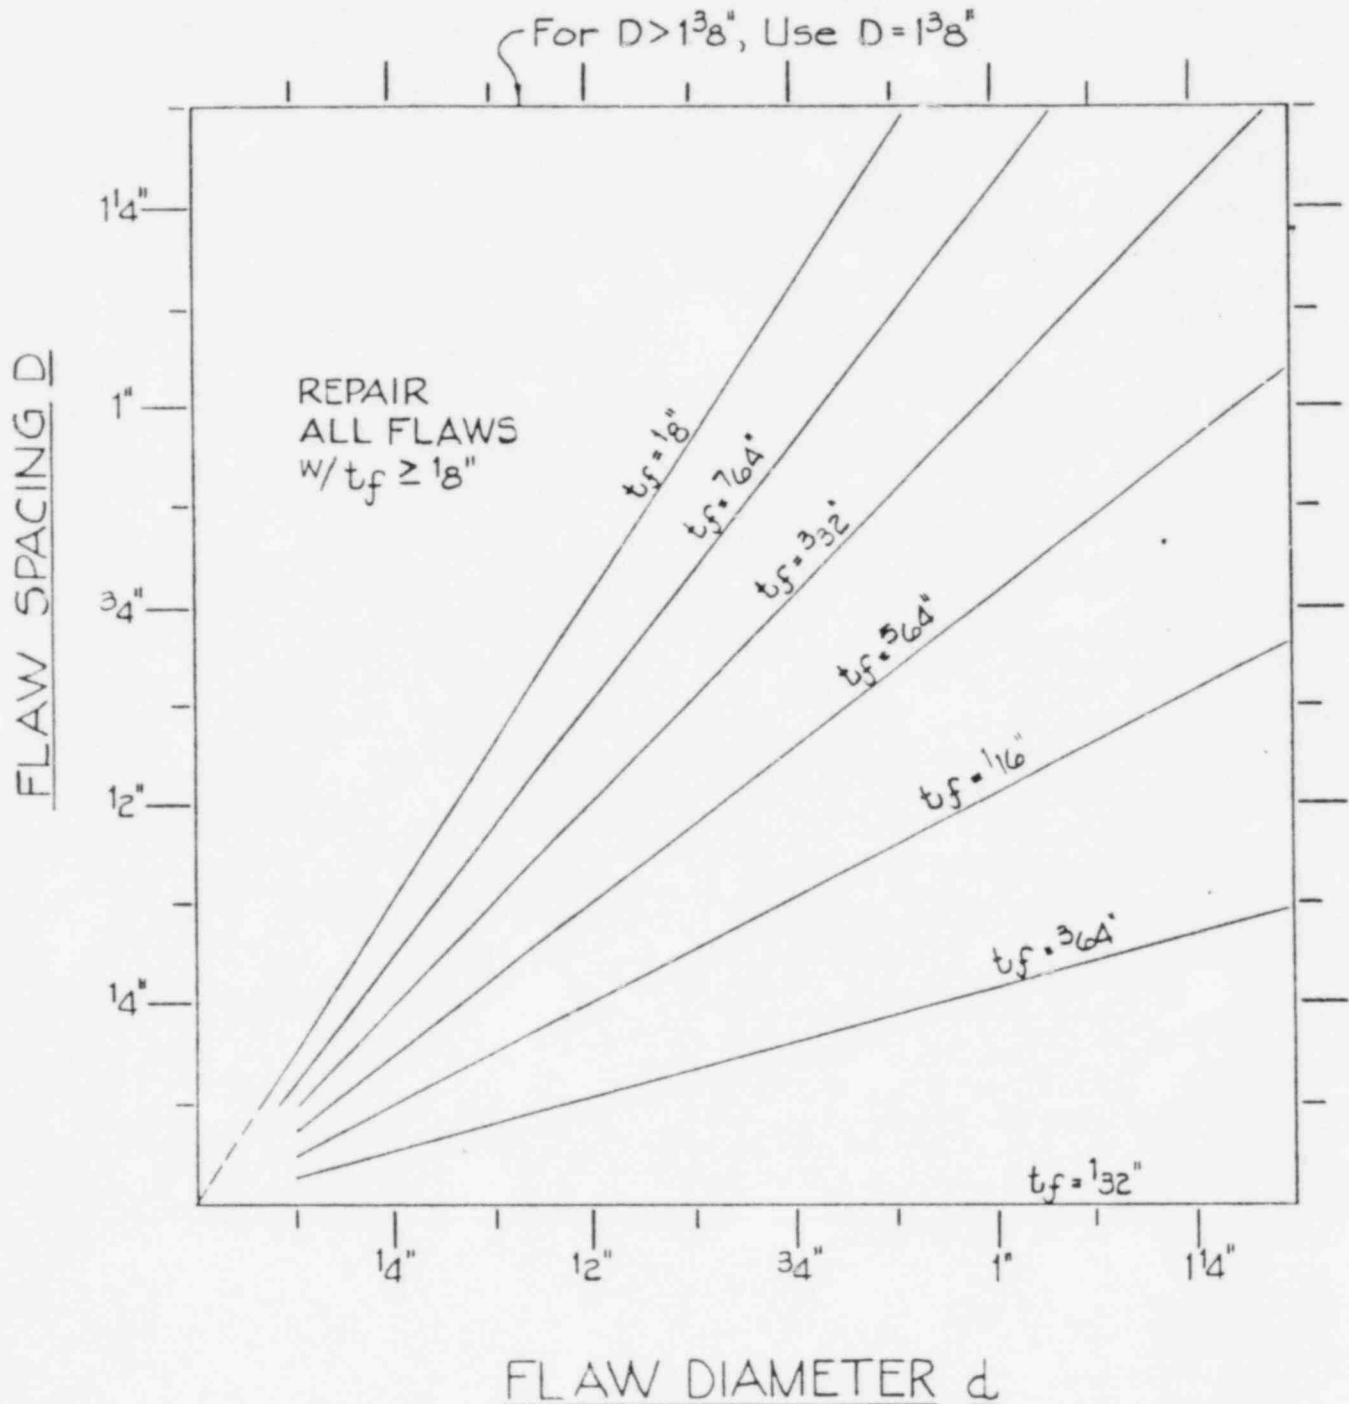
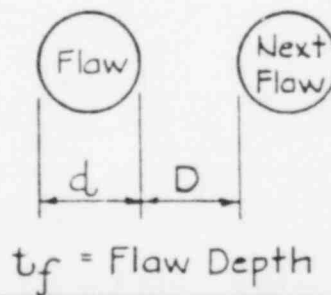
FIGURE 9092.1  
DOME PLATE SURFACE  
FLAW ACCEPTANCE  
CRITERIA

3. The remaining flaws shall be inspected to determine their acceptability using the attached Figure 9092.1. The acceptability of a given flaw will be determined by the size of the surface which it covers, the depth of the flaw, and the proximity of the flaw to other flaws. Surface defects failing this criteria shall be weld repaired according to ASME procedures.

- NOTES: 1) WHERE VALUE IS NOT SHOWN, ALLOWABLE FLAW DEPTH = 124 MILS  
 2) FIELD MAY INTERPOLATE BETWEEN VALUES SHOWN  
 3) VALUES FOR  $d = 1/16"$  ARE GIVEN FOR INTERPOLATION PURPOSES ONLY - FLAWS WITH  $d < 1/8"$  ARE NOT REQUIRED TO BE REPAIRED UNLESS DEPTH IS GREATER THAN 124 MILS

1. Surface flaws with a depth of  $1/8"$  or greater shall be weld repaired according to ASME procedures.
2. Surface flaws with depth less than or equal to  $1/32"$  are acceptable if they do not interfere with other flaws as outlined below.

7. Surface flaws with a maximum dimension  $\underline{d}$  greater than  $1\ 3/8"$  shall be weld repaired according to ASME procedures except as noted in 2. above.

8. Surface flaws with a maximum dimension  $\underline{d}$  less than  $1/8"$  are not required to be repaired except as noted in 1. above.
9. Repairs are to be done in accordance with Section III, Subsection NE, of the ASME Code.
