LICENSEE EVENT REPORT (LER)

PALISADES NUCLEAR PLANT

Loss of Communications

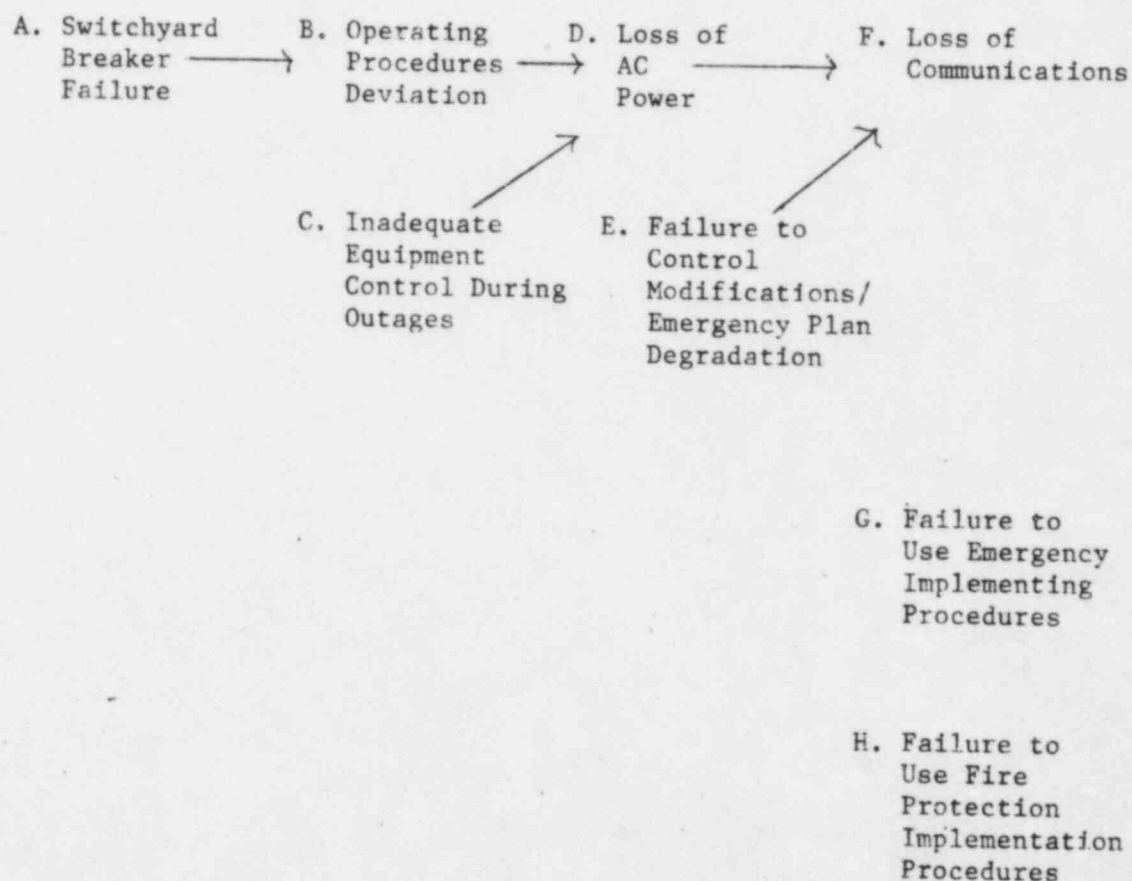
FIGURE 1

Loss of Communications
Sub-events
