Subject: Final Report - DER 82-61
A 50.55(e) Reportable Condition Relating to Reactor Coolant
Pump Diffuser Ring Cap Screws May Fail And Damage Pump
File: 84-019-026; D.4.33.2

FINAL REPORT - DER 82-61
DEFICIENCY EVALUATION 50.55(e)
ARIZONA PUBLIC SERVICE COMPANY (APS)
PVNGS UNITS 1, 2, & 3

TITLE: REACTOR COOLANT PUMP DIFFUSER BOLT FAILURE SUMMARY

Metallurgical Investigation
of
Diffuser/R.C.P. Casing Bolt
Failures
(791350)

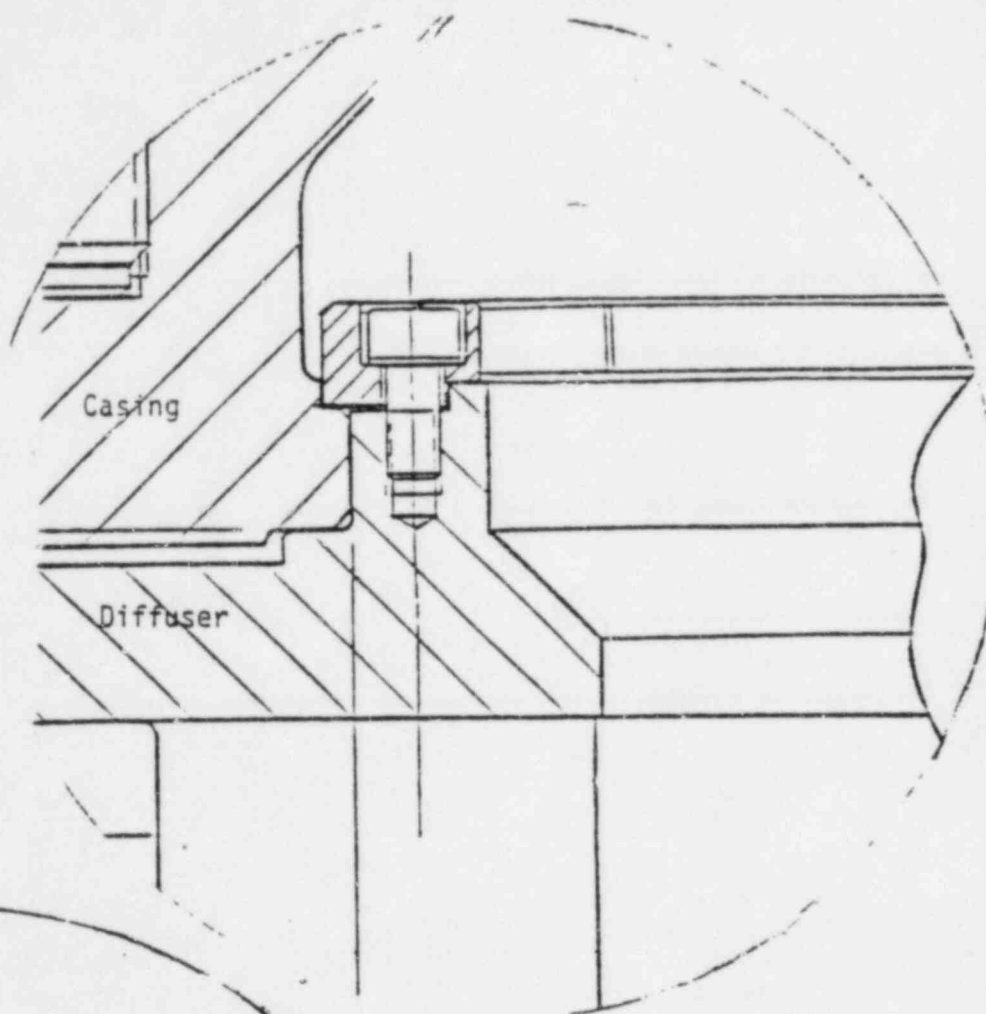
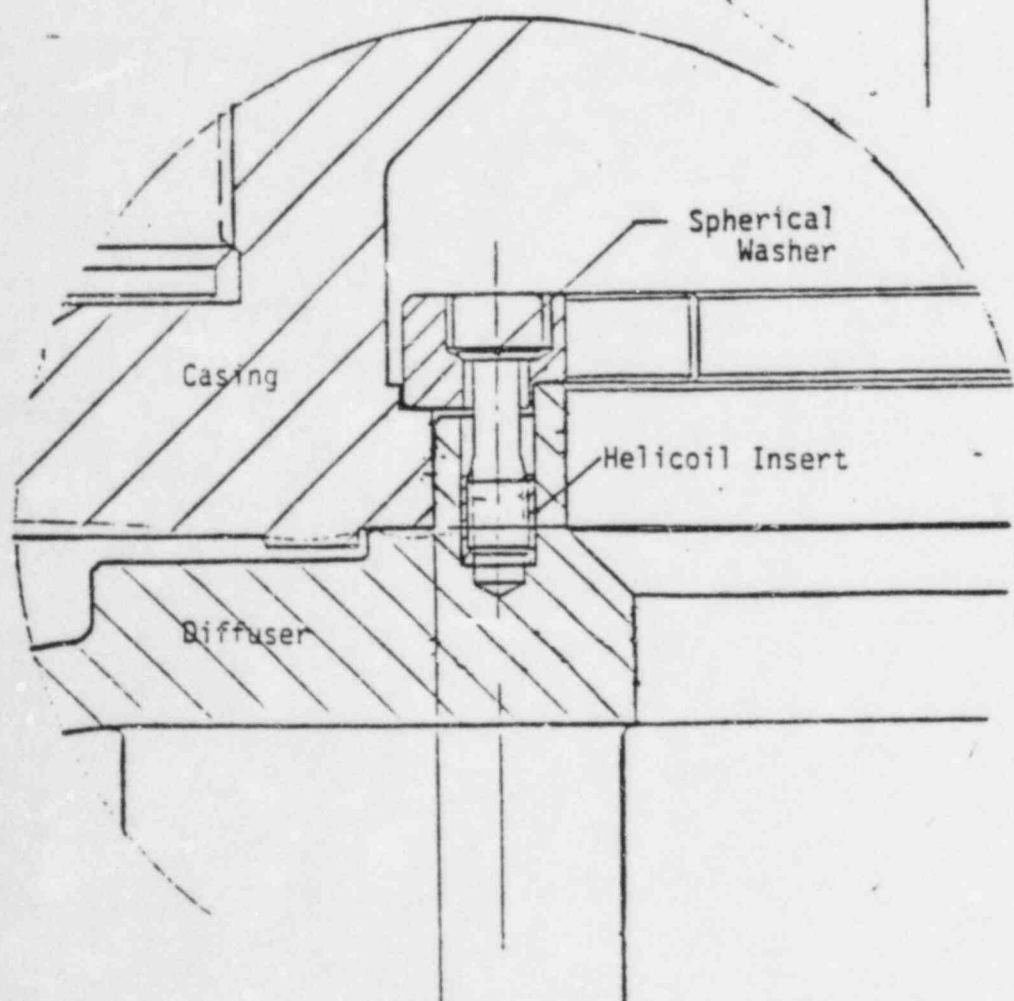
DIFFUSER/CASING
BOLTED CONNECTION

The bolt failure in Reactor Coolant Pump #1 was originally identified as failure due to improper mechanical assembly procedures. Engineering felt, at the time, that a spherical washer, necked down bolt, and a higher strength bolting material would result in a more conservative bolted connection. The original diffuser-to-casing bolting connection is shown in Figure 1. The bolts were M20 x 40 made from ASTM A193-47 Grade B6 material. The re-designed bolts (M20 x 65 Unbrako KS-17 material) are also shown in Figure 1.

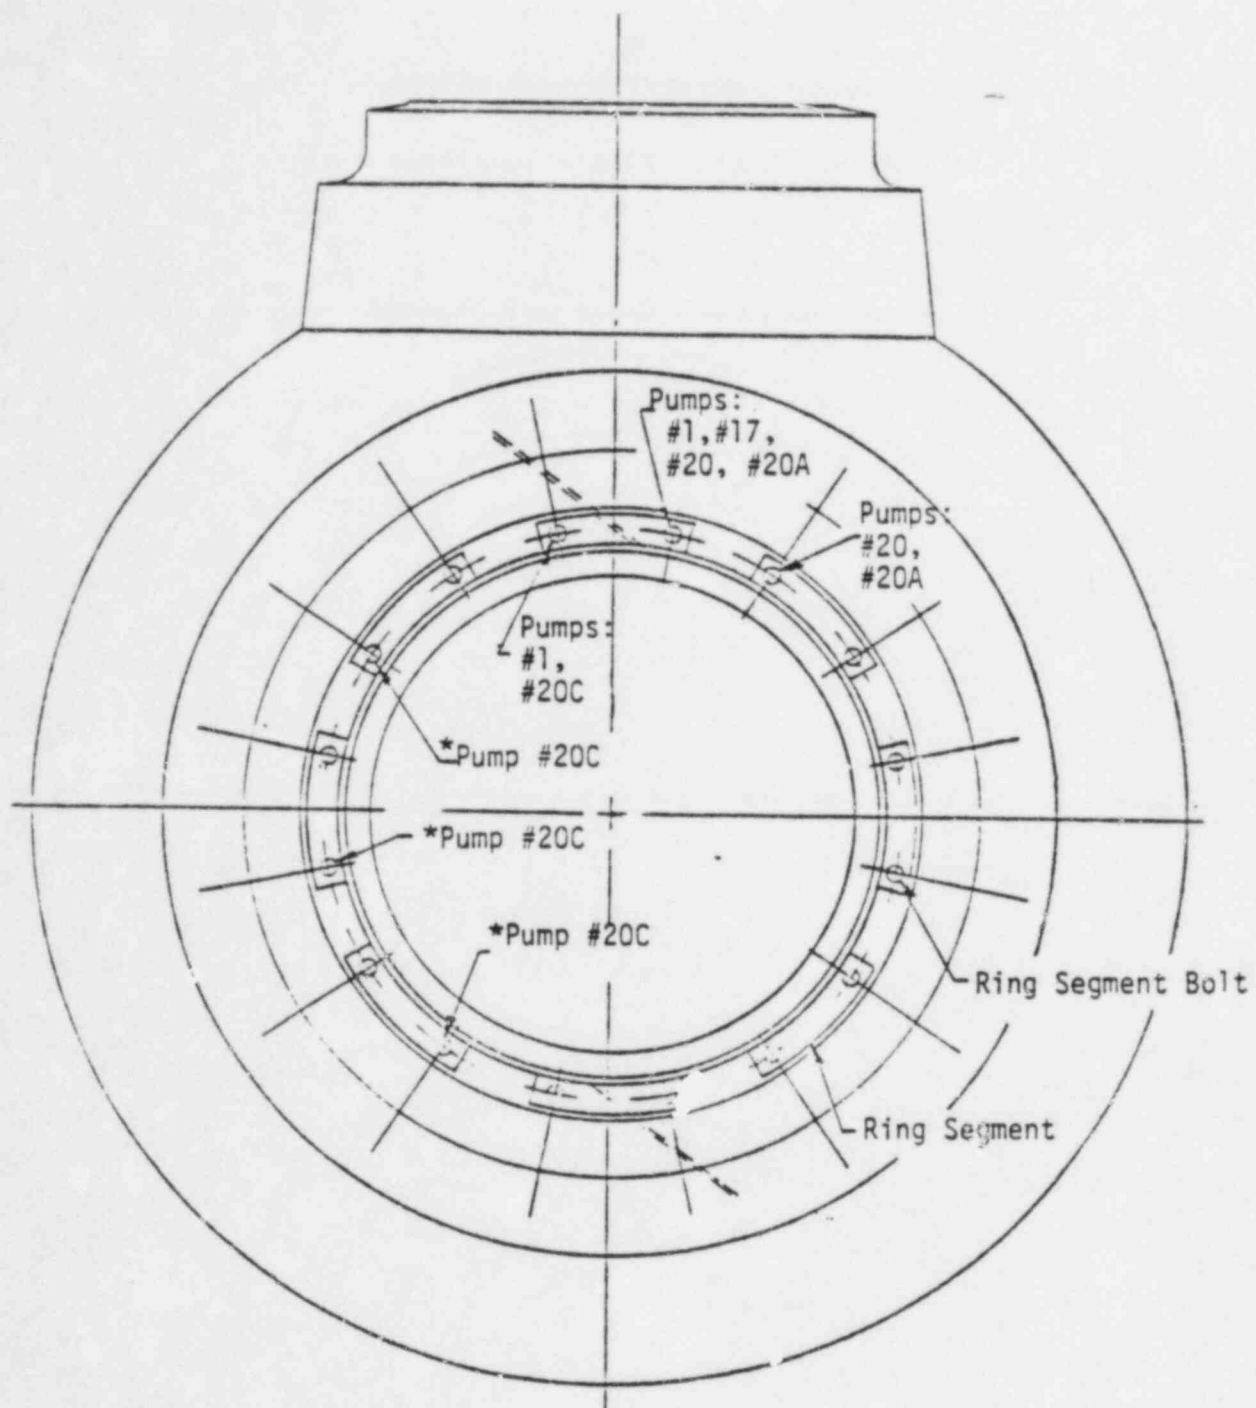
1. The bolt failures occurred within a sector of 1130 to 0130 to the discharge nozzle center (See Figure 3).
2. The bolt failures occurred with diffusers supplied from two different vendors.
3. Failures occurred with virgin bolts.

The metallurgical examination of the broken bolts indicated that the failures were related to hydrogen induced stress corrosion. However, the location of the reported bolt failures (see Figure 3), did not show the randomness expected if the failure mechanism were initiated by hydrogen induced stress corrosion in combination with the normal loadings reviewed in Part I.

Note 1: Two bolts were found broken and the ring segment was found sitting on the impeller. The exact location of the broken bolts is not certain, but it is thought that they were the "bolts bridging the gap."

Note 2: One ring segment bolt found broken on the ring segment "bridging the gap" on the six vane diffuser half.

Note 4: One bolt was on the ring segment "bridging the gap" on the six vane diffuser half, and the second bolt was on the adjacent segment on the six vane diffuser half.

Note 5: Four ring segment bolts ultimately found cracked on the five vane diffuser half.

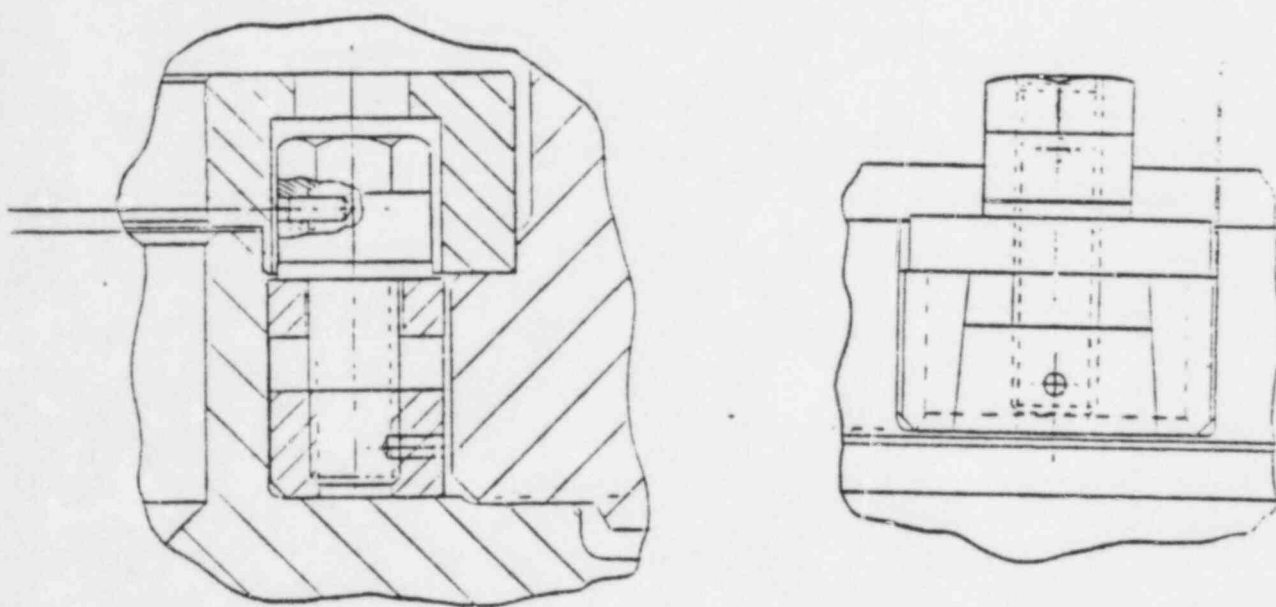
DIFFUSER WEDGE ASSEMBLY

The resultant moments on the diffuser half tended to pivot the diffuser outermost edges about a keyway in the diffuser. These loading conditions were greatly reduced by physically supporting the two diffuser halves against each other as the resulting moment is directed towards the hydraulic centerline of the diffuser. This physical support was achieved by using two wedges (see Figure 4) positioned in the gap between the two diffuser halves.

1. Continue to use Type 410 bolting material with a modified heat treatment procedure.
2. Position the five vane diffuser half on the right hand side of the pump casing to minimize the induced stress levels in the bolts.
3. Install diffuser wedges to limit the movement of each diffuser half.

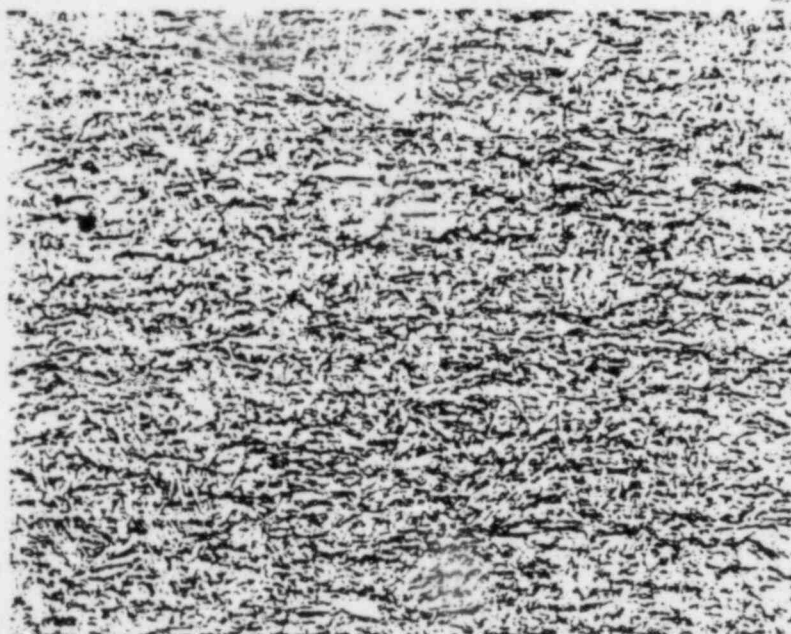
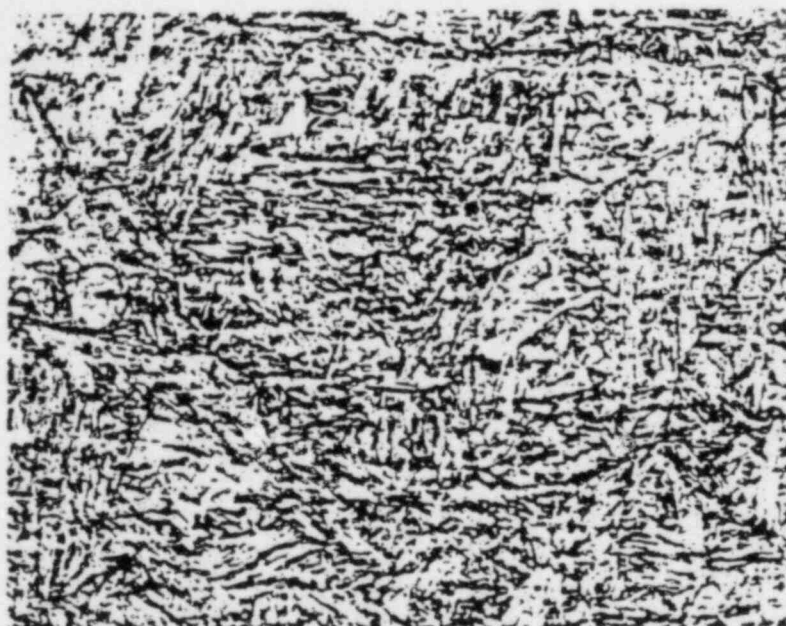
Fig. 3 Microstructure of Bolt No. 13 (A-Bolt)
Grain Size -ASTM No. 7
DPH Hardness 455-459

Metallographic examination of the broken and also new bolts revealed the microstructure to be tempered martensite with a grain size of about ASTM No. 7 (Fig. 3, broken bolt No. 13 - microstructure typical for all samples). Normally the former, austenitic grain boundaries should not be visible as clearly after hardening and tempering. This will be discussed later.

The micro hardness was found to be DPH 455-459 (500g load), corresponding to about Rc 46. The macro hardness of new, unused bolts was Rc 41-42.

If the grain boundaries appear again after tempering (see Fig. 3), it can be assumed that particles, most likely carbides, have precipitated during the tempering treatment. This is possible because after hardening the former austenitic grain boundaries are still represented as imperfections in the orientation of the lattice, even though they are invisible. Precipitation of carbides along the former, austenitic grain boundaries can adversely affect properties, e.g., impact resistance, ductility, corrosion, etc.

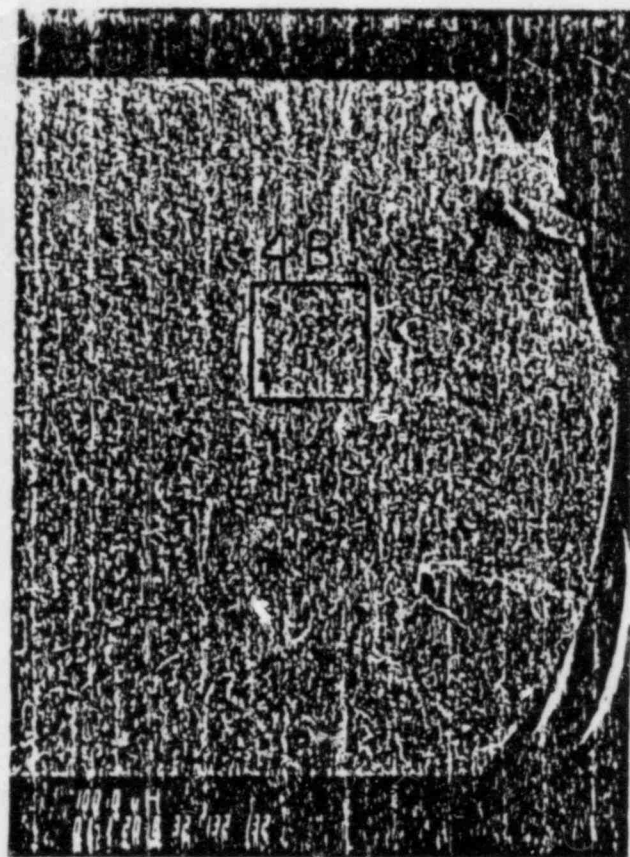
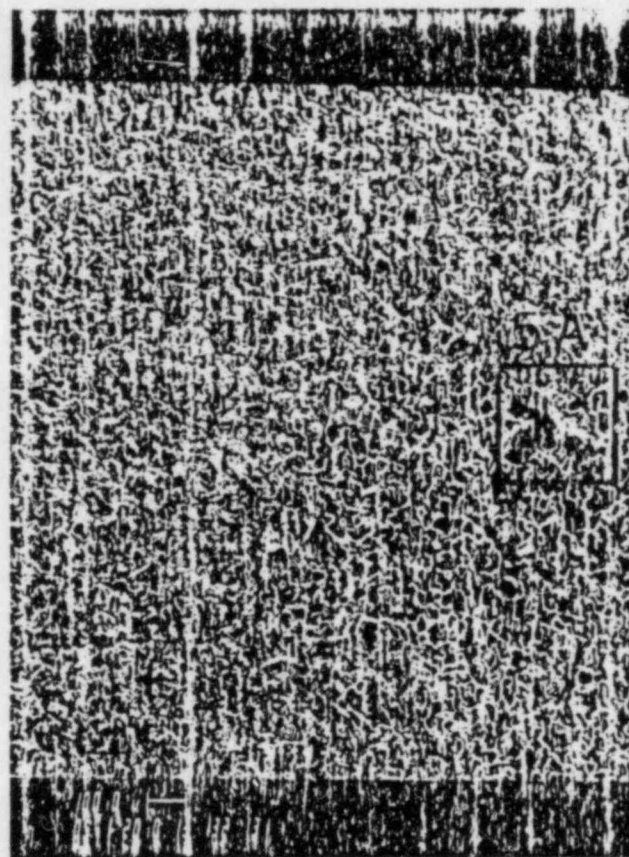
Fig. 4 SEM Photographs of Fracture Surface of Bolt No. 13

The crack which initiated the failure of bolt No. 13 (see Fig. 2) is distinguishable at the right hand side of the two SEM photographs in Fig. 4. Fig. 5 shows the same location at higher magnifications. As can be seen the crack is intergranular and follows the former, austenitic grain boundaries visible in the photomicrographs of Fig. 3.

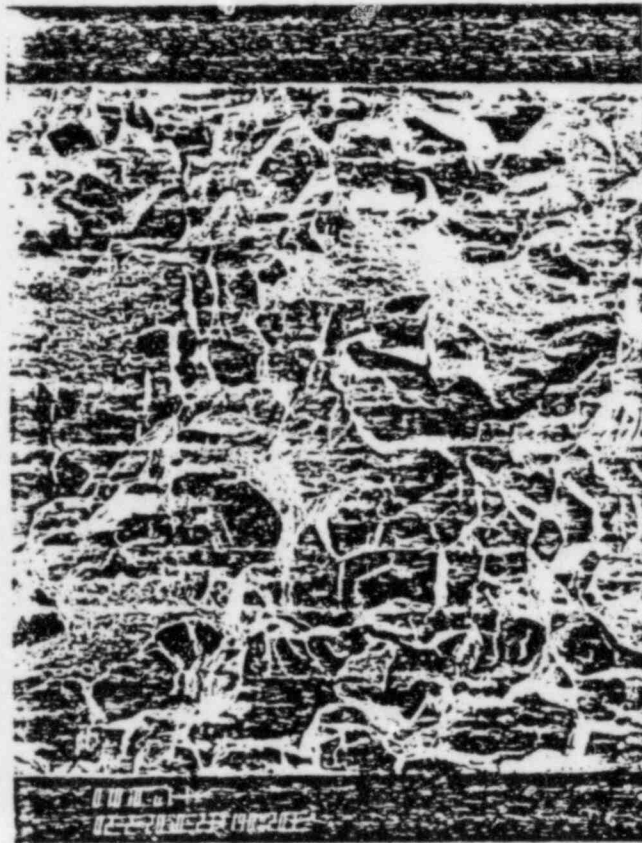
Fig. 6 SEM Photograph of Fracture Surface of Broken Impact Specimen from a Retempered A-Bolt (B-Bolt)

SEM examination of broken impact specimens revealed the fracture to be intergranular, following the former austenitic grain boundaries (Fig. 6, see also Fig. 5A).

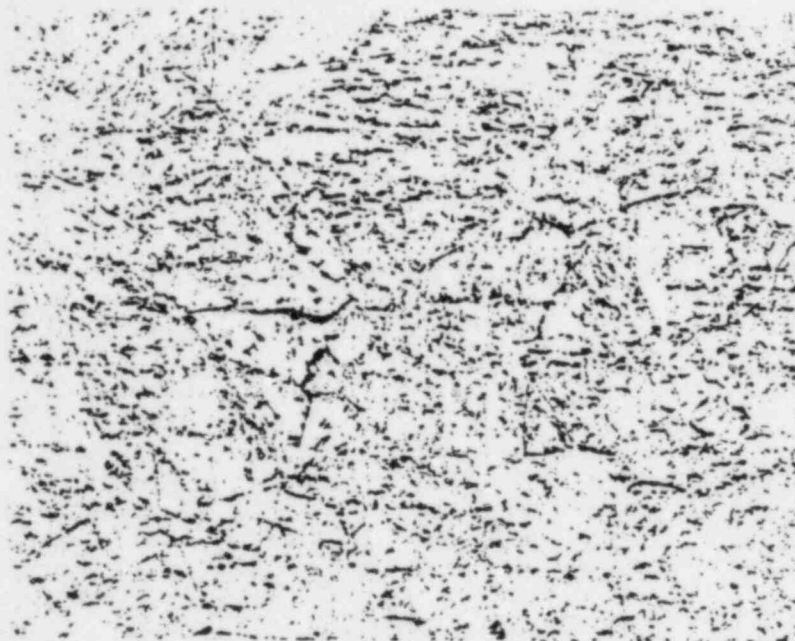
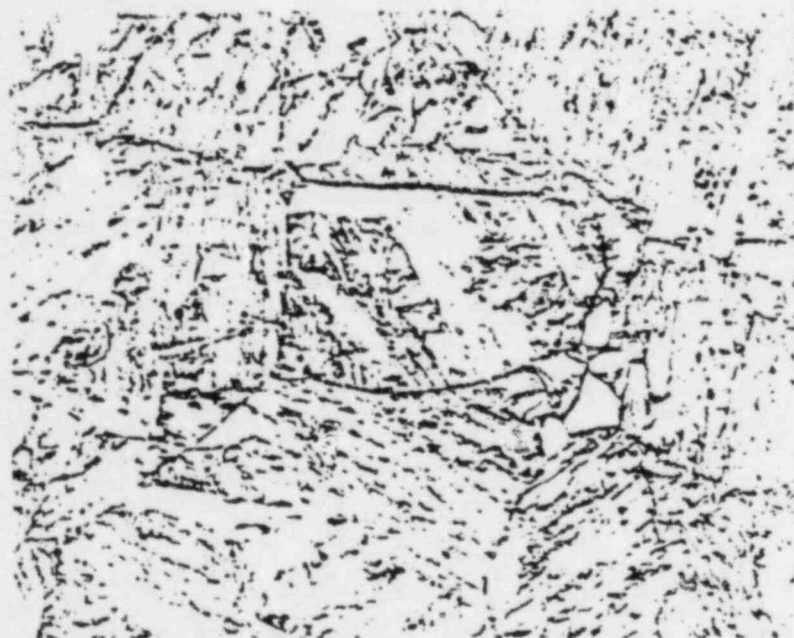
Fig. 7 Microstructure of a C-Bolt
(completely reheat treated A-Bolt)
DPH Hardness 270-292

One of the broken impact specimens was used for metallographic examination. Fig. 7 shows the microstructure consisting of tempered martensite with heavy former austenitic grain boundaries and possibly some ferrite. The DPH hardness was 270-292 (about 27 Rc).

All heat treatment experiments have resulted so far in good tension and hardness test values but unacceptable impact properties. This can be explained only by the development of precipitates along the former, austenitic grain boundaries during tempering. All experiments consisted basically of hardening from 1750F and tempering at 1150F. This heat treatment is recommended in steel specifications not only domestic but also foreign (e.g., DIN 17 440 "Corrosion Resistant Steels" Grade X7Cr13; JIS G 4303 "Stainless Steel Bars" Grade SVS 51 B). One would be inclined to suspect that the bolts used for the heat treatment experiments were made from a bastard heat. The Test Certificate, Attachment (1), however, does not indicate anything unusual. A sample was sent to MML Chattanooga for investigation.

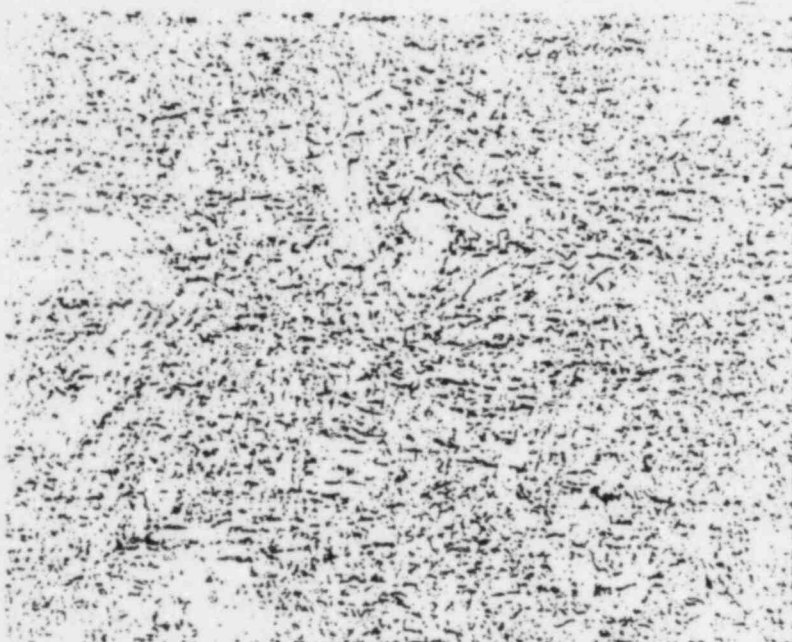
Fig 8. Microstructure of a D-Bolt
 (A-bolt heat treated 1665F/oil+2x1150Fwater)
 DPH Hardness 264
 Lower Photo: Etched to Reveal Ferrite

Metallographic examination of one of the broken impact specimens (D-bolt) revealed the microstructure to be tempered martensite without former, austenitic grain boundaries (Fig. 8 top - Vilella's reagent etch, compare with Fig. 7). This micro was also etched electrolytically with alkaline sodium picrate which revealed the presence of about 20% ferrite in the microstructure (Fig. 8 bottom - white particles).

Because of the poor impact test results, SPS asked Carpenter for assistance. The steel producer recommended oil hardening from 1650-1700F and double tempering at 1150F followed by water quenching. This heat treatment gave good results (see also Table I):
