DOCKET NUMBER
PROD. & UTIL. FAC. 50-322

Diesel Generator 102 Crankshaft

PRELIMINARY METALLURGICAL EVALUATION OF FAILED CRANKSHAFT FROM DG102

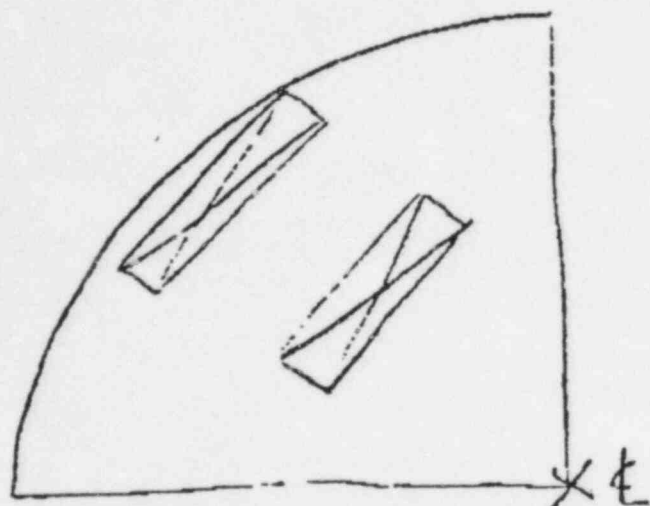
TRANSVERSE SECTION

TENSILE SPECIMEN POSITION ($\frac{1}{2}$ " TEST BAR)
