**Beaver Valley Power Station, Unit No. 1**  
**Docket No. 50-334, Licensee No. DPR-66**  
**LER 95-002-00**

LER 95-002-00, 10 CFR 50.73.a.2.i.B, Condition Prohibited by Technical Specifications-"Safety Related 480 Volt Bus Found Seismically Unqualified".

## Safety Related 480 Volt Bus Found Seismically Unqualified

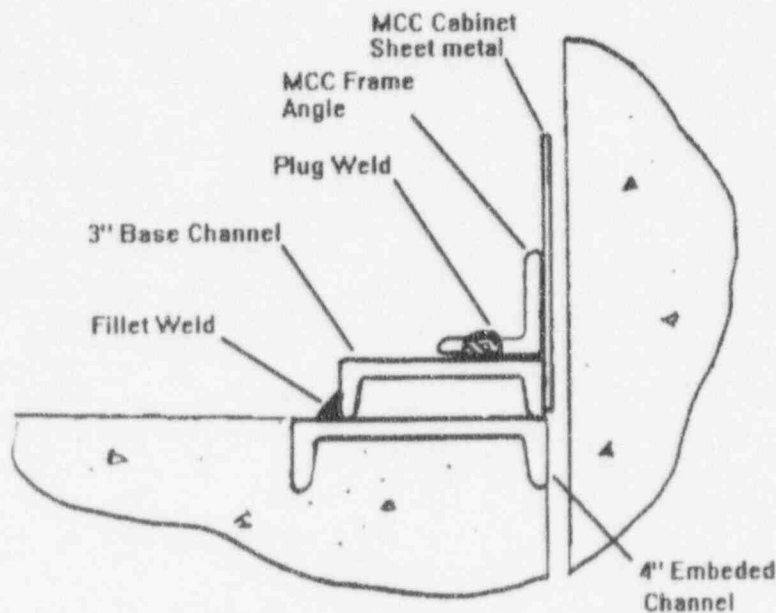
**DESIGN DETAIL**

The designed mounting system at the base of the MCC consists of two steel channels welded together by an intermittent (stitch) fillet weld. A four inch steel "C" channel with the open side facing downward is imbedded in the concrete base. A three inch steel "C" base channel is welded on top of the four inch channel with the fillet weld. The MCC frame angle is welded to the base channel and secures the MCC to the base structure as shown below.

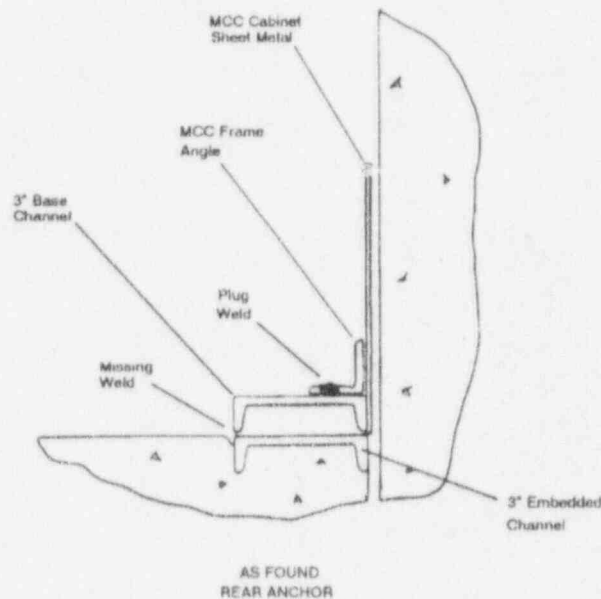
The mounting deficiency on MCC-E7 consisted of a missing fillet weld that was supposed to join the rear base channel anchoring the MCC cabinet to the embedded channel. Contrary to design, the installed embedded steel channel was only three inches wide instead of the intended four inch width and the fillet weld was missing. See figure below.

The cause of this event was determined to be improper installation of the rear mounting anchor of MCC-E7 during initial construction.

Seismically qualified tie straps were installed prior to placing the plant in a condition requiring Train A Class 1E Emergency Power Supply operability. These straps returned the MCC to a fully seismically qualified condition.
