GRAND GULF NUCLEAR STATION
COMPREHENSIVE REPORT ON STANDBY DIESEL GENERATORS -
SIGNIFICANT ACTIVITIES TO ENHANCE AND
VERIFY RELIABILITY

February, 1984

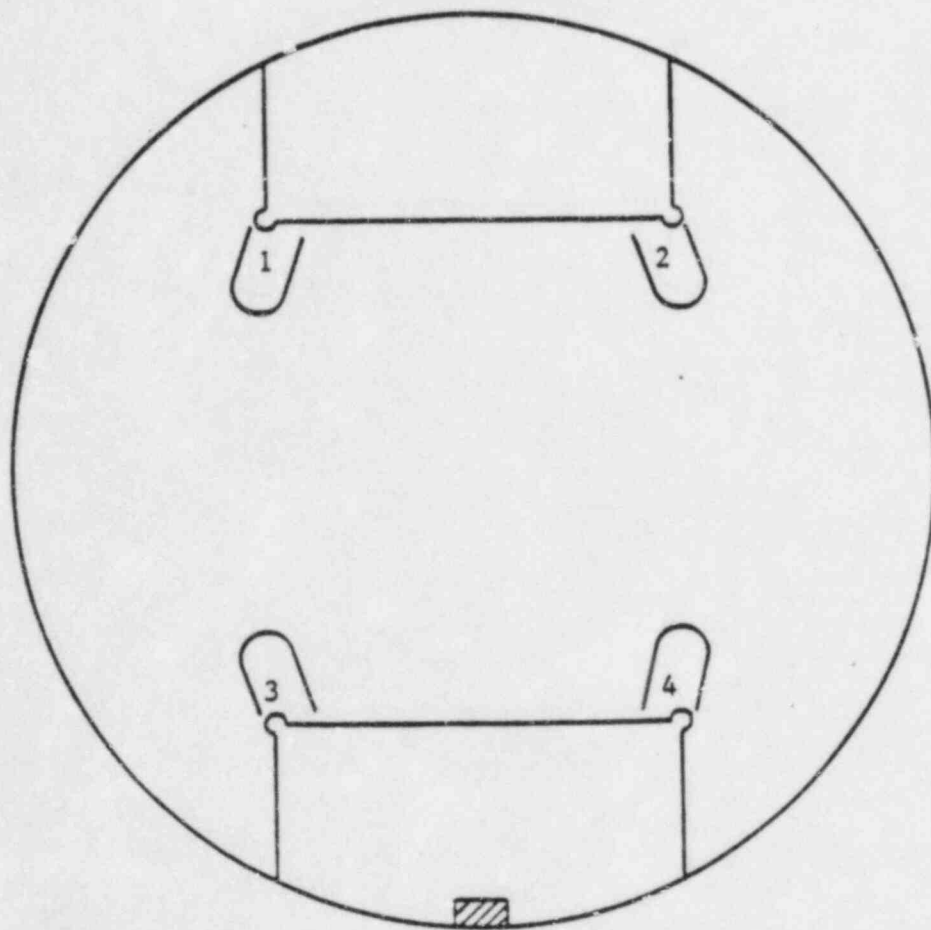
FIGURE 2-1: LOCATION OF STUD BORE AREAS
WITHIN PISTON

Numerous indications were found, ranging from 1/32 to 9/16 inches in length. The following additional inspections were performed to determine if the linear indications were superficial in nature. Each linear indication was ground and/or sanded to a depth of approximately 0.062 inches. These indications were then re-inspected using the liquid fluorescent dye penetrant or wet fluorescent magnetic particle process. Linear indications were found ranging from 1/32 to 1/2 inch in length. The results of these additional inspections are summarized in Table 2-2.

To characterize these indications, a confirmatory metallurgical analysis will be performed. The analysis will attempt to determine the mode of cracking, characterize the crack propagation rate, and estimate the depth.

As a result of the Division II modified "AF" piston skirt inspection, the piston skirts in the Division I and II D/Gs have been replaced with the type "AE" piston skirts.

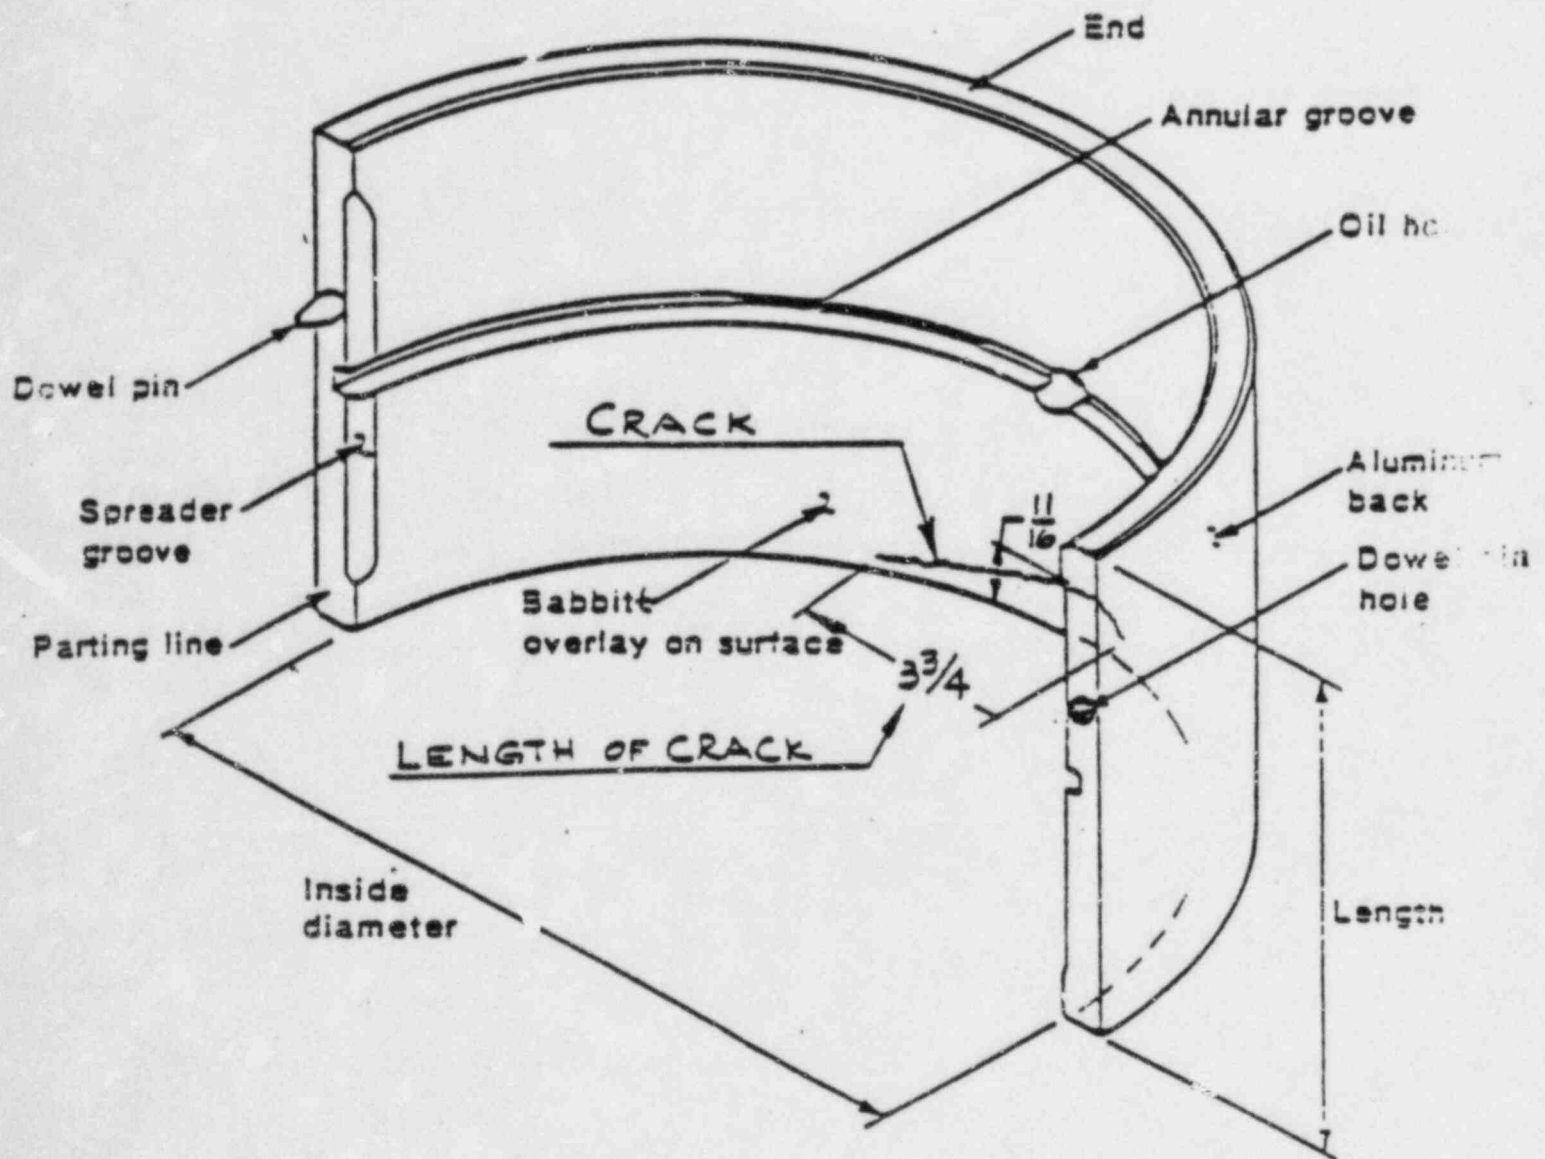
FIGURE 4-1: SHOREHAM CONNECTING ROD BEARING
DESIGN AND NOMENCLATURE
(SCHEMATIC)

A schematic of a cracked Shoreham bearing is shown in Figure 4-1. FaAA performed an analysis (Reference 18) on one of the cracked Shoreham bearings. The cracked bearing was checked for its chemical and physical properties. A scanning electron microscopy (SEM) analysis of the fracture was also performed and dimensional checks were made for wear. The chemical and physical properties met the current design specifications except for elongation. The elongation was found to be below specification, however, the test specimen was not standard, and led to results that were inconclusive. Reference chemical properties for B850.0-T5 are shown in Table 4-1. A Shoreham SEM examination of the fracture face indicated that voids in the bearing shell may have been crack initiation locations. In compression, voids in the "overhang" area would not pose a problem. However, the bearing/rod arrangement on the Shoreham diesels did not support the end part of the bearings (Figure 4-2). This unsupported end combined with the yawing of the crankshaft would put the internal diameter surface into tension. The surface porosity acting as a stress intensifier may have contributed to crack initiation in the unsupported end ("overhang" area). Also, the subsequent shell thickness measurements showed the bearing to be within the manufacturing tolerances, i.e., no appreciable wear.

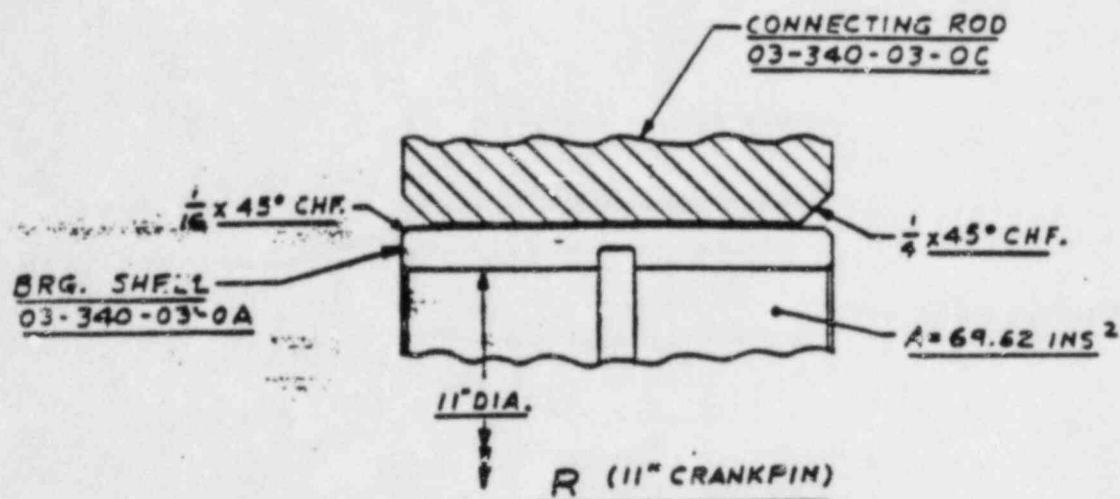
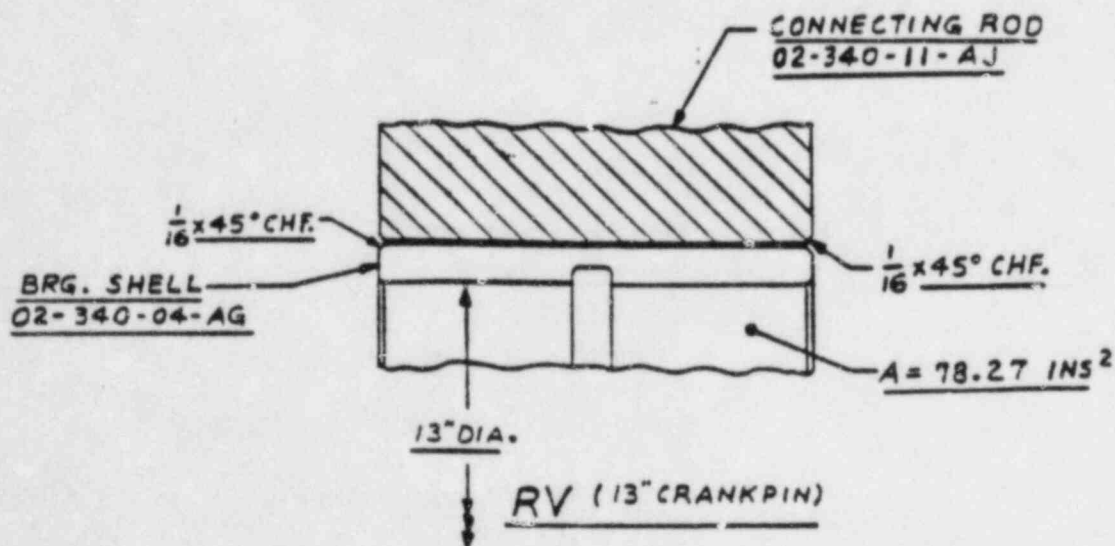
FIGURE 4-2: COMPARISON OF CONNECTING ROD/BEARING CHAMFER ARRANGEMENTS

3. The results of the chamfer measurements indicate that there is no "overhang" arrangement on the #7 connecting rod/bearing assembly and that the #2 connecting rod/bearing assembly has an "overhang" of approximately 0.016 inch (i.e., 0.016 inch of unsupported bearing material). This amount of "overhang" is insignificant compared to the 0.25 inch "overhang" that existed on the Shoreham bearings at the time of bearing cracking.

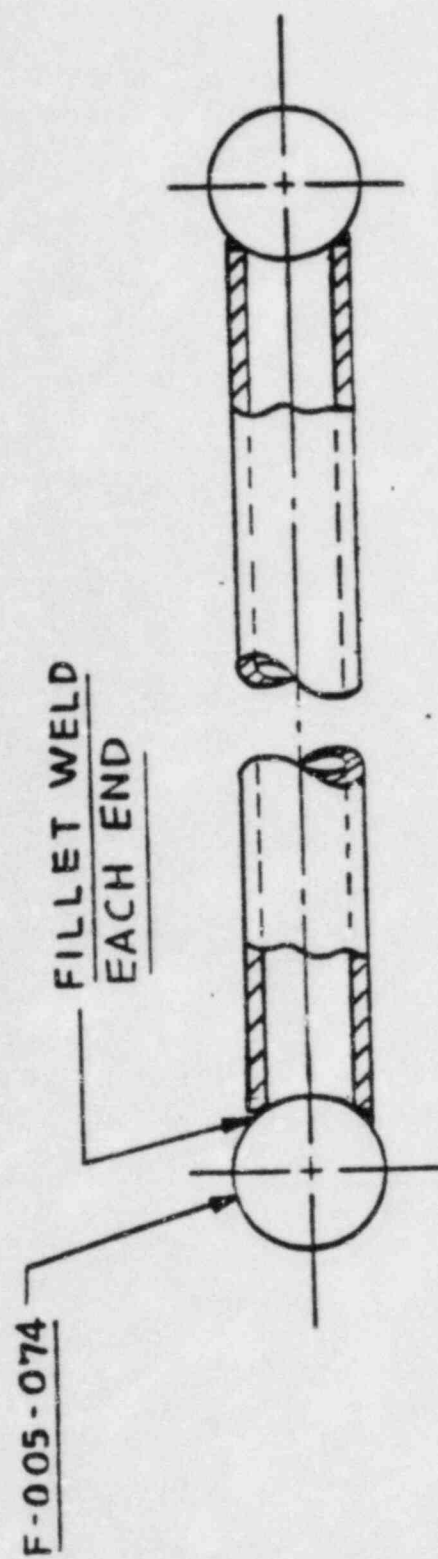
FIGURE 5-1: WELDED BALL CONNECTOR

The connector push rod consisted of a tubular steel body fillet-welded to carbon steel ball bearings. This design is the type which exhibited defects at Grand Gulf and is shown in Figure 5-1. A 1 1/2-inch high carbon steel ball bearing is fitted to 1 1/4-inch OD tubing with a 1/4-inch wall. The inside edge of the tubing has a 45° chamfer which results in a 7/8-inch circular seating ring for the ball at the end of the tube. The ball is attached to the tube with a continuous 360° fillet weld. The materials of construction are as follows:

The first connector push rod found defective was subjected to metallurgical evaluation (Reference 3). The initial weld defect resulted from lack of penetration of the fillet weld with the tubing. Destructive examination of the ball and weld on the opposite end of the defective connector push rod revealed additional cracks in the heat-affected-zone (HAZ) of the ball bearing. The welds exhibited lack of penetration and slag inclusions in the crevice area behind the weld. The metallurgical evaluation concluded that the ball material is difficult to weld. The possibility of finding underbead cracks all around the ball in the HAZ is very high.

MP&L proceeded with an interim inspection program, until replacement connector push rods free of defects could be obtained. The discovery of a cracked connector push rod ball in the Division I diesel, however, demonstrated that the underbead cracks could, in fact, propagate through the ball material.

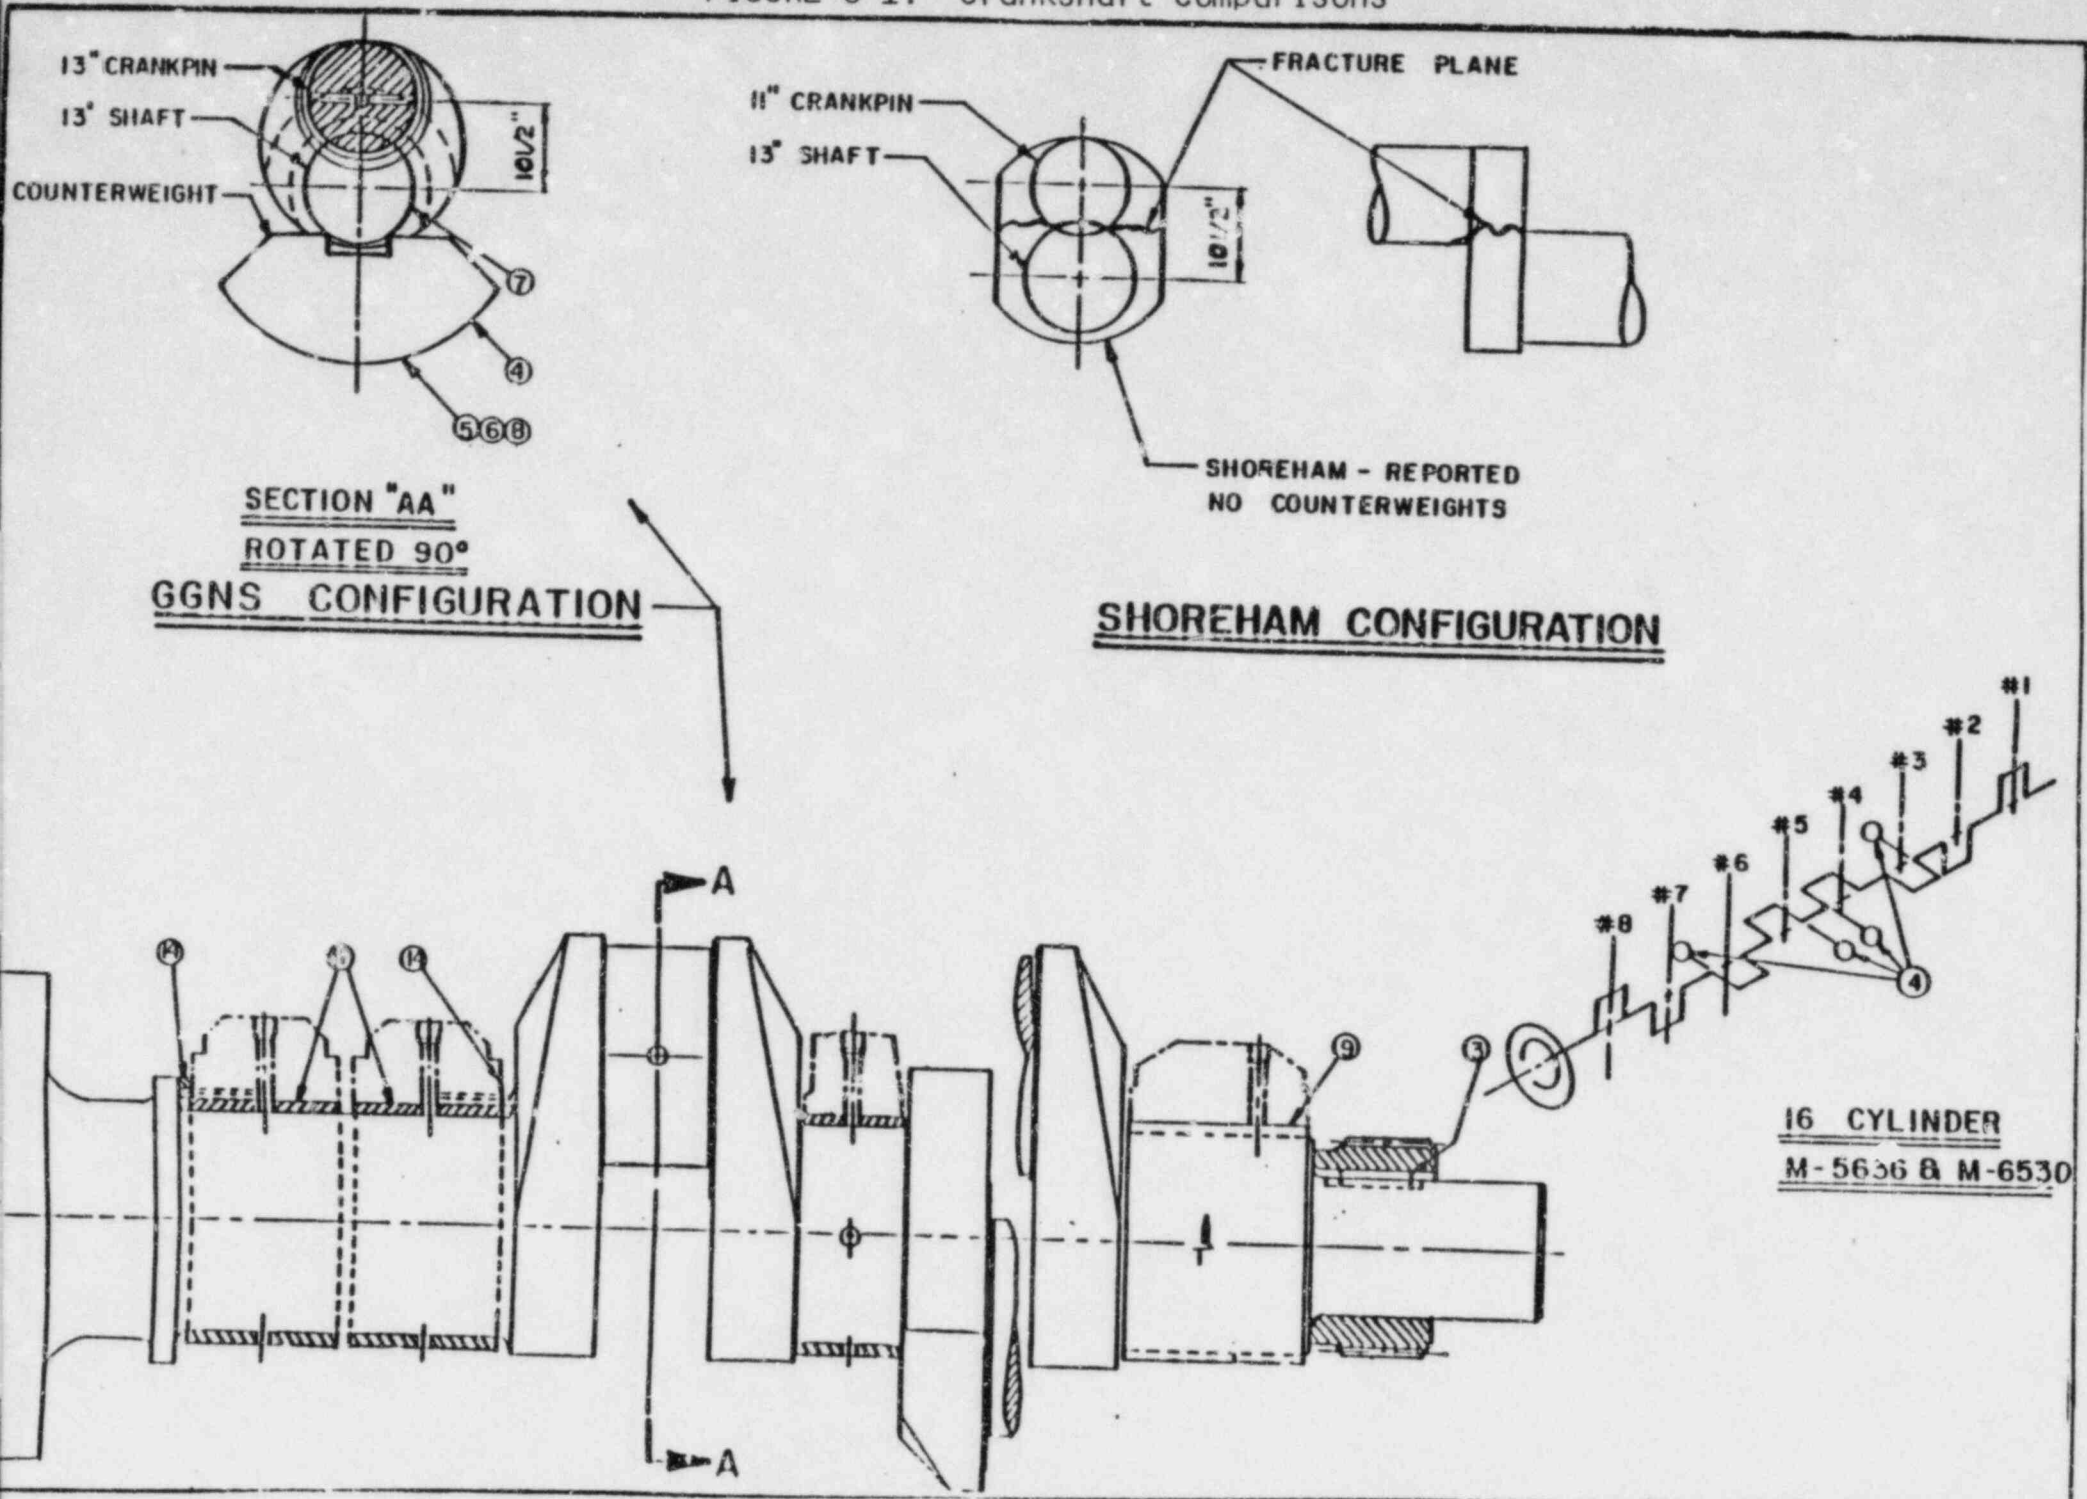
FIGURE 6-1: Crankshaft Comparisons

Investigations were immediately conducted by MP&L on the applicability of the failures at Shoreham to the Grand Gulf TDI diesel generators. A physical comparison (Reference 19) of the DSR-48 (in-line eight cylinder) series engine crankshaft that failed, with that employed in the DSRV-16-4 (Vee-16 cylinder) series at Grand Gulf revealed some important differences. Among the significant design improvements on the Grand Gulf engine are the larger web size and shape, larger crankpin diameter, larger pin fillet radius and the use of counter-weights. In addition, it was learned that TDI may have used potentially non-conservative (1st generation) design harmonic coefficients in 1974 when the Shoreham stress analysis was performed.
