## LICENSEE EVENT REPORT

TOLEDO EDISON COMPANY  
DAVIS-BESSE NUCLEAR POWER STATION UNIT ONE  
SUPPLEMENTAL INFORMATION FOR LER NP-33-83-59

IDENTIFICATION OF OCCURRENCE: HP49, High Pressure Injection Stop Check Valve, required excessive differential pressure to establish forward flow

LER #83-048

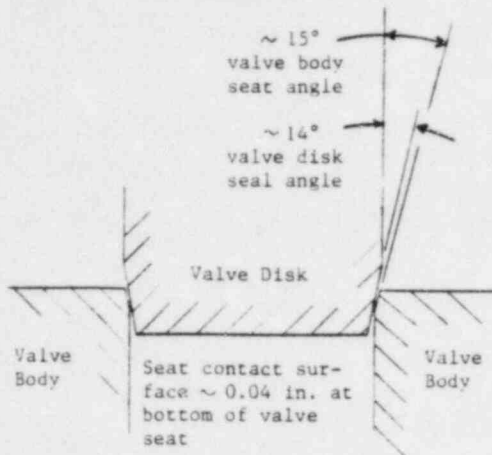
HP48, HP96, & HP57 seat  
 configuration prior to  
 modification in 1982

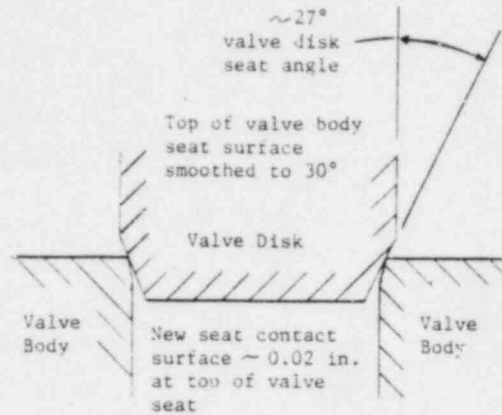
Description of Occurrence: On September 1, 1983, all four high pressure injection (HPI) stop check valves were tested to determine the differential pressure required to establish forward flow. Three of these valves (HP48, HP56, and HP57) were modified during the 1982 Refueling Outage due to a problem involving the valves sticking in the closed position. The cause of the three valves sticking in 1982 was determined to be a steep seating surface of 15° (reference Licensee Event Report NP-32-82-04 [82-023]). HP49 had a seating surface of approximately 28°, and at no time exhibited signs of sticking.

HP48, HP56, & HP57 seat  
 configuration after 1982  
 modification

With this modification, HP49 has a narrower contact area and a steeper plug angle to more closely approach the modified design of HP48, HP56, and HP57. See the attached Figure 1 for the details of the modifications made to these valves. HP48, HP56, and HP57 have a 15° angle below the point of contact while HP49 has a 30° angle below the point of contact. These valves will again be tested during the 1984 Refueling Outage.

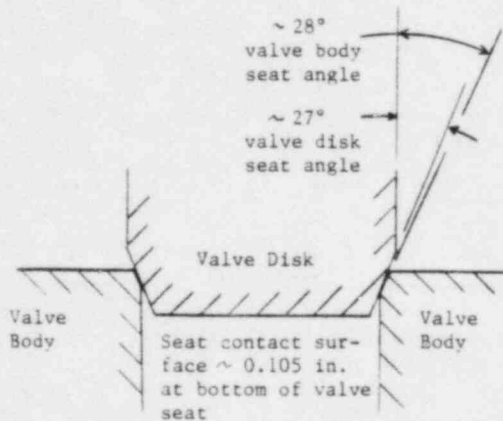
Designation of Apparent Cause of Occurrence: The cause of this occurrence was a design deficiency. HP49 had a disk to seat contact area of approximately one tenth of an inch wide. According to the valve manufacturer, a wide seat contact area increases the likelihood of the valve sticking. Based upon this information, Toledo Edison has determined the cause of this problem to be the wide seat angle.

Corrective Action: HP49 was disassembled on September 12, 1983. An inspection revealed a wide seat contact area did exist and that it was irregular around the circumference of the disk. Based upon this information, the disk in HP49 was replaced with one with a 33° seat angle. This resulted in a narrow seat contact area existing at the very top of the seat in HP49. This was verified by a blueing check of the seating surface.

HP49 seat configuration  
 before modification

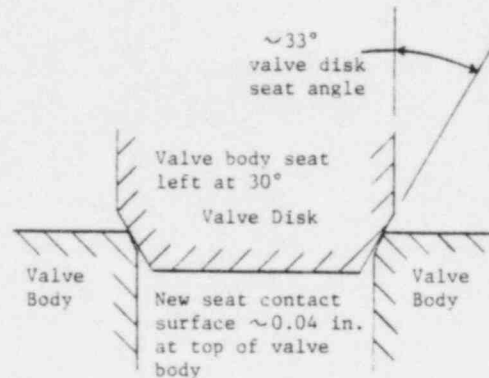
HP49 seat configuration  
 after modification

On September 13, 1983, HP49 was reassembled, and the handwheel was torqued closed with 150 ft. lbs. of torque to assure the disk was seated. This amount of torque simulated approximately double the force of RCS pressure. The handwheel was then opened, and the differential pressure needed to establish forward flow was determined. This test was repeated three times with each test showing 2 psid would open the valve.
