Generator Report on
Virginia Electric Power Company
North Anna Unit #1
Transformer Incident of December 5, 1982

ENG2354

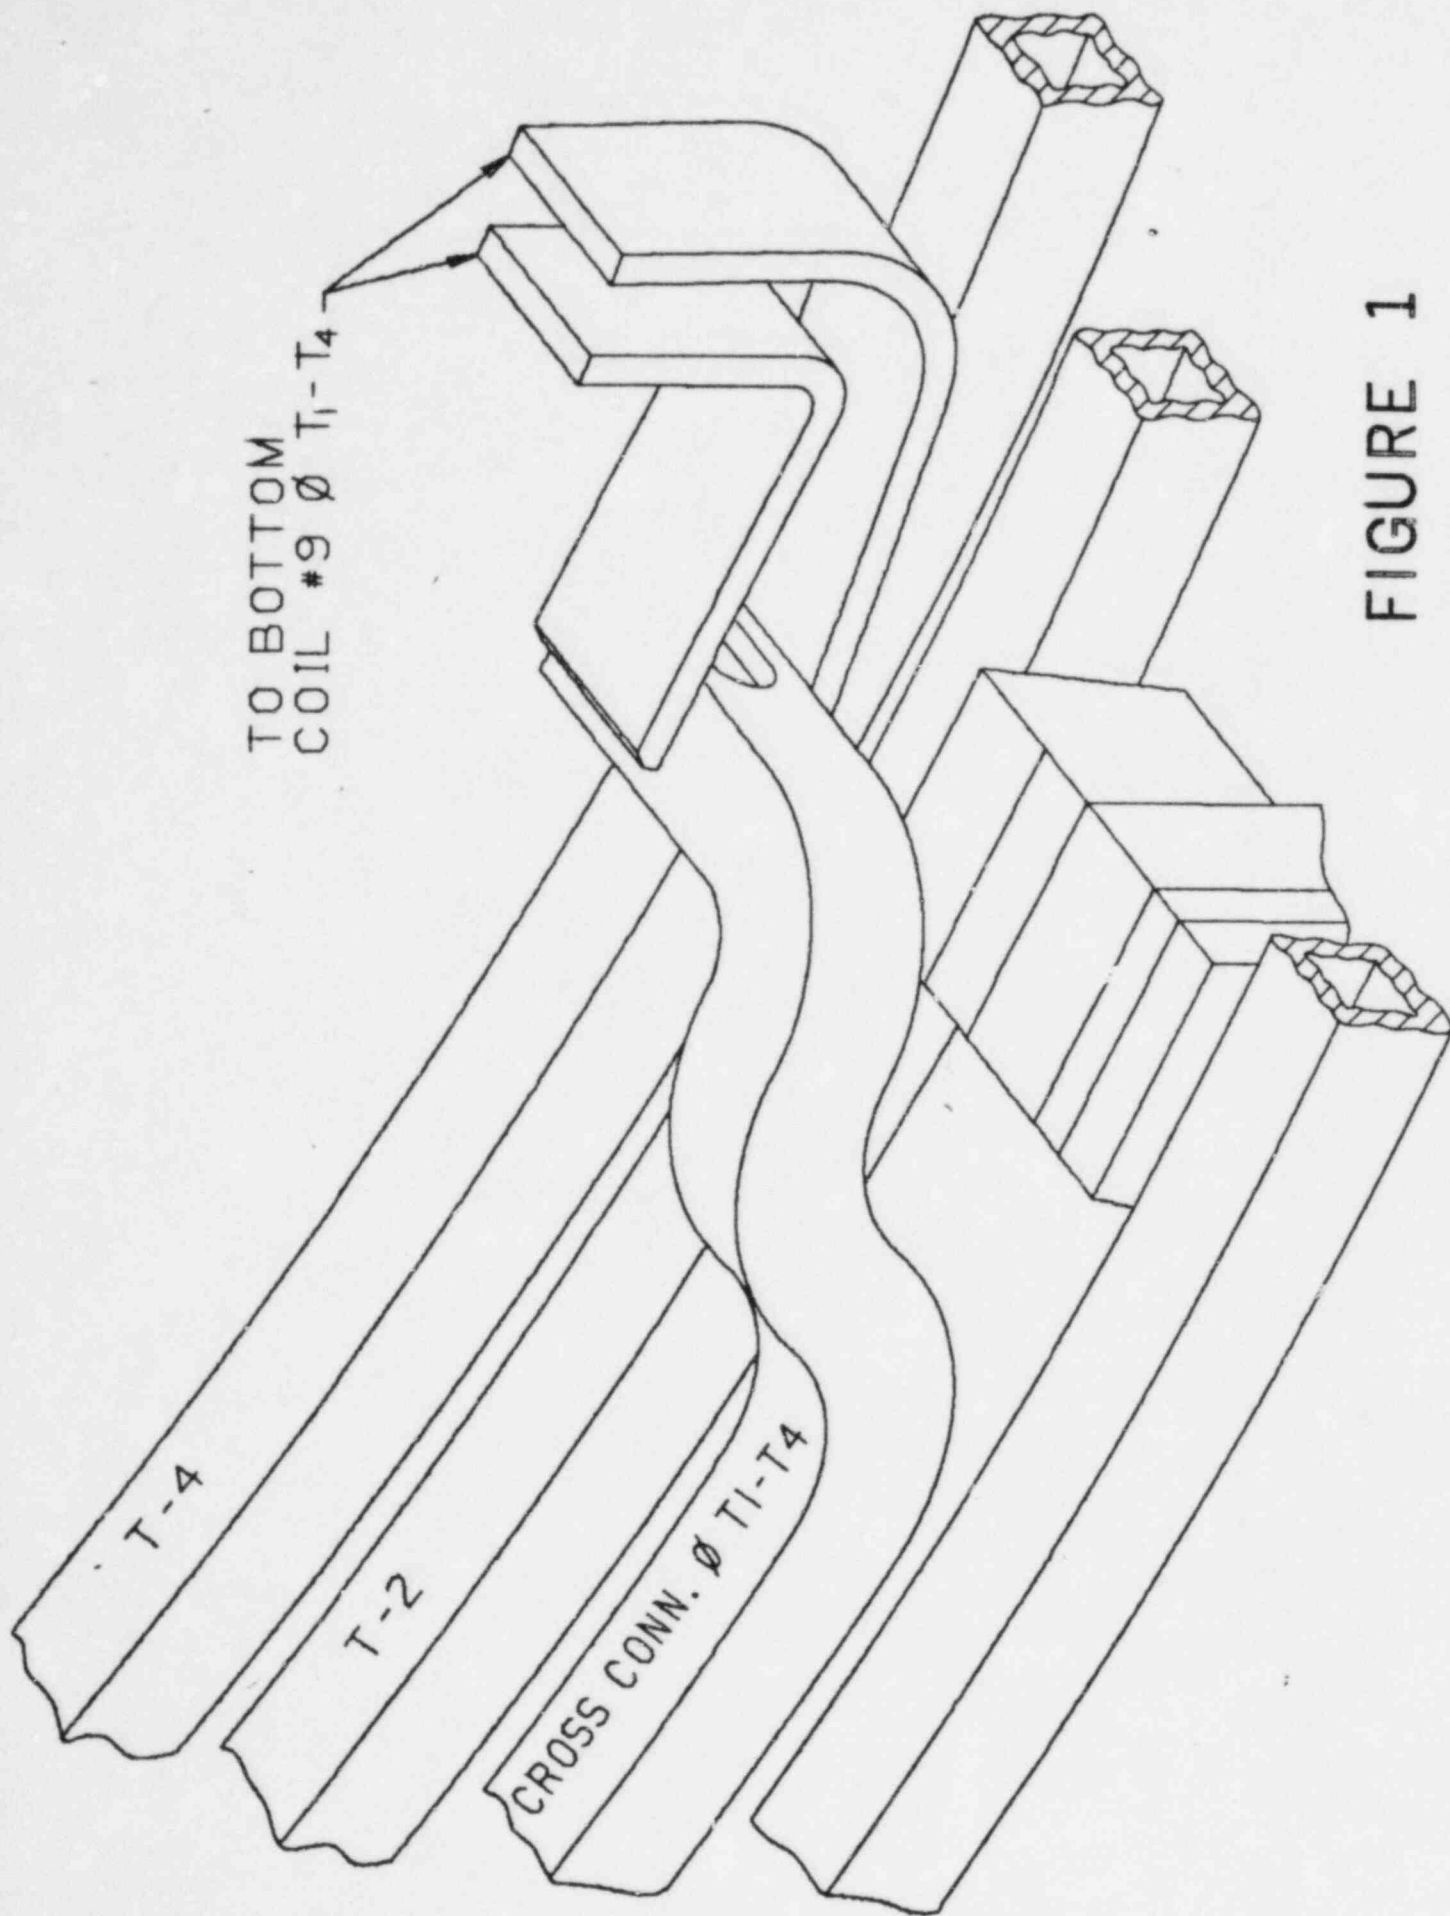
FIGURE 1

During this period, a phase-to-phase fault through the insulation occurred at the parallel rings. Figure 1 shows the fault area prior to the incident and without insulation. Initial breakdown was probably a phase-to-phase fault between the cross-connection and the coil B-9 and the T-2 parallel ring. Shortly thereafter, T-4 parallel ring was involved. Figure 2 shows the area of copper removed as the result of the incident and subsequent arcing.

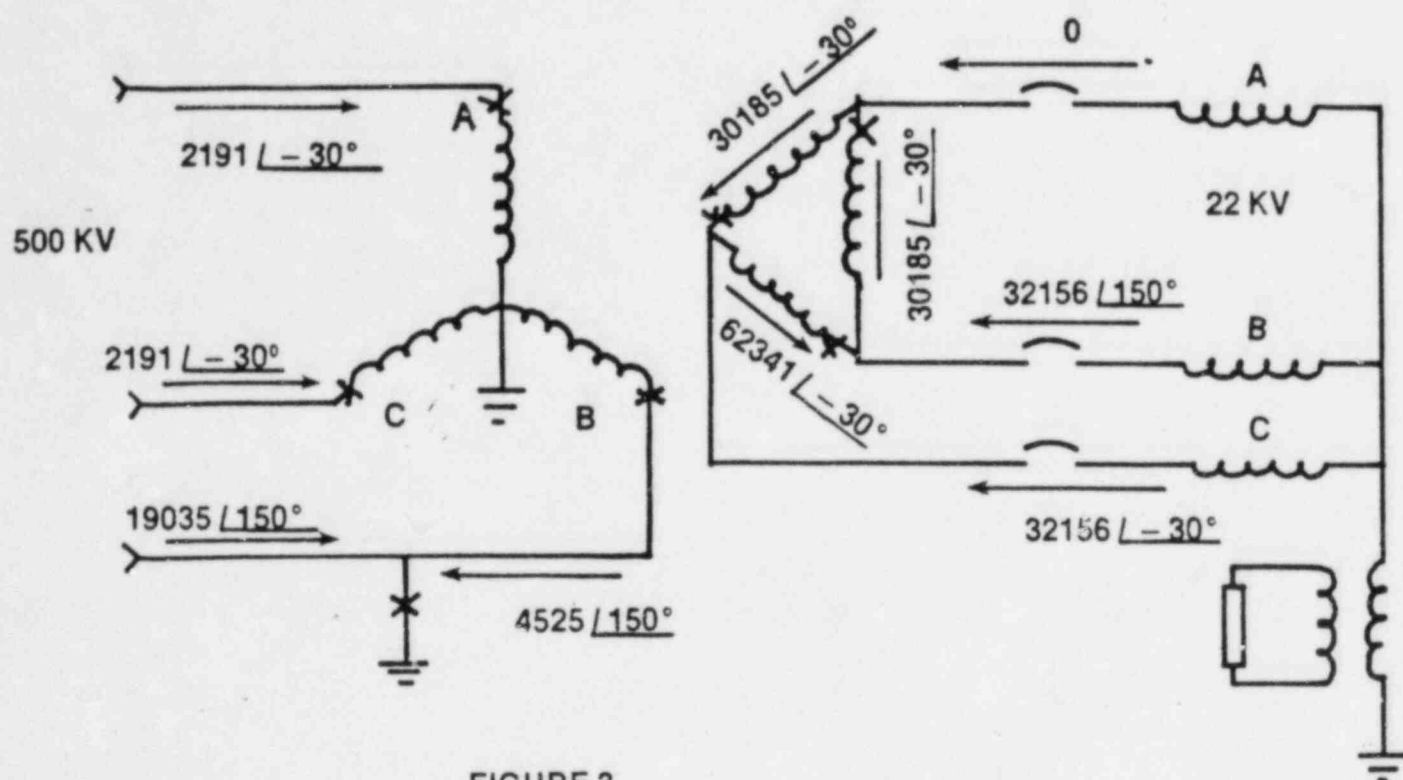
FIGURE 3

generating unit for a single phase to ground fault on the high voltage terminals of the B-Phase transformer with no other event occurring. For purposes of this calculation, the system positive and negative sequence reactances were assumed to be five percent on the generator MVA base and 525 kv base; the zero sequence impedance of the system was assumed to be ten percent on the same MVA and voltage base. The results of this calculation are shown in Figure 3.

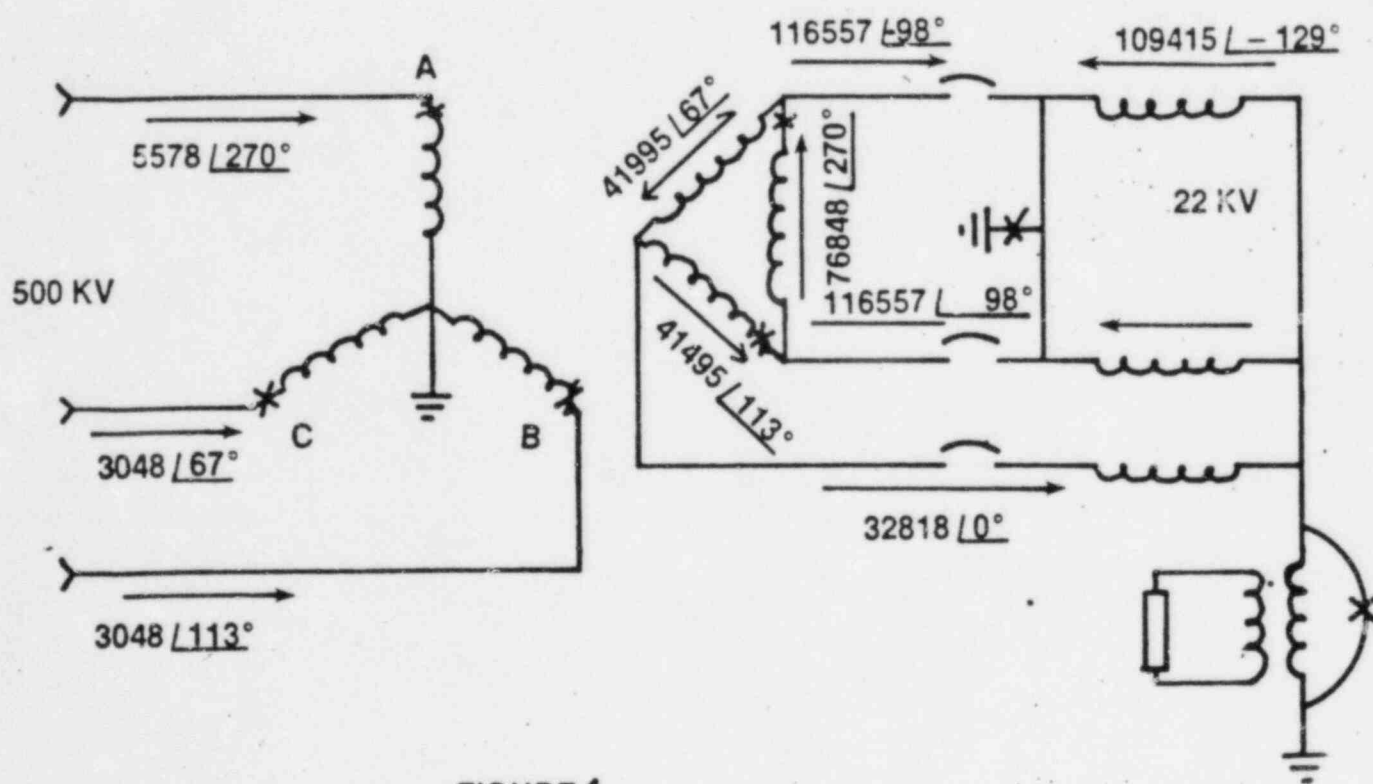
FIGURE 4

A calculation was also made to determine the approximate values of system and generator currents for a double phase to ground fault on the 22 kv system with no grounding impedance on the 22 kv system. That is, the generator neutral grounding transformer was assumed to be shorted out. The results of that calculation are shown on Figure 4. The 500 kv oscillogram was analyzed by VEPCO personnel and determined to be as follows:
