Arizona Public Service Company

Subject: Interim Report, Revision 1 - DER 83-84
A 50.55(e) Potentially Reportable Deficiency Relating to
Eighty Seven (87) 3/8" Bolts Found Missing From The Seismic
Tie Downs Of The Floor Frame Assemblies for Six (6) Motor
Control Centers in Unit 1.
File: 84-019-026; D.4.33.2

INTERIM REPORT - DER 83-84
POTENTIAL REPORTABLE DEFICIENCY
ARIZONA PUBLIC SERVICE COMPANY (APS)
PVNGS UNIT 1

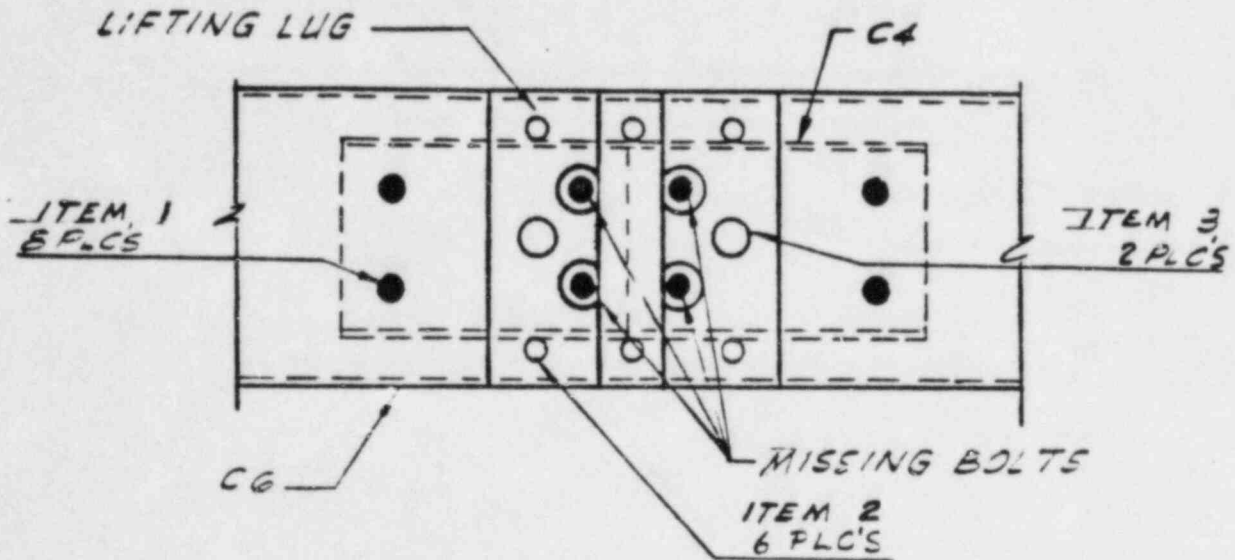
FIGURE 1 - FRONT LIFTING LUG ASSEMBLY (Two per cabinet)

On the front side of the cabinets (see Figure 1), the 4-3/8-diameter bolts (Item 1) that the lifting lug fits over were either removed when the lifting lugs were removed, or were never installed by General Electric (GE) prior to shipment. For the front side, the 3/8-inch diameter bolts serve as part of the connection between the front base channel (C6) and a parallel channel (C4) which, in turn, is connected to a transverse channel (C4). On the back side of the cabinets (see Figure 2), the 2-5/8-inch diameter bolts (Item 6) which connect the lifting lug to the base channel (C6) were not reinstalled after the lifting lugs were removed. It was not apparent from the vendor drawings that these bolts also serve as part of the connection between the back base channel (C6) and a parallel channel (C4) which, in turn, is connected to a transverse channel (C4).

Item 1 - Holes for 3/8-inch diameter mounting bolts which attach the C4 support grid to the C6 base. These bolts are required after lifting lug removal.

Item 2 - Mounting holes for the lifting lugs attachment bolts. No bolts are required after lifting lug removal.

Item 3 - Holes for 5/8-inch diameter bolts used to attach the lifting lug. These bolts are not required after lifting lug removal.

Note A - After lifting lug removal 2-5/8-inch diameter bolts (Item 3) may be installed as a substitute for the 4-3/8-inch diameter bolts (Item 1).

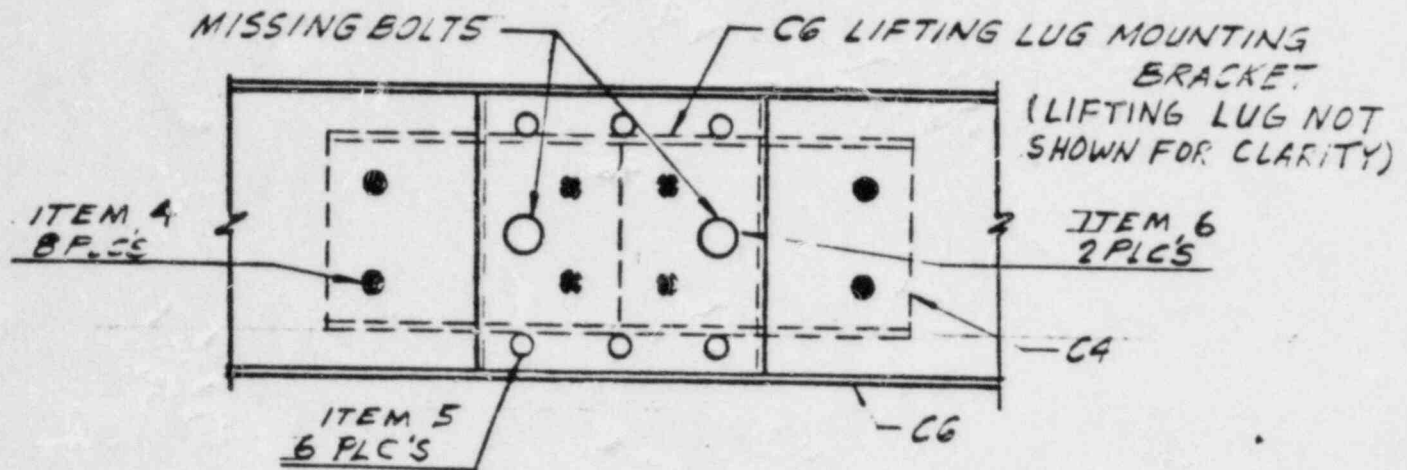
FIGURE 2 - BACK LIFTING LUG LOCATION (Two per cabinet)

Item 4 - Holes for 3/8-inch diameter mounting bolts which attach the C4 support girt to the C6 base.

Item 5 - Mounting holes for the lifting lug attachment bolts. No bolts are required after lifting lug removal.

Item 6 - Holes for 5/8-inch diameter bolts used to attach the lifting lug. These bolts are required to be reinstalled after lifting lug removal.

Note B - The C6 lifting lug mounting bracket, which is welded in place, covers the four middle 3/8-inch diameter bolt locations. This makes installation of the middle 3/8-inch diameter bolts impossible. The two 5/8-inch diameter bolts shall be reinstalled as a substitute after lifting lug removal.
