LICENSEE EVENT REPORT

REPORTABLE OCCURRENCE 83-035

FORT ST. VRAIN NUCLEAR GENERATING STATION  
PUBLIC SERVICE COMPANY OF COLORADO  
16805 WELD COUNTY ROAD 19 1/2  
PLATTEVILLE, COLORADO 80651-9298

REPORT NO. 50-267/83-035/03-L-0

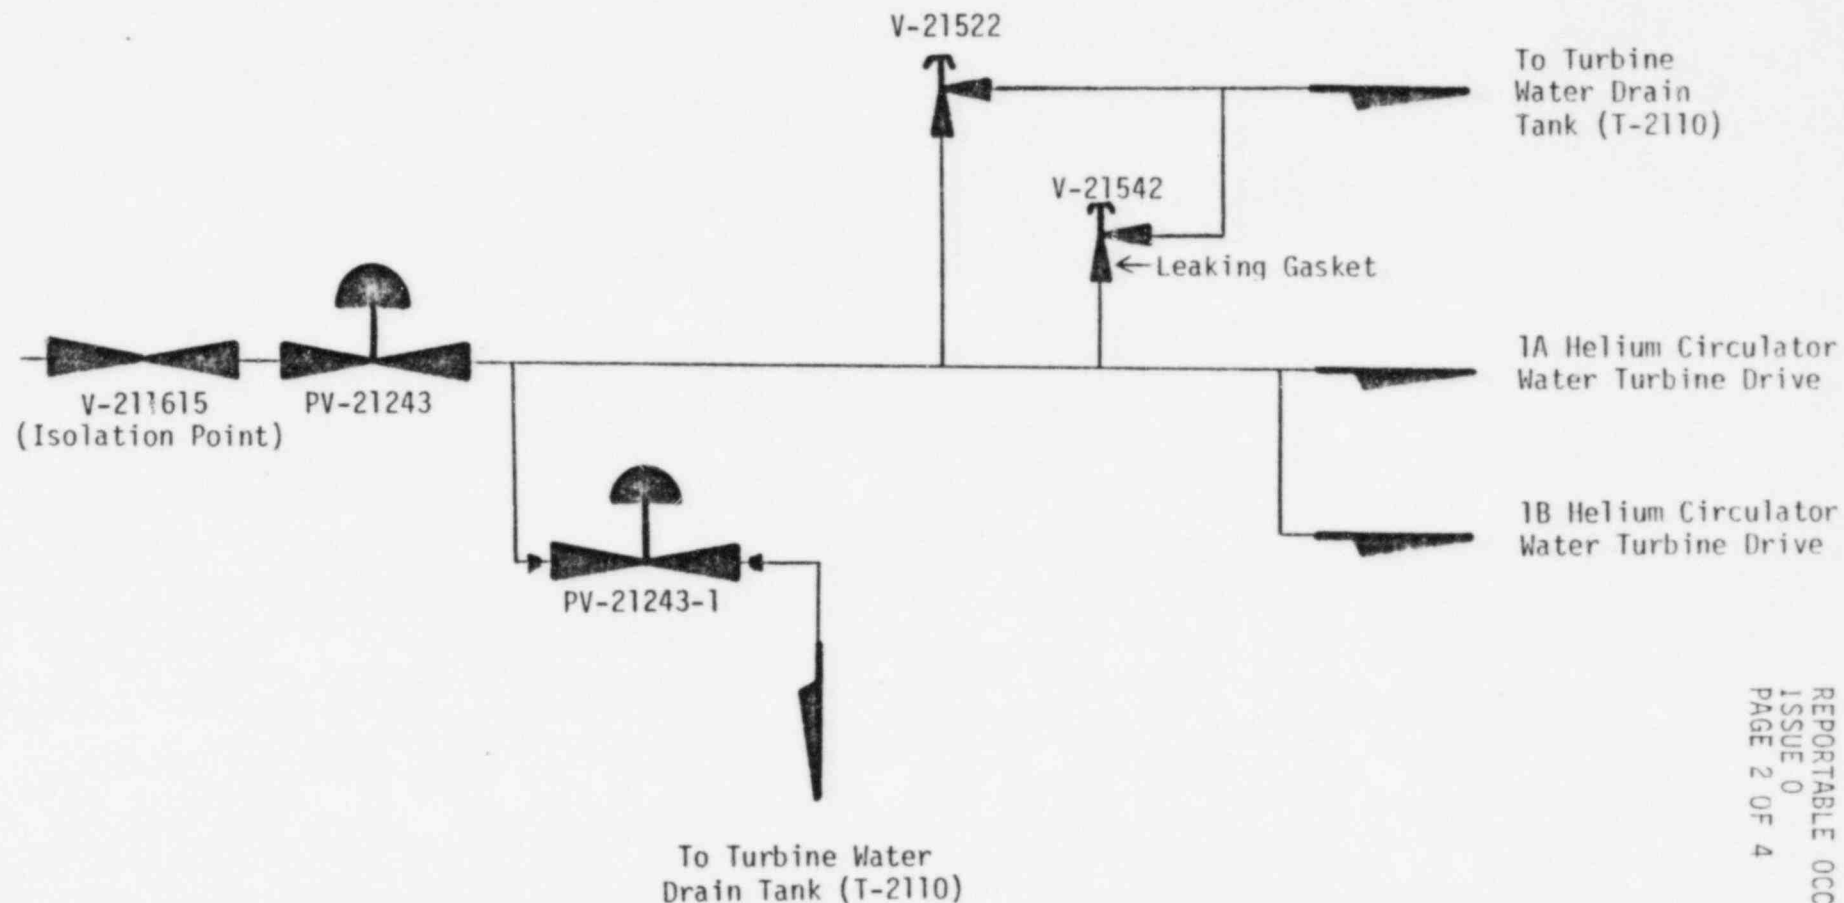
FIGURE 1

At 0710 hours on September 22, 1983, with the reactor operating near 66 percent power, emergency feed water to the Loop I helium circulator water turbine drives was isolated to allow repair of relief valve V-21542, and perform calibration checks on pressure control valves PV-21243 and PV-21243-1.

Emergency Feedwater to Helium Circulator  
Water Turbine Drives - Loop 1

Thermal expansion and contraction of a copper gasket caused external valve leakage. The gasket and threaded plug, located on the side of V-21542, allow internal adjustment access to the relief valve blowdown ring.

Relief valve V-21542 was repaired and returned to service.

Pressure control valves PV-21243 and PV-21243-1 were checked, calibrated as necessary, and returned to service.
