SNUPPS

SLNRC 83-0063 FILE: 0671.1
SUBJ: NUREG-0737, Item I.D.1 "Control
Room Design Reviews"

HUMAN ENGINEERING FINDINGS AND RESPONSES

SNUPPS CONTROL ROOM

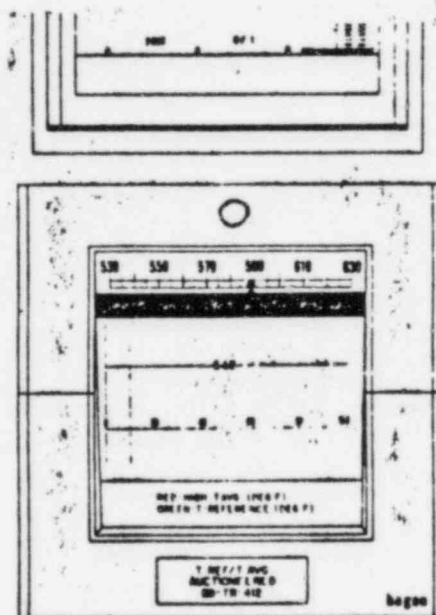
Finding 16 (3¹) The label for the T REF/T AVG AUCTIONEERED trend recorder is located at the bottom of the recorder, rather than above as is the plant convention.

Response The location of the label is such that there is no question at all as to which device it refers to. There is inadequate room to locate the label above the recorder. See sketch

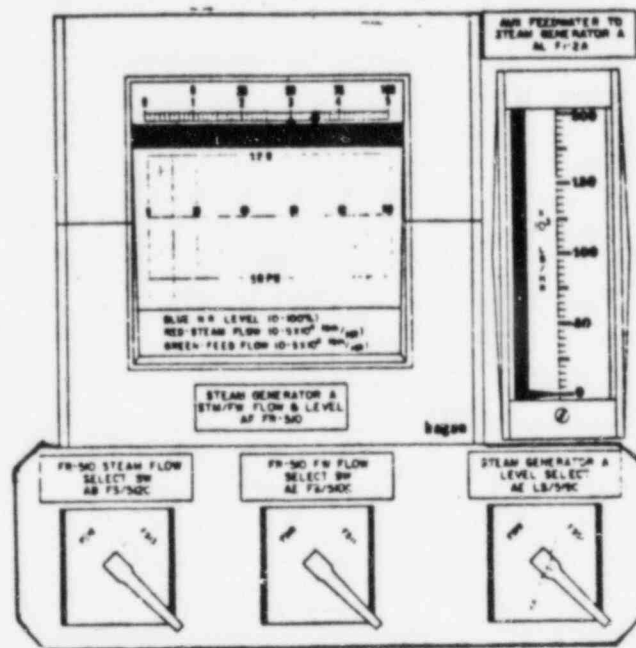
Finding 4 (3¹) The STM GEN A through D LVL SEL SW controls are not located directly below their associated trend recorders. These switches may be inadvertently associated with the AUX FEEDWATER display that they are located directly beneath.

Response Demarcation lines will be added to clearly group these three switches (see sketch).

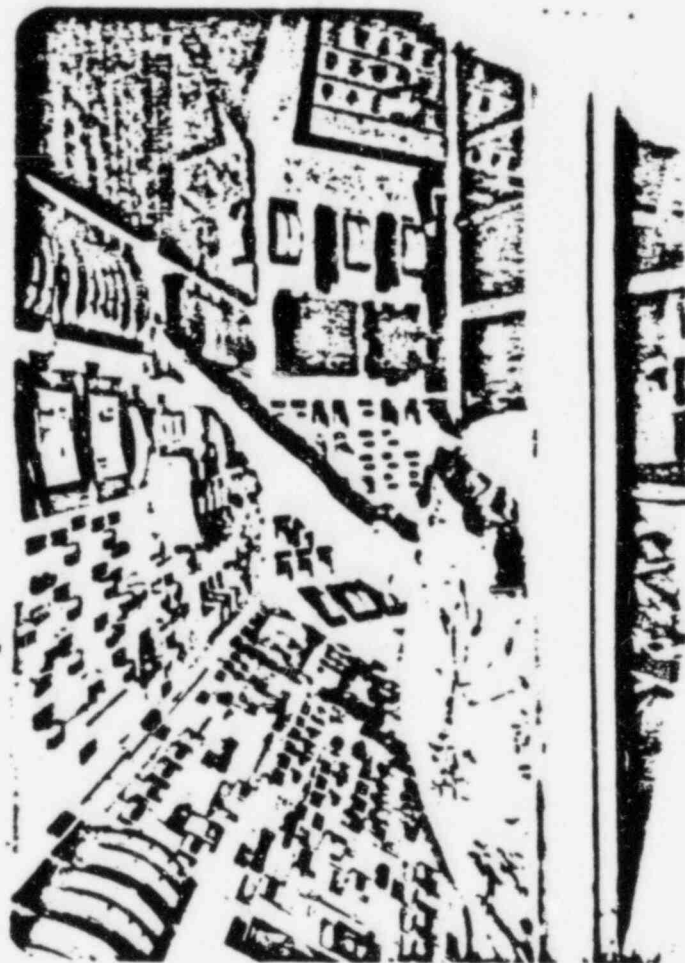
Attachment to Finding 1.1

Finding 1 (1) Some controls are located too high to be accessible to a 5th percentile operator. One J-handle switch is located 73" above the floor. Some emergency controls for the BORON INJ RECIRC PUMP are located 66" above the floor. The maximum recommended height for controls is 56".

Response On panel RL014 at Callaway, the switchyard breaker control switches are located above the recommended height in order to retain their proper relationship to the switchyard mimic which is arranged to show the correct association of the transmission lines, busses and circuit breakers. Manual operation of these control switches is infrequent and is performed only after discussion with and at the direction of the Union Electric system dispatcher so that the operator action is deliberate and unhurried. These control switches can be operated by a 5th percentile operator as the attached picture illustrates.

The referenced control (Boron Inj. Recirc. Pump) which is in panel RL017 is not an emergency control. With its present location (66" above the floor) a 5th percentile operator can perform any necessary functions required as the attached picture illustrates.

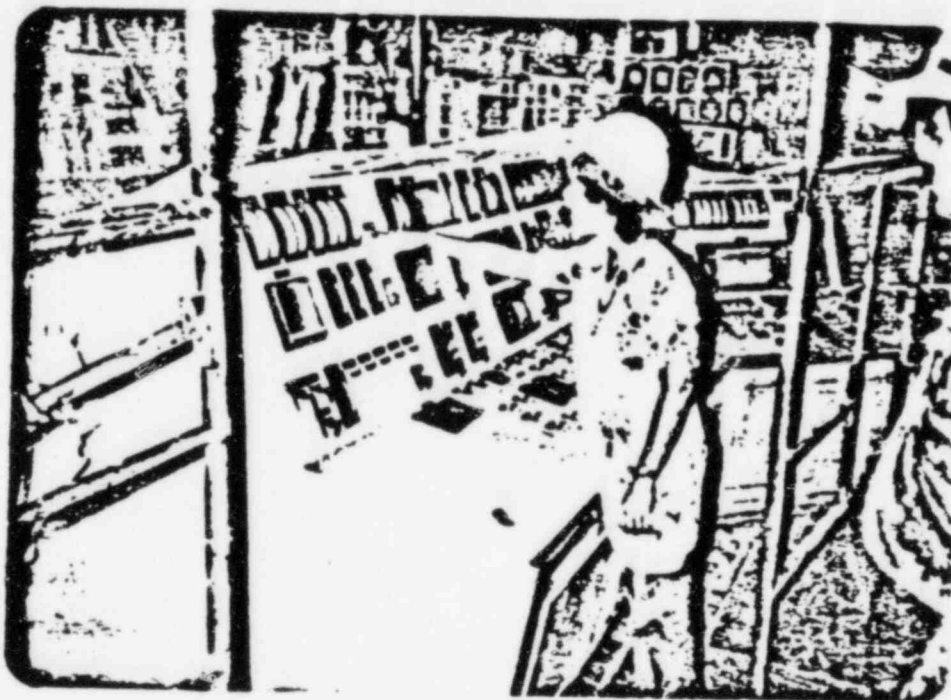
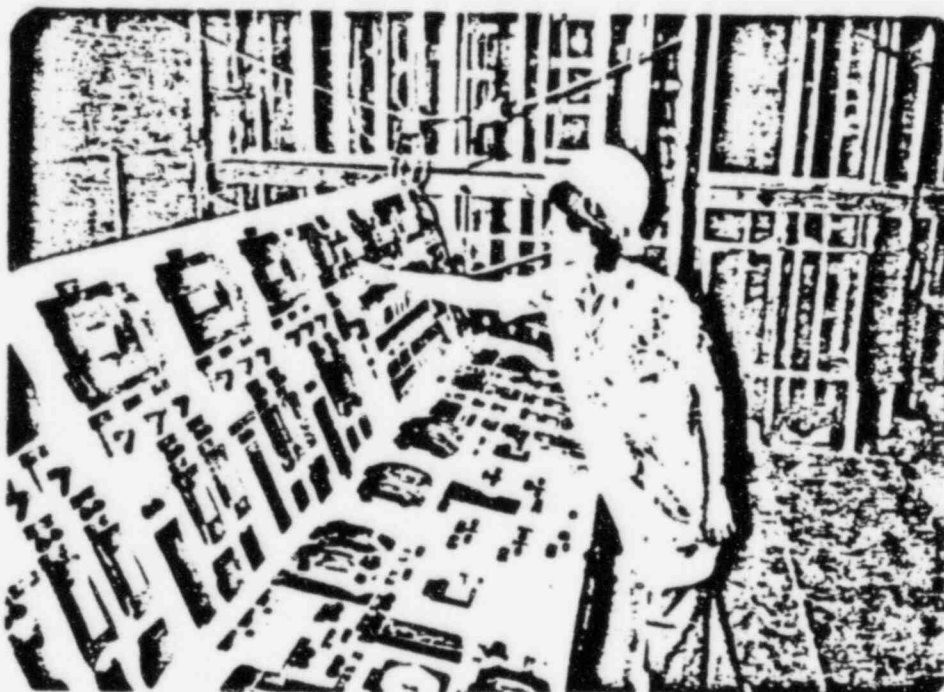
Attachment to Finding 1.7

Finding 7 (3) Some controls are located further in from the front edge of the inner ring consoles than the recommended 24". These controls will not be accessible to a 5th percentile operator.
