U.S. NUCLEAR REGULATORY COMMISSION
LICENSEE EVENT REPORT

Tennessee Valley Authority
Browns Ferry Nuclear Plant

DIESEL - GENERATOR COOLING WATER COOLERS

TENNESSEE VALLEY AUTHORITY - BROWNS FERRY NUCLEAR PLANT UNIT 3 - DOCKET
NO. 50-296 - FACILITY OPERATING LICENSE DPR-68 - REPORTABLE OCCURRENCE
REPORT BFR0-50-296/83026 - REVISION 4

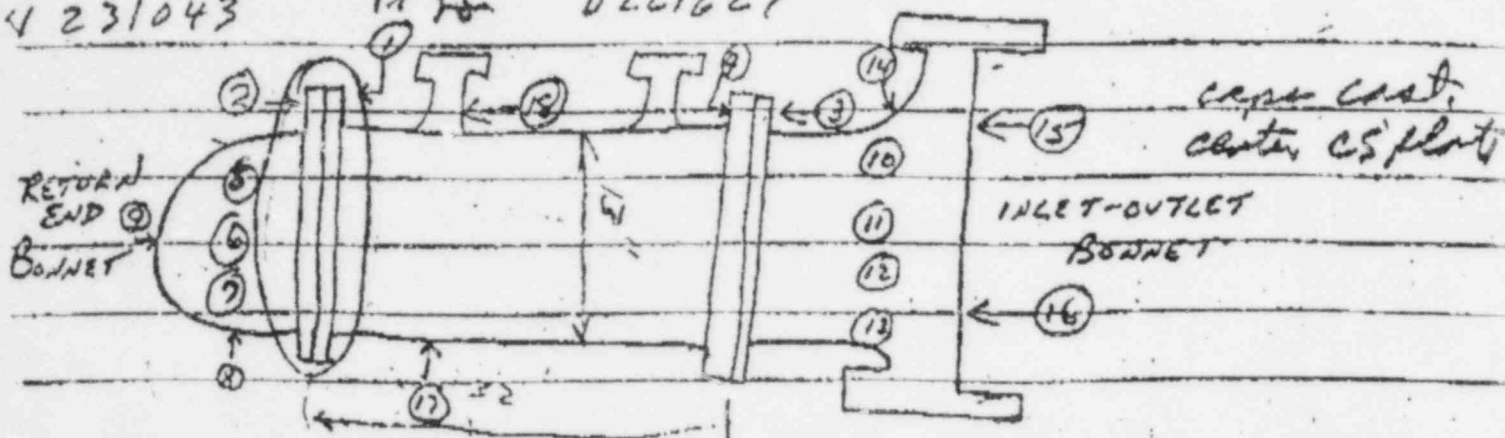
Bonnet flanges were 1-inch thick. ASME and American Water Works Association (AWWA) flanges with 165 or 150 psi ratings require 1-1/4-inch flanges with 12 or 8 bolts. These flanges had 24 bolts and full face gaskets. 4/5 of 165 approximately equal to 130 psi.

All pressure boundary dimensions of both bonnets were at least as thick as required for AWWA, 12 inch, 150 psi rated piping. The radius area of the inlet/outlet bonnet was thickened and present no concern.

a) RETURN END BONNET

b) INLET-OUTLET END BONNET

① 1.125"	⑤ .55	⑬ .520
② 1.00"	⑧ .59	⑭ .725
③ 1.00"	⑨ .58	⑮ .48
④ 1.065"	⑩ .610	⑯ .47
⑥ .605	⑪ .520	⑰ .125
⑦ .59	⑫ .445	⑱ .275
