Subject: Final Report, Revision 1 - DER 83-41
A 50.55(e) Reportable Deficiency Relating to Flooding in the
Control Building 'B' Train Room
F' : 83-019-026; D.4.33.2

FINAL REPORT - REVISION ONE - DER 83-41
DEFICIENCY EVALUATION 50.55(e)
ARIZONA PUBLIC SERVICE COMPANY (APS)
PVNGS UNIT 1

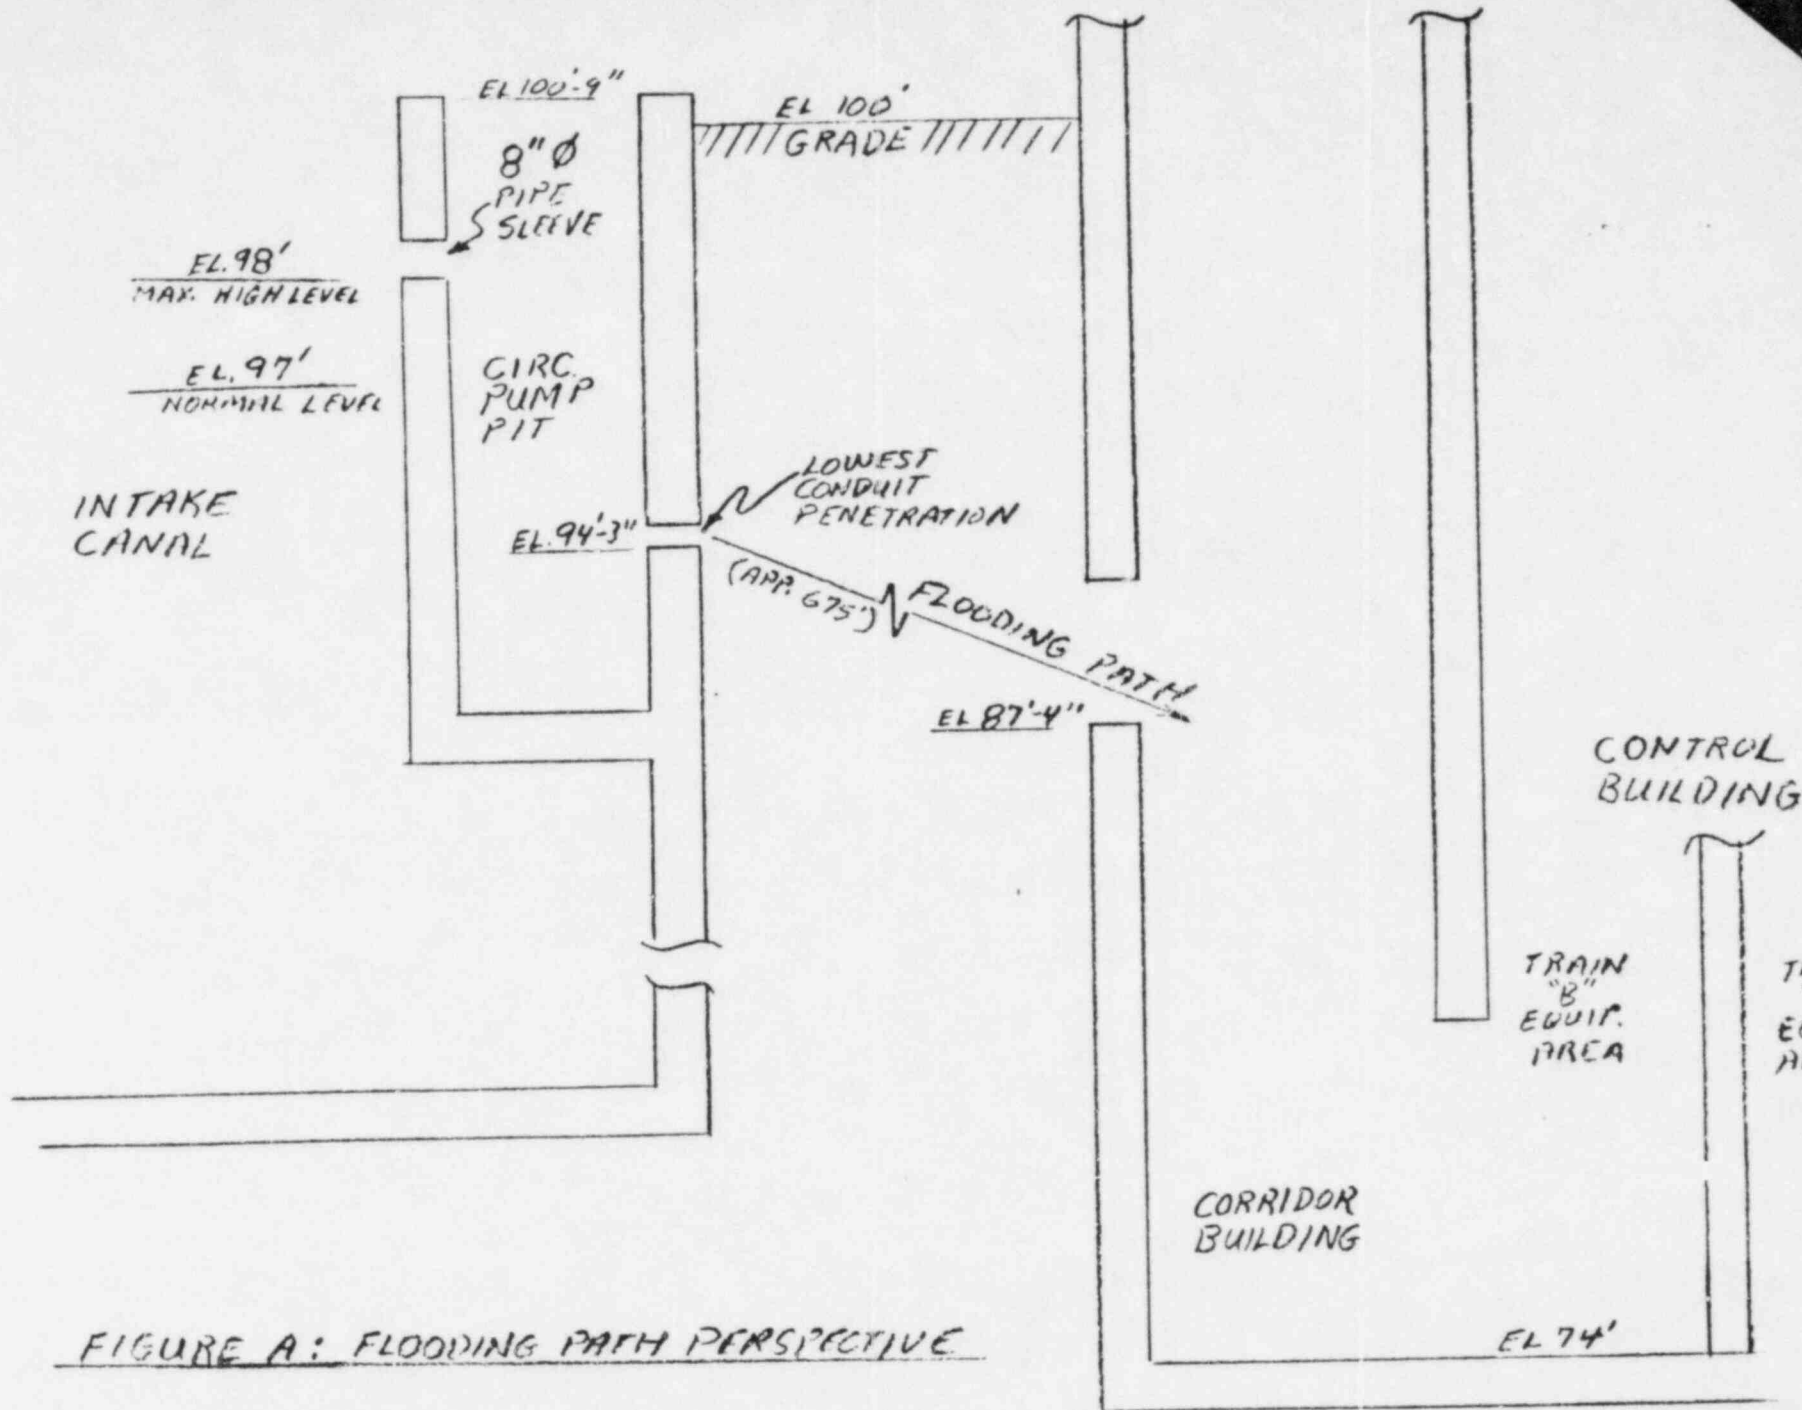
FIGURE A: FLOODING PATH PERSPECTIVE

On June 3, 1983, at 1130 hours, it was discovered that the circulating water intake canal was overfilled. This condition resulted in flooding the control building 74' elevation. The "B" train room was flooded to a depth of 7 inches and the "A" train room to a depth of 1 inch. The path of the flow was an open conduit running between the intake area and the control building.

During the event, the intake canal water level continued to rise above the normal operating level to the maximum high water level where water then passed through an unsealed pipe penetration to flood the circulating water pump pit area.

An unused (awaiting cable pulling) below grade conduit runs between the circulating water pump pit and the corridor building. Since the corridor building is connected to the control building below grade, a leakage path existed to the area containing safety related equipment. Figure A provides an overall perspective of the flood path.

1. The pipe penetrations between the circulating water intake canal and pump pit (shown in Elevation A on Dwg 13-C-CWS-285 Rev. 13, "Intake Structure Sections Sheet 2") will be sealed to limit the leakage rate into the pump pit to within the capacity of the pit drainage system. This will prevent flooding of the area in the event the canal is overfilled at some later time.

2. The seven below grade electrical duct bank penetrations of each power block facility (shown on Dwgs. 13-E-ZVU-006 Rev. 18, 007 Rev. 16, "Underground Electrical Duct Layout Plot Plan Sheets 1, 2 and 3") will be sealed to block the below grade moisture intrusion paths. Dwg. 13-E-AVU-014 Rev. 8, "Underground Electrical Installation Notes, Symbols and Details" will be revised to define where and how internal conduit passages are to be sealed.
