TENNESSEE VALLEY AUTHORITY - SEQUOYAH NUCLEAR PLANT UNIT 1 - DOCKET
NO. 50-327 - FACILITY OPERATING LICENSE DPR-77 - LICENSEE EVENT REPORT
(LER) 50-327/91023

LICENSEE EVENT REPORT (LER)

FACILITY NAME (1) Sequoyah Nuclear Plant, Unit 1										DOCKET NUMBER (2) PAGE (3) 0150100131217110F1015									
TITLE (4) Potential for loss of containment sump inventory to outside containment during a small break loss of coolant accident.																			
EVENT DAY (5)					LER NUMBER (6)					REPORT DATE (7)					OTHER FACILITIES INVOLVED (8)				
					SEQUENTIAL REVISION					FACILITY NAMES					DOCKET NUMBER(S)				
MONTH DAY YEAR					NUMBER NUMBER					MONTH DAY YEAR					Sequoyah, Unit 2				
0 8 3 0 9 1					0 2 3 0 0 0 0 3 0 1 1					0150100131213									
OPERATING THIS REPORT IS SUBMITTED PURSUANT TO THE REQUIREMENTS OF 10 CFR 5:																			
MODE (Check one or more of the following)(1)

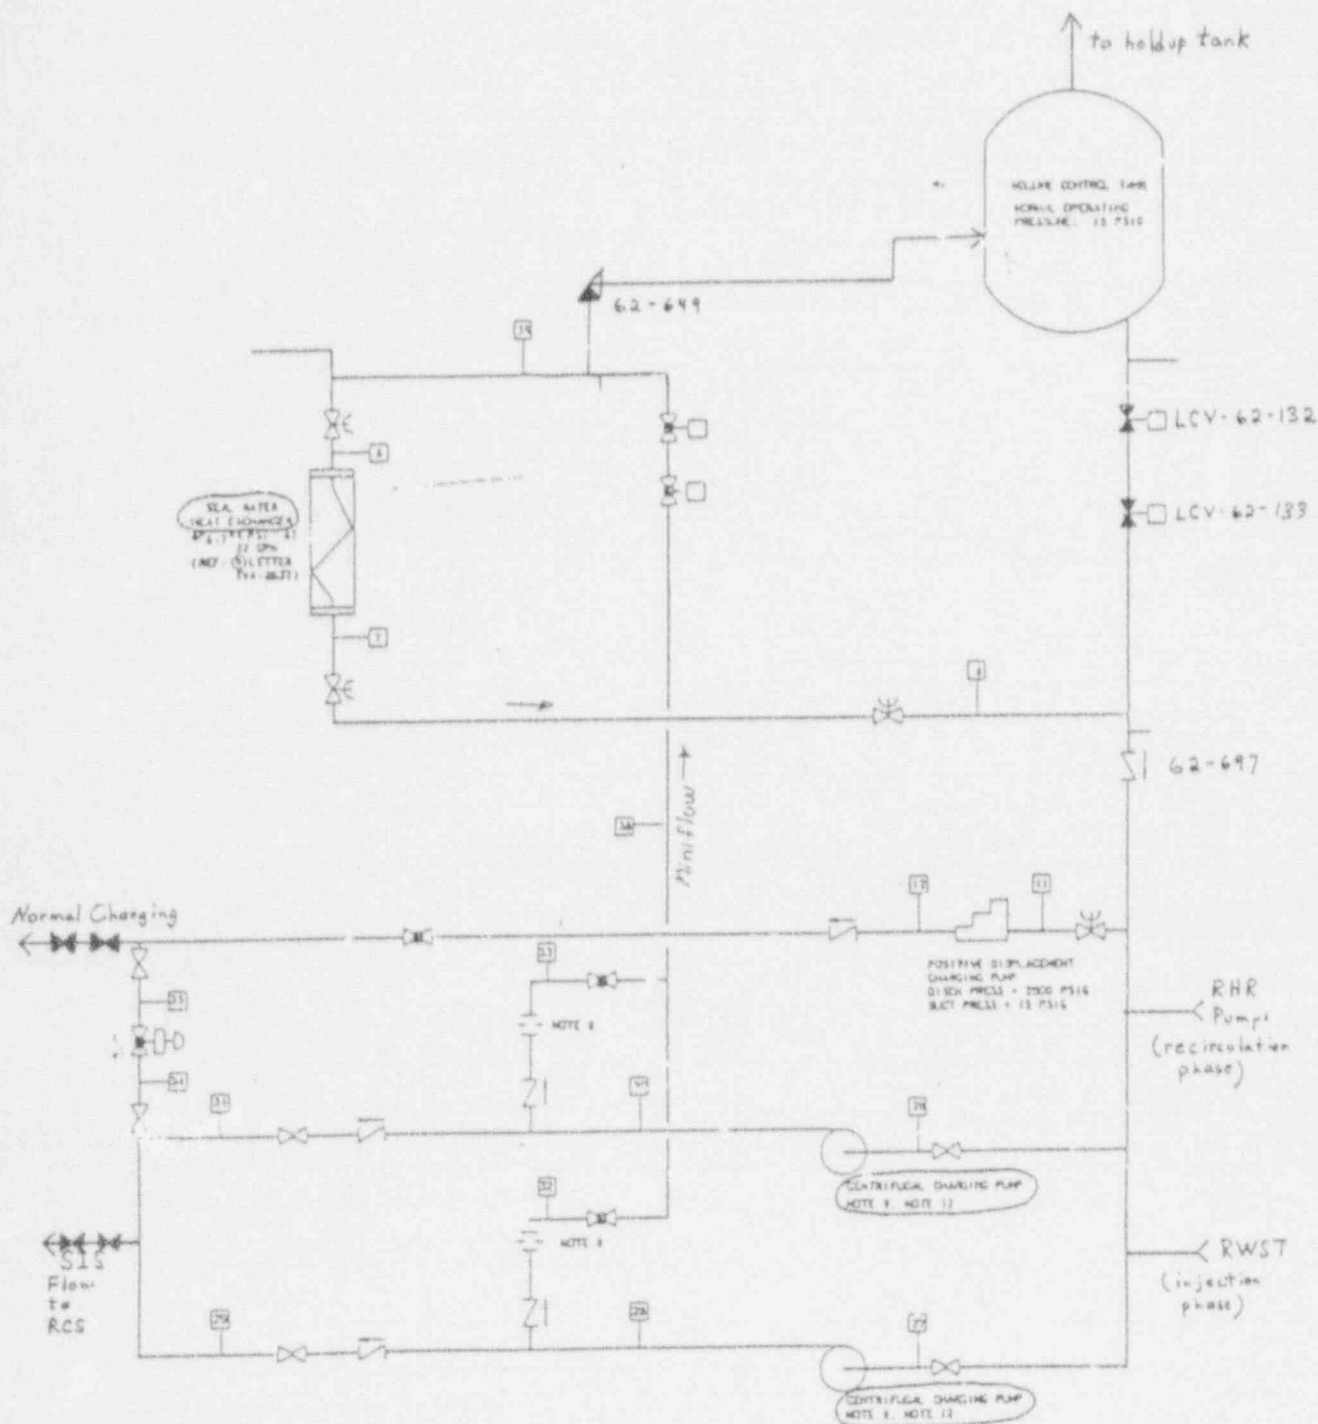
The condition for this event is a small break LOCA that holds the reactor coolant system (RCS) (EIIS Code AB) pressure above the shutoff head of the residual heat removal (RHR) (EIIS Code BP) pumps and emergency core cooling system (ECCS) recirculation (swapover to the containment sump) is required to mitigate the event. The initial action to recover from the LOCA is to provide cold leg injection to the RCS from the refueling water storage tank (RWST); then, upon reaching the RWST (EIIS Code BQ) low level setpoint, core cooling is switched to long-term recirculation of the containment sump inventory to the PCS cold legs then hot legs. See the attached sketch for the potential flow path.

The RCS pressure (for a two-inch or smaller break size) during the containment sump recirculation phase may still be greater than RHR pump shutoff head. The RHR pumps take suction from the sump and provide suction pressure and flow directly to the CCP and safety injection pumps. The high suction pressure could cause the seal water and CCP miniflow return line check valve (62-697) to close, isolating the miniflow return line thus increasing the miniflow pressure beyond the seal water heat exchanger relief valve (62-649) setpoint. The relief valve discharges sump inventory to the VCT, which is in turn relieved to the holdup tank. The VCT and hold-up tanks are located in the auxiliary building.

Operations' crews were briefed on the potential event and appropriate mitigating actions. The emergency procedures were reviewed and determined to be adequate to mitigate small break LOCA scenarios without compromising core and nuclear safety. However, Emergency Preparedness Implementing Procedure 6, "Activation and Operation of the Technical Support Center," was revised to identify this potential small break LOCA concern and actions to address the scenario.
