TITLE METALLOGRAPHIC EXAMINATION OF A FUEL ROD FROM  
SEGMENT 2 FSV FUEL ELEMENT 1-2415

906968

TITLE: METALLOGRAPHIC EXAMINATION OF A FUEL ROD FROM SEGMENT 2 FSV FUEL  
ELEMENT 1-2415

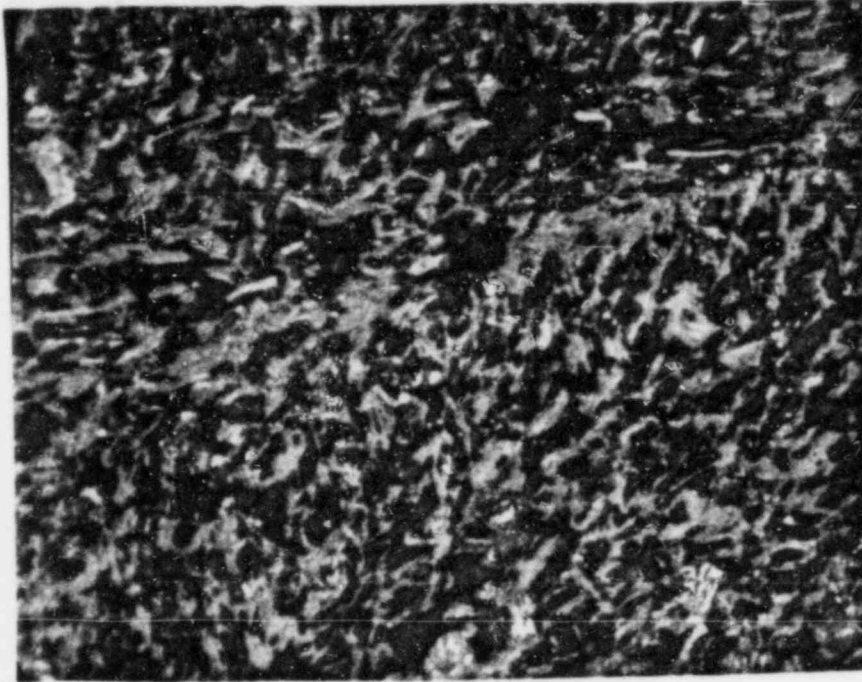
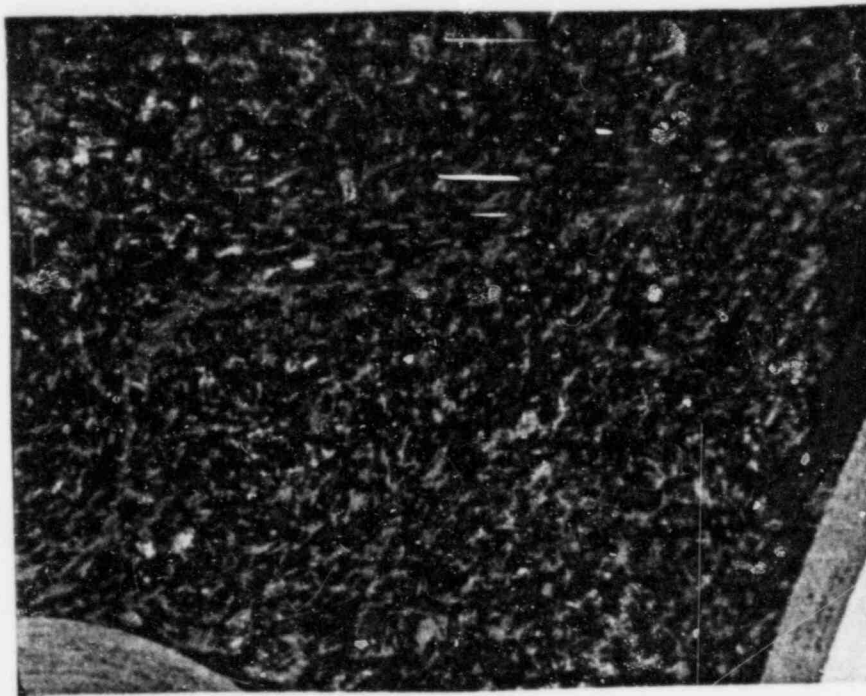
after irradiation is shown in Figure 6. The irradiated microstructure was similar to the microstructure observed for FSV fuel rods irradiated in the FSV fuel proof capsule F-30 (Ref. 7). The measured macroporosity for rod 13 was 17.5%. This value is within the (14-29%) range of macroporosities observed for fuel rods from capsule F-30 (Ref. 7). An example of a radial cross section showing the macroporosity in the matrix is shown in Figure 7.

Fig. 6 Photomicrographs representative of matrix phase of irradiated rod 13 from stack 308. The time average fuel temperature was approximately 765°C at an average fast fluence of  $1.6 \times 10^{25} \text{ n/m}^2$  ( $E > 29 \text{ fJ}$ ) HTGR

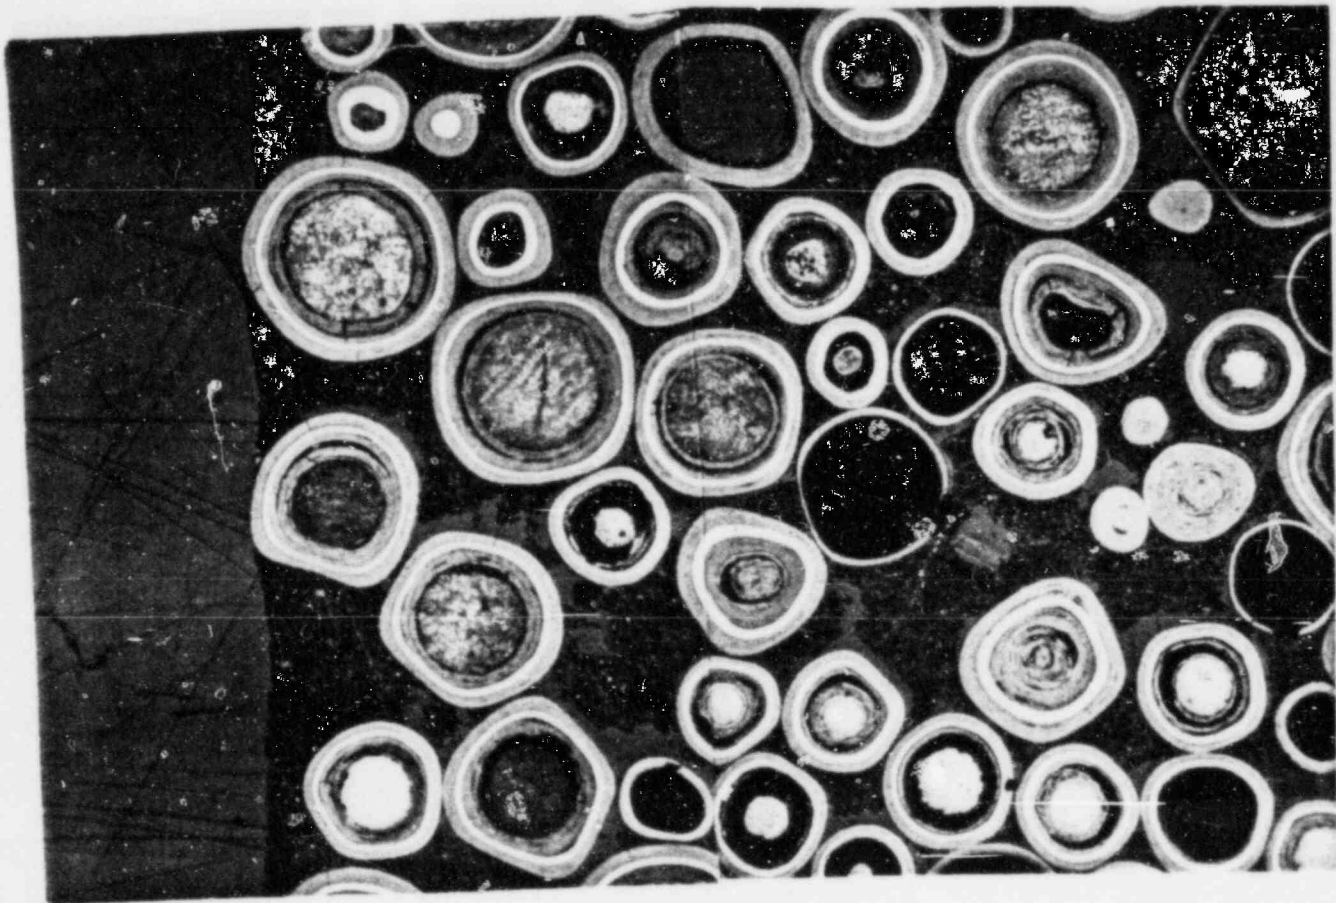
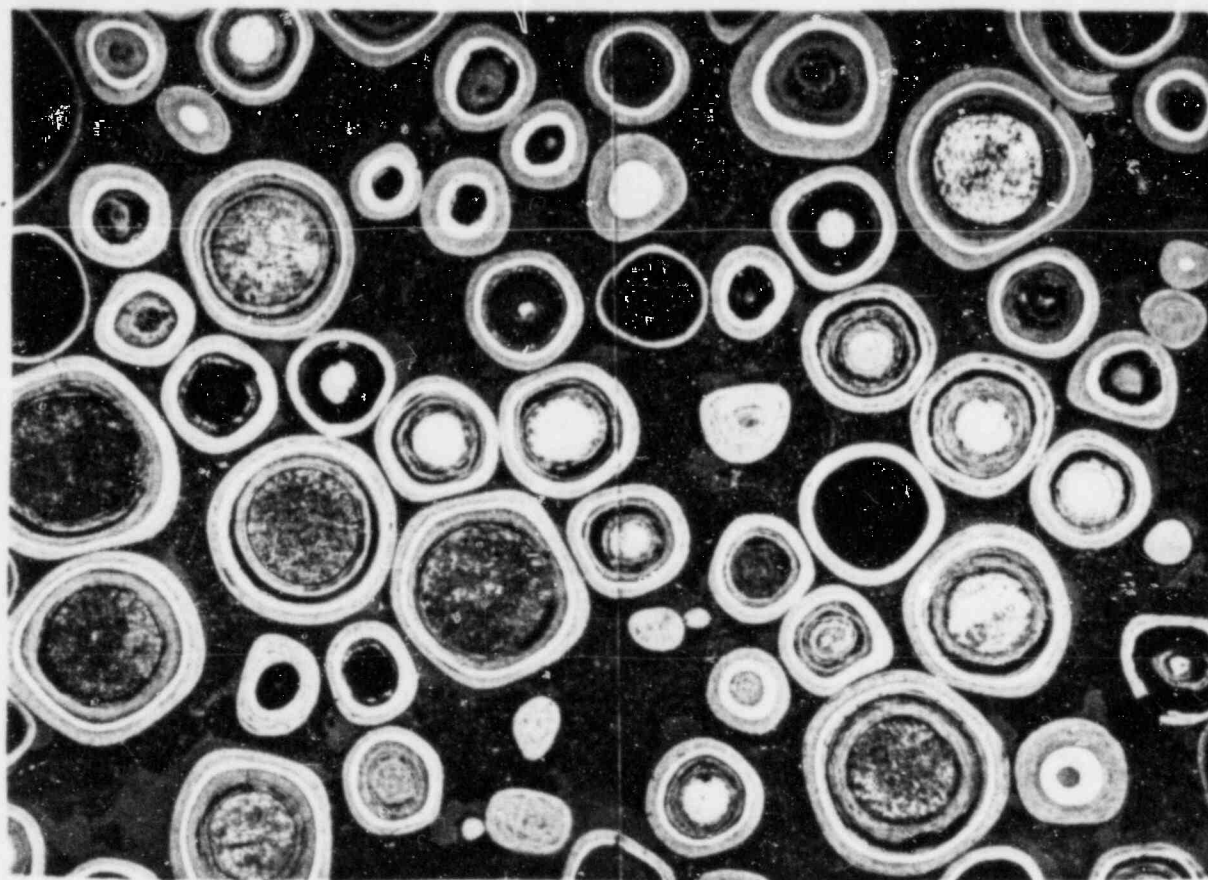
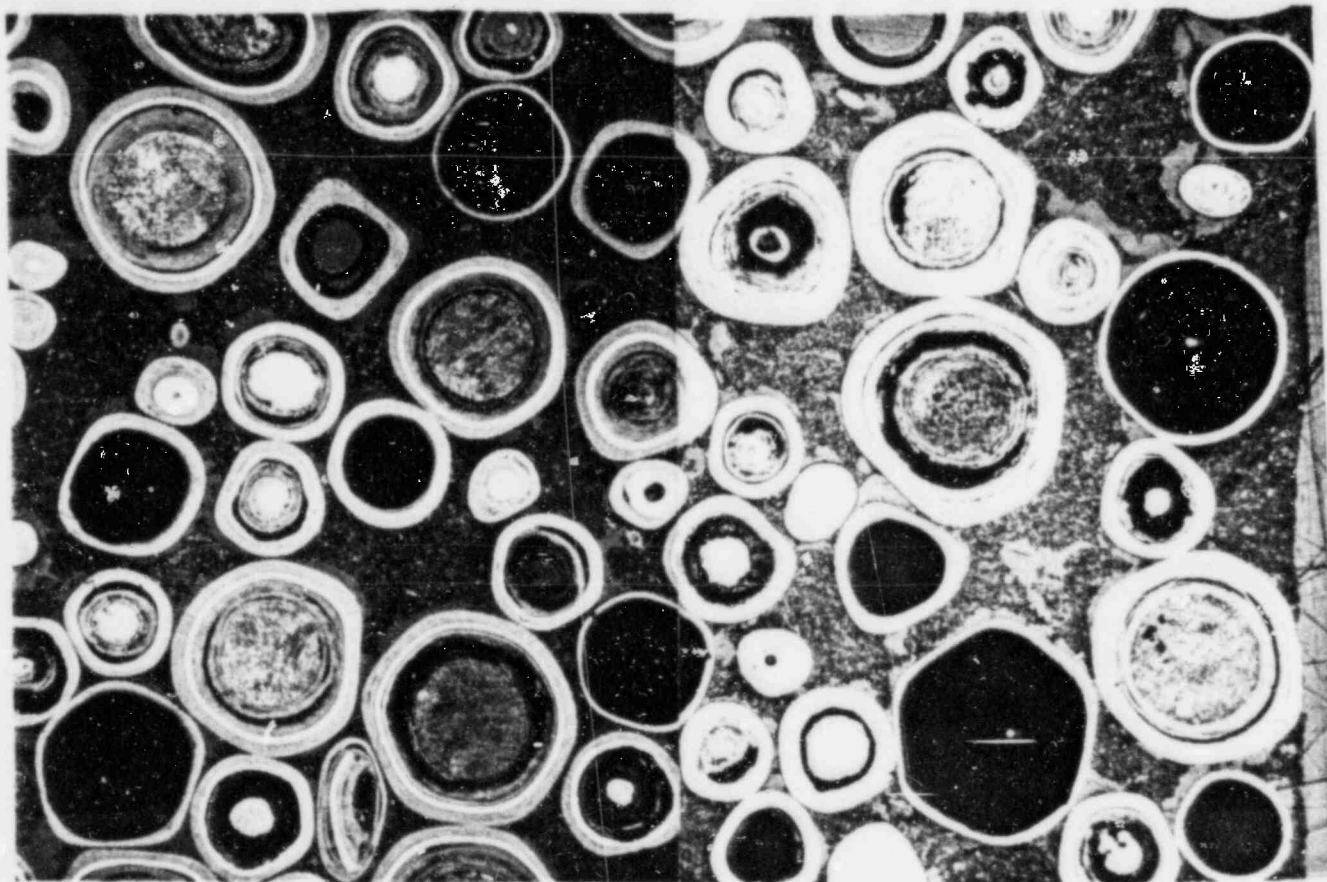
Fig. 7 Representative photomicrographs of composite of radial cross section of fuel rod from FSV element 1-2415 (left side of rod)

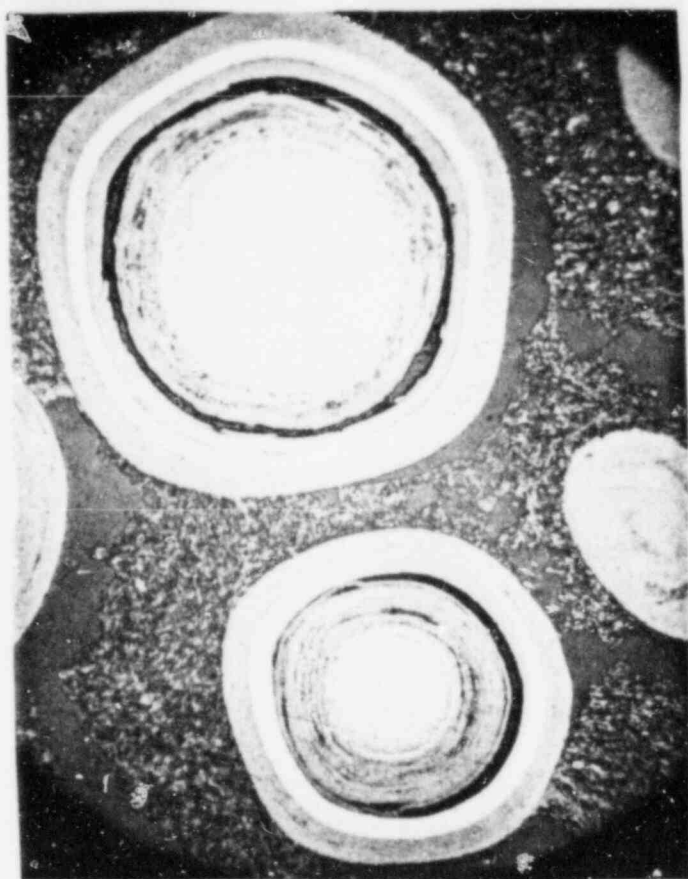
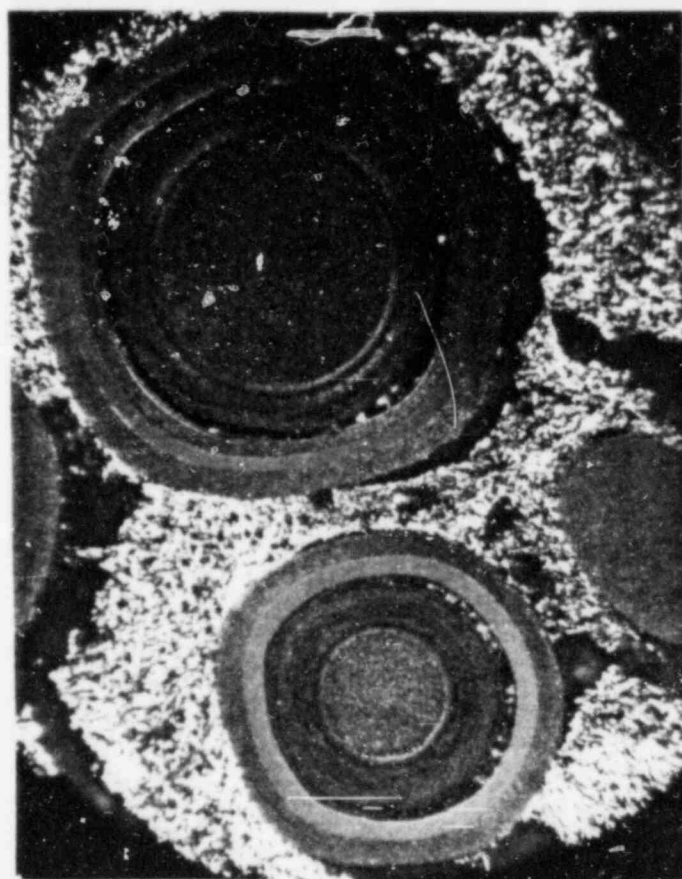
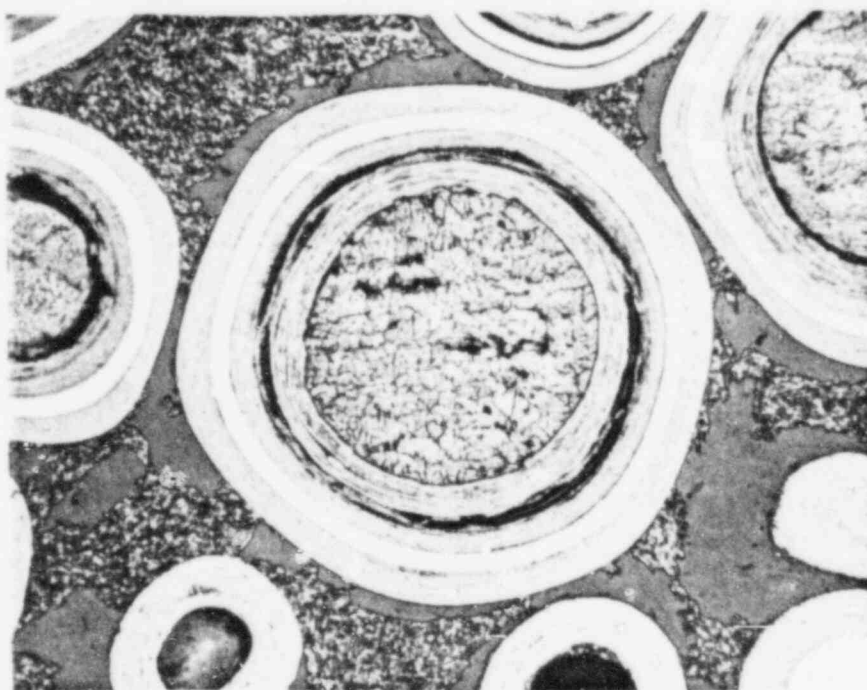
The results of the metallographic examination of fuel rod 13 from fuel stack 308 are presented in Tables 5 and 6. The irradiation performance of the fissile and fertile TRISO coated particles was satisfactory as evidenced by the moderate coating failures and good thermal performance. The microstructures of typical particles after being exposed to a peak fast neutron fluence of approximately  $1.79 \times 10^{25} \text{ n/m}^2$  ( $E > 29 \text{ fJ}$ ) HTGR and a time-averaged fuel temperature of  $765^\circ\text{C}$ , are shown in Figure 8. A total of 231 fissile and 184 fertile particles were examined.

Fig. 8 Photomicrographs of fissile (a,b) and fertile (c) particles. (a) and (c) are bright field illuminated and (b) is polarized light.

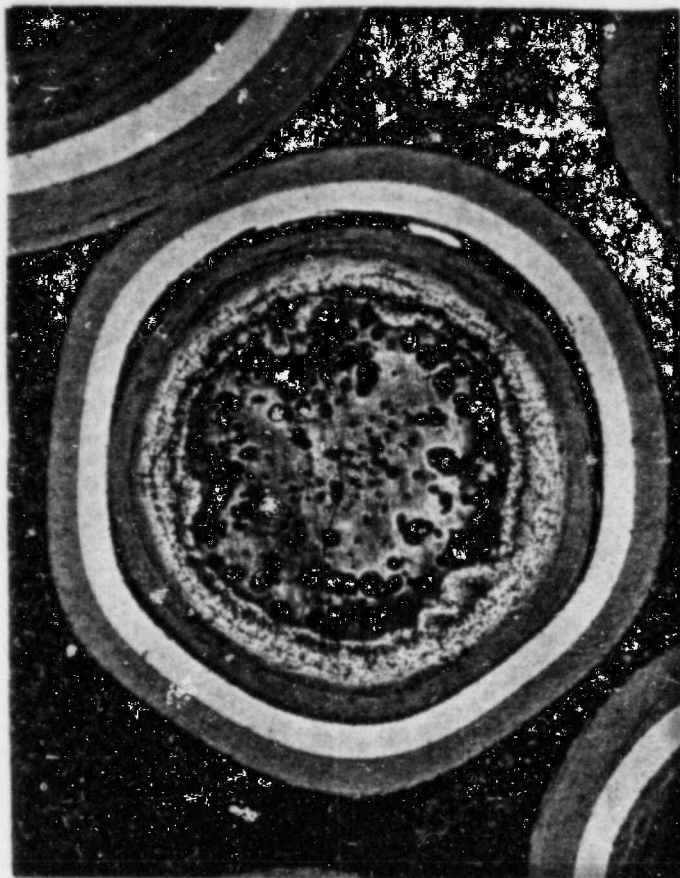
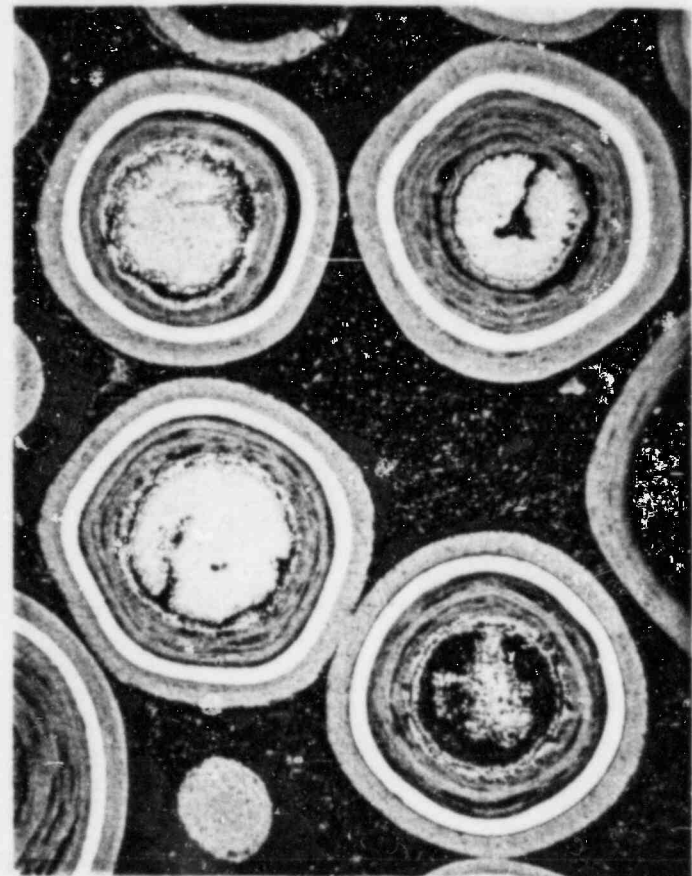
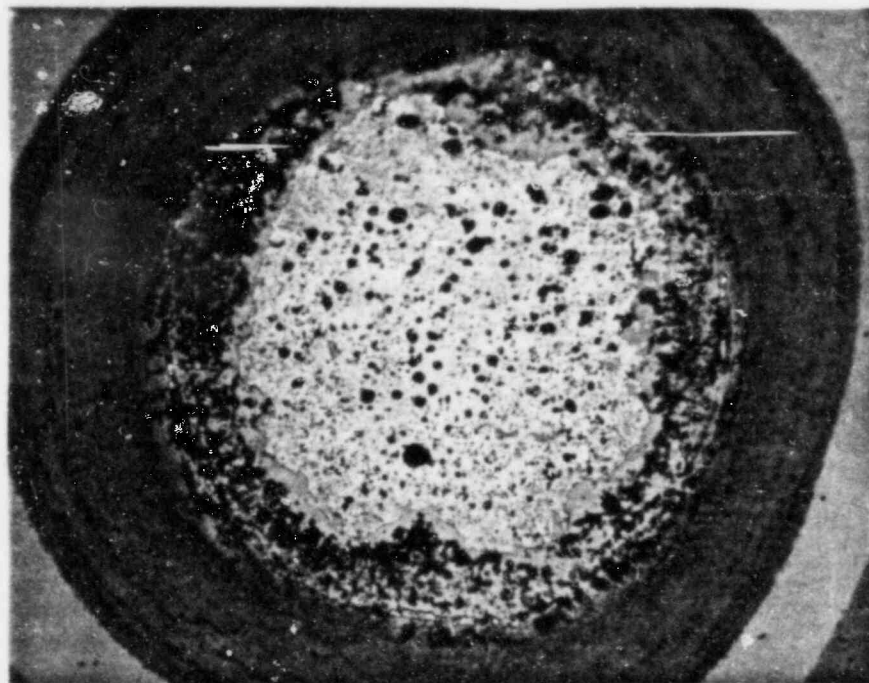
Fuel dispersion was observed in 75% of the fissile and 5% of the fertile particles. An example of fuel dispersion is shown in Fig. 9. Fuel dispersion can be caused by chlorine which can diffuse through a permeable IPyC into the buffer during the SiC coating operation. Production records indicate that this fuel had relatively low density IPyC and a tendency to exhibit fuel dispersion.

6. Fuel dispersion, which is attributed to chlorine diffusing through a low density IPyC into the buffer layer during the SiC coating process, and IPyC debonding were observed in some of the TRISO  $(\text{Th,U})\text{C}_2$  and  $\text{ThC}_2$  particles. Fuel dispersion and IPyC debonding did not detrimentally affect the performance of the particles.

Fig. 9 Photomicrographs of fissile particle (Th,U)C<sub>2</sub> showing fuel dispersion. Note the dense phase in the buffer coatings and the low-density IPyC coating.

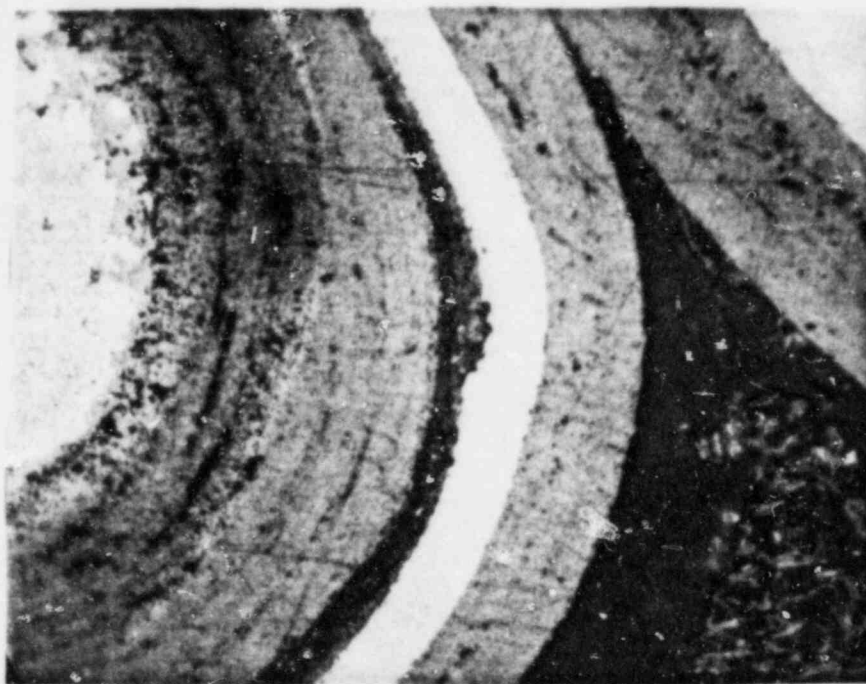
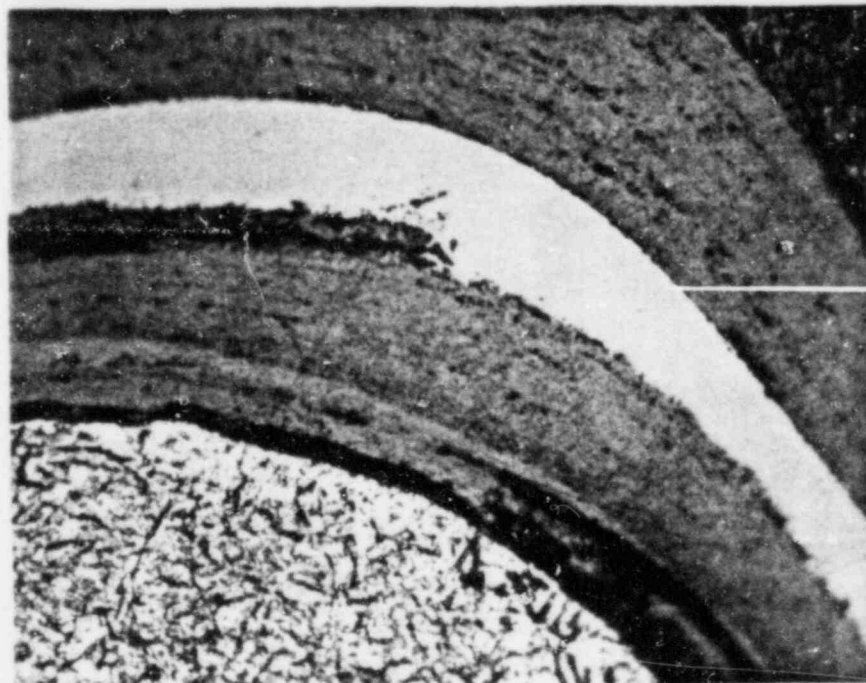
The primary purpose of the metallography was to examine the fuel for thermal effects. In this regard the chemical behavior of the TRISO particle was acceptable. Kernel migration was not observed. Interaction of the SiC coating with fission products was observed in both particle types. Figure 10 shows examples of the SiC interaction. SiC interaction was observed in 3.9% of the  $(\text{Th}, \text{U})\text{C}_2$  particles and 3.3% of the  $\text{ThC}_2$  particles. The reaction penetrated about  $5 \mu\text{m}$  into the SiC layer for both particle types.

This kind of interaction is expected in carbide fuel, where rare earth fission products are released from the kernel and react with the SiC (Ref. 8).

However, the observed depth of reaction ( $\sim 5 \mu\text{m}$ ) was larger than the  $< 1 \mu\text{m}$  expected depth based on the time-temperature history of the fuel. This rapid penetration rate may have been associated with fuel dispersion caused by chlorine trapped in the buffer layer during the SiC coating operation, as discussed above, and/or a higher operating temperature than the average calculated for the fuel element. Penetration depths on the order of 10 to 15  $\mu\text{m}$  might lead to some volatile fission product metal release, but total coating failure and fission gas release would not increase (Ref. 8). The penetration depth measured for these particles is significantly less than these values. Since fuel dispersion in the fuel which will reside in the core for up to six cycles is much less than dispersion in these fuel particles, it is not expected that fission product-SiC interaction will have an impact on core performance. However, this phenomenon will be monitored in future FSV fuel surveillance so that any influence on core performance can be properly assessed.

5. The chemical behavior of the particles was acceptable. There was no kernel migration observed. However, there was evidence of fission product interaction with the SiC coating. 3.9% of the fissile particles and 3.2% of the fertile particles showed fission product - SiC interaction with a penetration depth of  $\sim 5 \mu\text{m}$ , which was higher than the expected value of  $< 1 \mu\text{m}$ . The phenomena may have been caused by fuel dispersion resulting from chlorine trapped in the buffer layer during the SiC coating and/or by higher operating temperatures than the average calculated for the element.

Fig. 10 Photomicrographs showing SiC-fission product interaction in the fissile (a) and fertile (b) particles

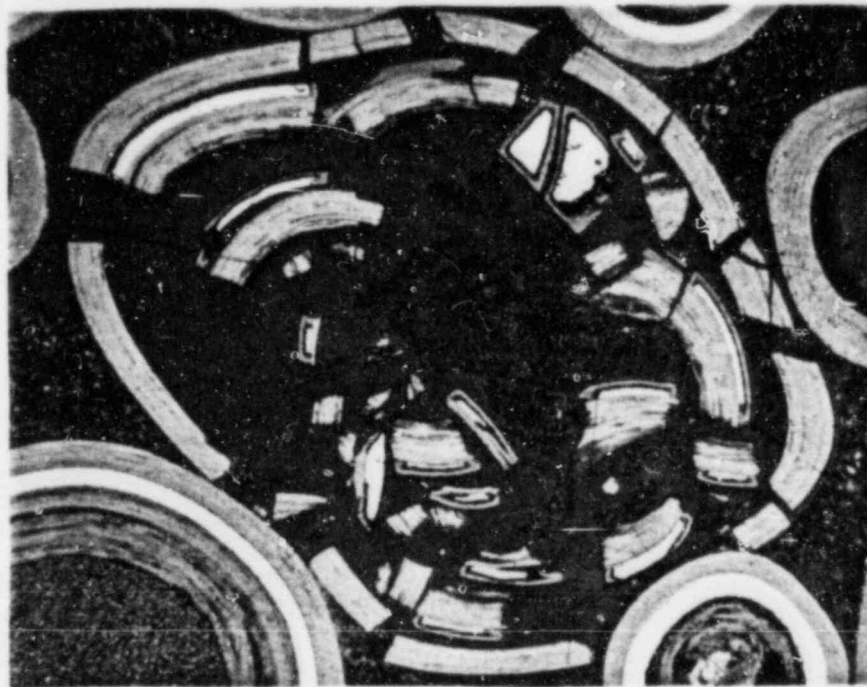
Fig. 11 Photomicrograph of an as-manufactured defective particle in an irradiated fuel rod. Note total coating failure with the matrix pressed in the particle. Also, note that the kernel has been leached out.

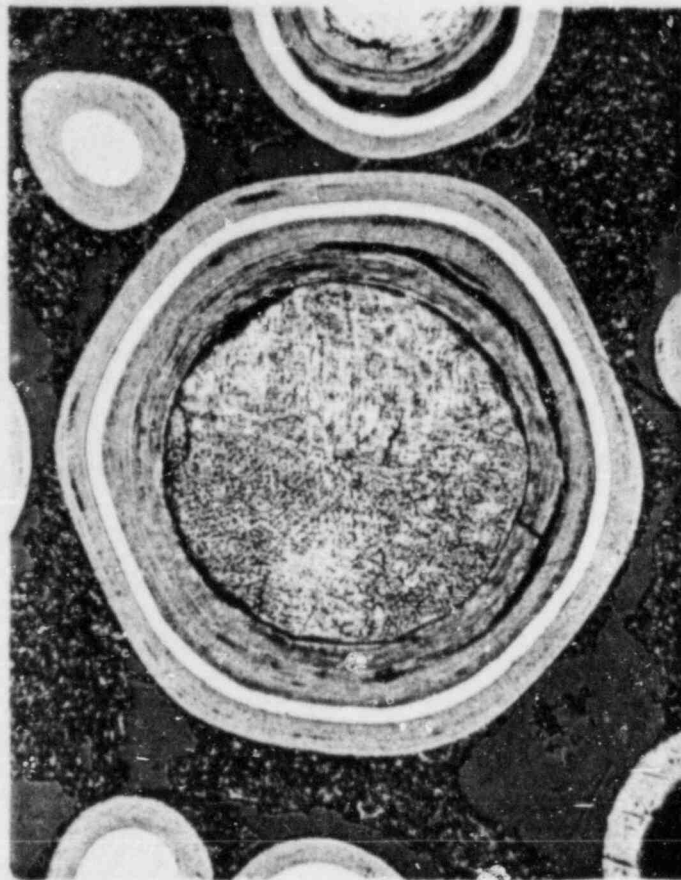
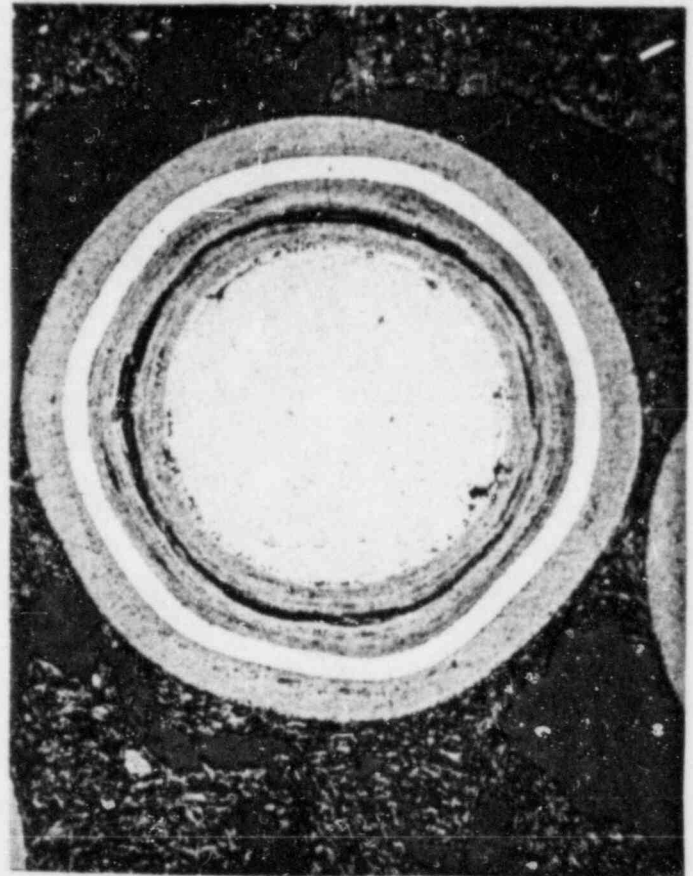
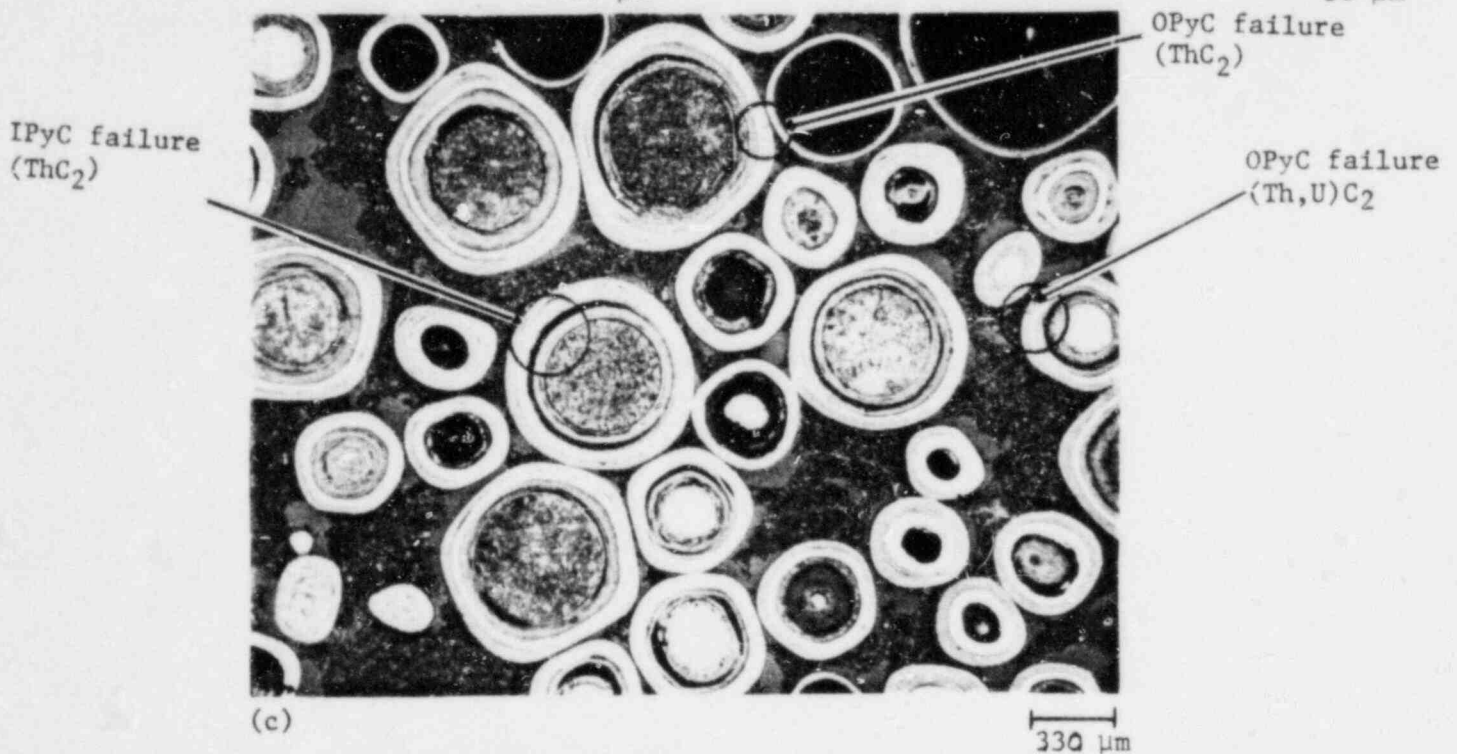
In the course of metallography the mechanical condition of the coating can be observed, but conclusions from these data are difficult to draw because coating failure can be caused during manufacture and during the grinding and polishing procedure in connection with making a metallographic mount. There was evidence that some of the coating failures can be attributed to as-manufactured failures which occurred during coating or rod fabrication. This conclusion is supported by the appearance of failed particles. An example of this type of failed particle is shown in Figure 11 where the particle had the appearance of having been crushed and fuel rod matrix was pressed into the coating cracks at the time of manufacture. In this case as-manufactured failure rather than in-pile failure was indicated. However, unlike the metallographic results of Segment 1 (Ref. 9), there was partial coating failure which may have occurred in-pile as seen in Figure 12. Irradiation induced shrinkage of the pyrocarbon was apparently enhanced by the additional exposure of cycle 2 and both IPyC and OPyC failures were observed as expected from accelerated capsule results (Ref. 7). For purposes of comparing with prior work, counts of observed failed individual coatings are reported in Tables 5 and 6. These

values should be considered upper limits. The total coating failure with resulting gas release can be expected to be very low because circulating gas activity has remained consistently low and indicates virtually no particle failure. However, as noted in Tables 5 and 6, the actual number of total coating failures was not determined due to hydrolysis of the kernels in the fuel rod mount.

Fig. 12 Photomicrographs showing in-pile coating failures. (a) and (b) show IPyC failures in the fertile and fissile particles, respectively. (c) Shows examples of OPyC and IPyC failures in the fertile particle and OPyC failure in the fissile particle.
