NIAGARA MOHAWK POWER CORPORATION
NINE MILE POINT - UNIT 2
DOCKET NO. 50-410

Interim Report for a Problem
Concerning HEA Relays

SUBJECT: SERVICE ADVICE 721PSM-175.1 HEA RELAY MISOPERATION

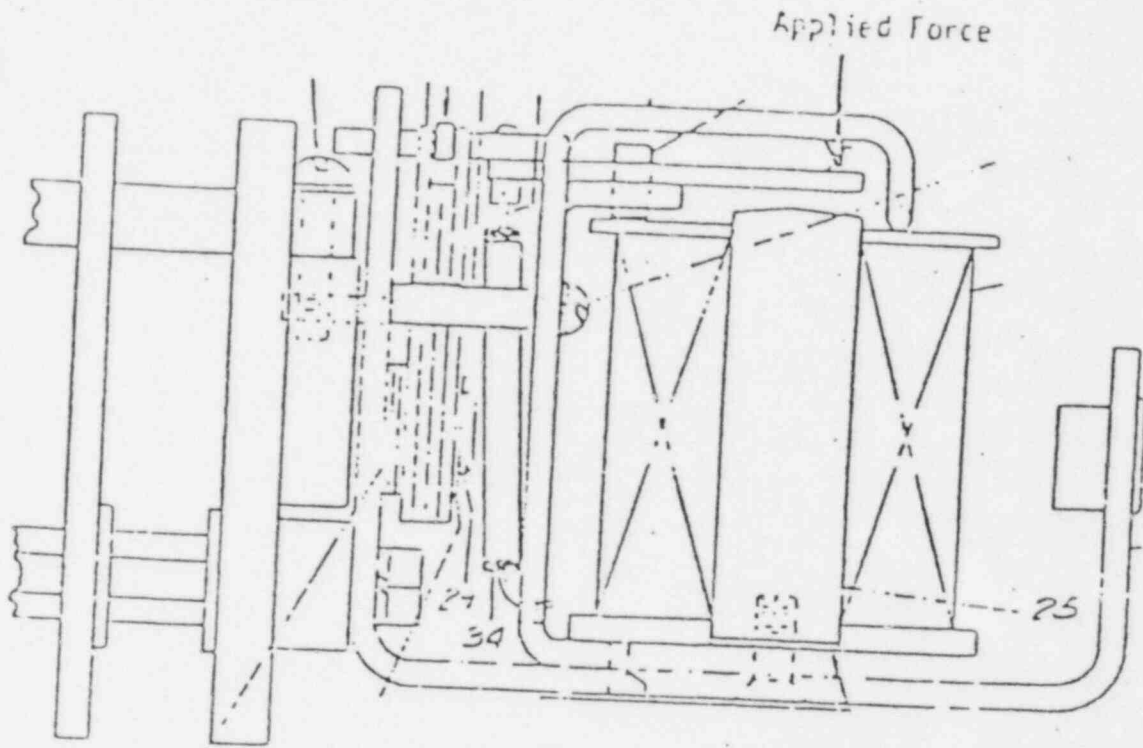
Figure 1

We recommend that all HEA relays manufactured between September 1980 and August 1983, corresponding to date codes KS, LS, MS, AT through MT, AU through MU, and AW through LW, should be checked to determine the force, applied at the armature, to trip the relay. This force should be checked by applying a measurable force perpendicular to the armature at the armature rivet above the pole piece as shown in Figure 1. (Attached)

Any relay requiring a force less than 500 grams or 1.1 pounds should be considered out of specification.

It is recommended that any HEA relay, with the above date codes, that does not meet the above specification be replaced.
