SUBJECT: Grand Gulf Nuclear Station
File 0260/15521/L-860.0
Tornado Report
AECM-78/80

EFFECTS OF APRIL 17, 1978 TORNADO
ON CATEGORY I STRUCTURES AT THE
GRAND GULF NUCLEAR STATION

PREPARED BY
BECHTEL POWER CORPORATION
JULY, 1978

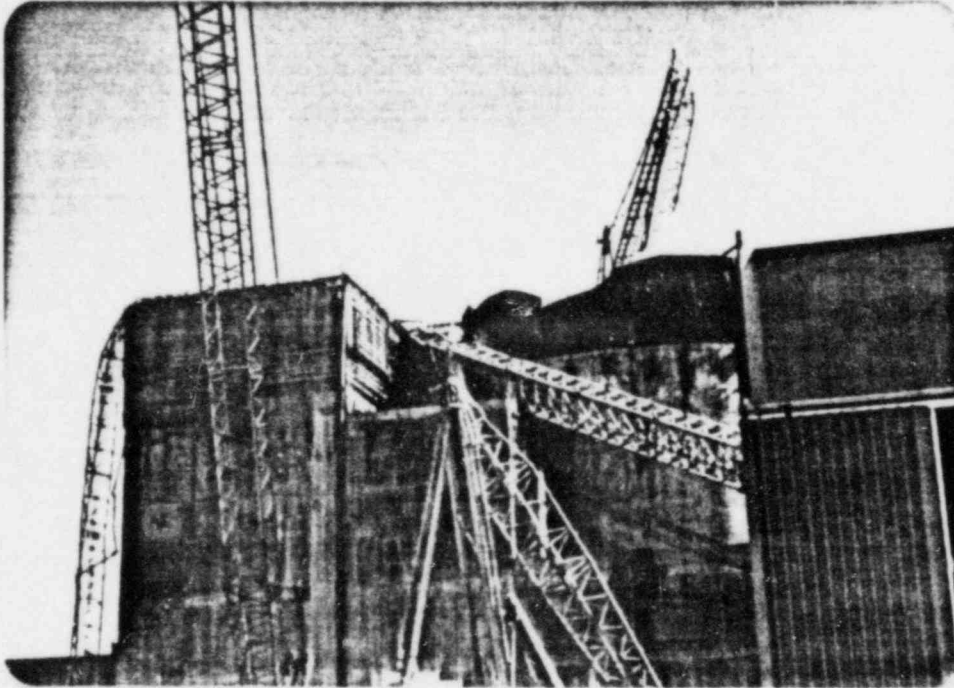
Tornado winds caused the collapse of the south tower construction crane which damaged the freestanding Unit 1 containment liner plate hip course (see drawing SKC-0012T and Photograph 4-1). Most of the damage extended between azimuth 53° and azimuth 153° above elevation 247' - 6" (see Photograph 4-2) and between azimuth 213° and azimuth 273° above elevation 247' - 6".

When the south tower construction crane collapsed over the Unit 1 auxiliary building the counterweight and motor fell onto the roof slab at El. 228'-0". The weight of the motor and counterweight was estimated to be 12 tons.

At the time, there were steel frames, concrete forms, pipe shoring and scaffolding, loose timbers, and other stacked construction materials placed at various locations on the slab. These items partially absorbed the impact of the counterweight and motor with the result that only superficial damage was sustained by the composite roof slab.

A field survey of structural connections and slab deflections indicated that there was no damage to the bolts or welds and no permanent deflection of the slab under the impact area. From this it has been concluded that the loading to the structure was within the elastic range of the steel and concrete. In the impact area there is a margin of additional shear capacity in the structural connections of between 14 and 59 kips. Neither visual cracks on the top of the concrete slab nor deflection of the steel decking underneath was observed.

This leads to a conclusion that the impact was insufficient to impair the integrity of the structure.

- 4.1 South elevation of the Unit 1 containment and auxiliary building showing the collapsed south tower crane across the auxiliary building roof slabs at El. 228'-0" and El. 266'-0" (not poured) with boom draped over the west (left) side.

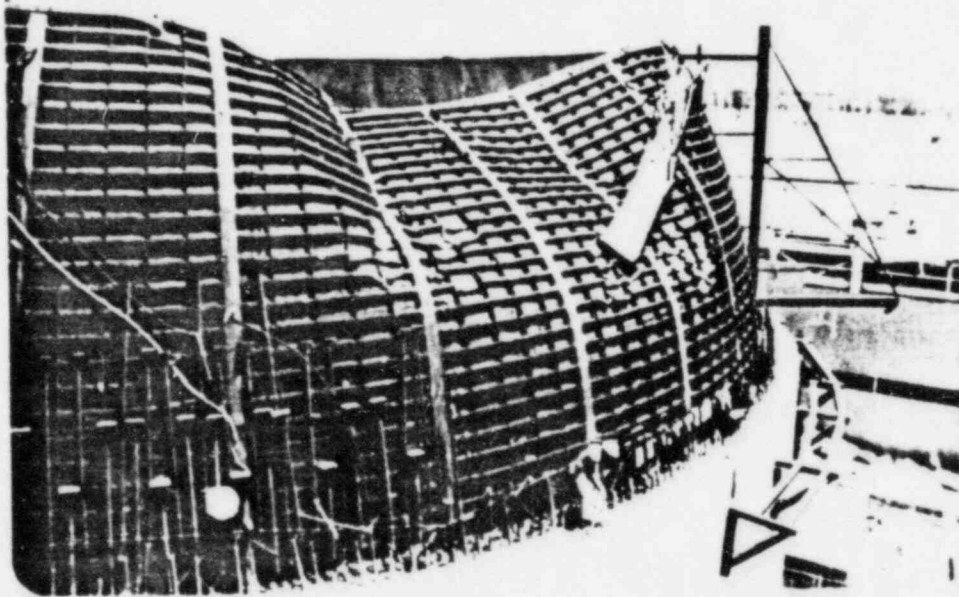
There was less severe damage between azimuth 173° and azimuth 213° above elevation 268' - 0". This consisted of buckling of the liner plate due to the impact. The portions of liner plate that were damaged were being erected at the time of the tornado and had not been accepted as part of the permanent plant. The fabricator of the liner plate has removed the damaged portions and replaced with new material.

An inspection of the permanent structure revealed no major damage to its structural integrity. No separation occurred between the liner plate and the cast concrete. Minor chipping of concrete cover occurred in several areas and a few exposed reinforcing bars were bent but there was no general cracking.

4.2 Damage to the freestanding Unit 1 containment liner plate between azimuth 53° and 153° . Concrete shown is poured to El. 243'-6".

The chipped concrete was repaired using the applicable concrete specification. Bent reinforcing bars were heat bent back into position and examined using nondestructive tests.
