LICENSEE EVENT REPORT (LER)																		
Facility Name (1) SAN ONOFRE NUCLEAR GENERATING STATION, UNIT 2												Docket Number (2) 0 5 0 0 0 3 6 1				Page (3) 1 0 4		
Title (4) LOSS OF PRESSURIZER LEVEL DUE TO A VALVE ALIGNMENT ERROR.																		
EVENT DATE (5)			LER NUMBER (6)				REPORT DATE (7)			OTHER FACILITIES INVOLVED (8)								
Month	Day	Year	Year	///	Sequential Number	///	Revision Number	Month	Day	Year	Facility Names				Docket Number(s)			
										NONE								
0	4	0	6	9	5	9	5	0	0	5	0	0	0	5	0	8	9	5
OPERATING MODE (9)			THIS REPORT IS SUBMITTED PURSUANT TO THE REQUIREMENTS OF 10CFR (Check one or more of the following) (11)															
POWER LEVEL (10) 0 0 0			<div style="display: flex; justify-content: space-between;"> <div> 20.402(b) 20.405(a)(1)(i) 20.405(a)(1)(ii) 20.405(a)(1)(iii) 20.405(a)(1)(iv) 20.405(a)(1)(v) </div> <div> 20.405(c) 50.36(c)(1) 50.36(c)(2) 50.73(a)(2)(i) 50.73(a)(2)(ii) 50.73(a)(2)(iii) </div> <div> 50.73(a)(2)(iv) 50.73(a)(2)(v) 50.73(a)(2)(vii) 50.73(a)(2)(viii)(A) 50.73(a)(2)(viii)(B) 50.73(a)(2)(x) </div> <div> 73.71(b) 73.71(c) <input checked="" type="checkbox"/> Other (Specify in Abstract below and in text) Voluntary Report </

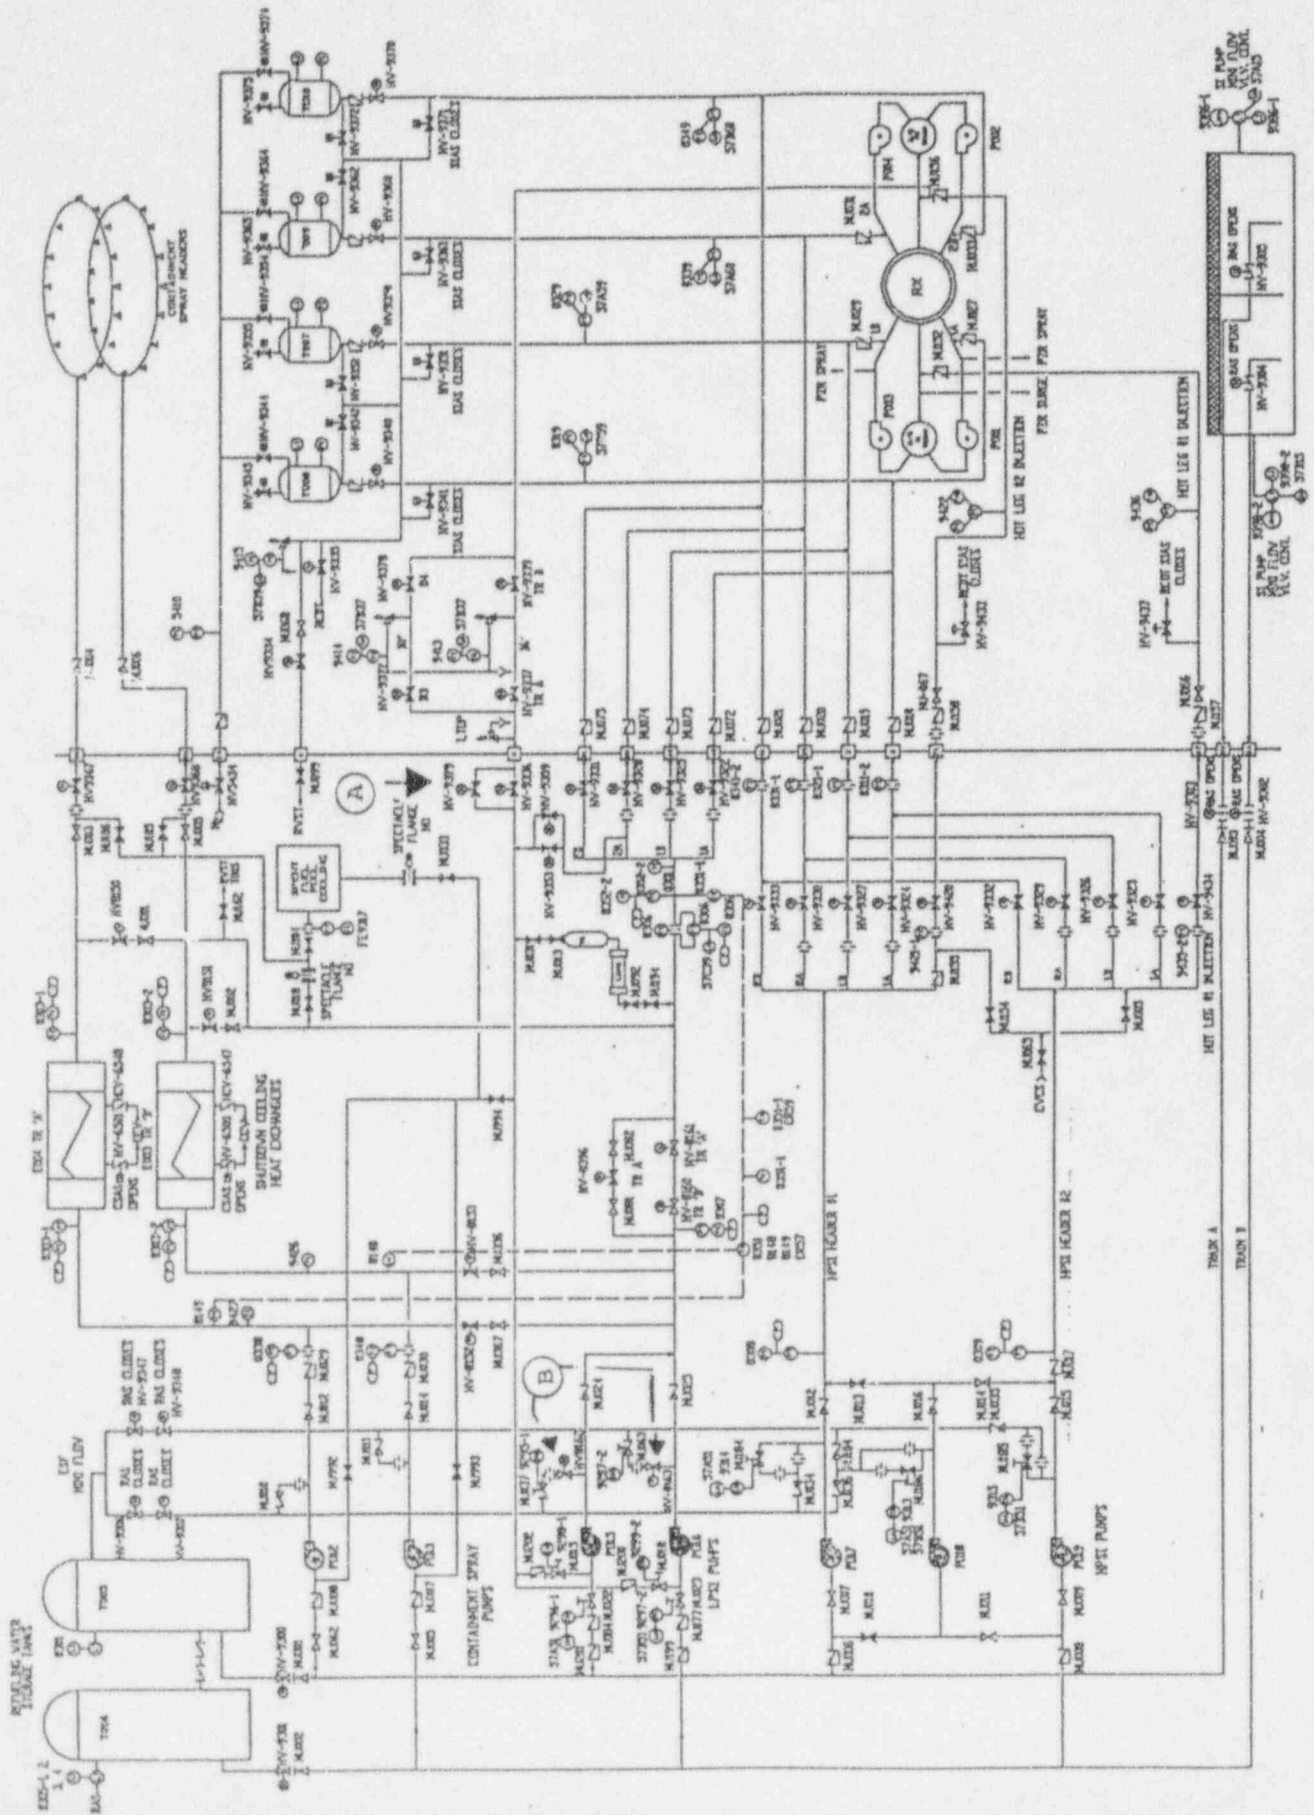
At approximately 0205, the LPSI mini-flow isolation valves were opened before 2HV-9379 had been closed. This created a flow path from the RCS to the Refueling Water Storage Tank (RWST) [BP,TK] through 2HV-9379 and the LPSI mini-flow isolation valves (See attached figure). Pressurizer (PZR) [AB,PZR] level began to decrease and the "PZR Level Error Lo" alarm [IB,LA] actuated. The control room operators responded by starting a second charging pump [CB,P] and closing the LPSI pump mini-flow isolation valves. PZR level immediately began to recover and was restored to normal within 10 minutes.

The event was terminated at 0207 when the mini-flow isolation valves were reclosed, eliminating the flow path from RCS to RWST. Edison Management issued the following to the Operations Staff: 1) a special order restating management's expectation on procedure step sequencing, and 2) a special order restating control command structure, clarifying the duties of control room personnel and the Shift Superintendent. Edison also implemented an around the clock management oversight presence in the control room during the unit's startup from the current outage. The individuals involved in this event were coached and counseled, as appropriate. SO123-0-20, "Use of Procedures" was also revised to clarify requirements for following procedure steps in sequence.
