Public Service Company of Colorado

SUBJECT: Fort St. Vrain Unit No. 1
Fuel Element Meeting

FORT ST. VRAIN
FUEL ELEMENT INFORMATIONAL MEETING
APRIL 4, 1984

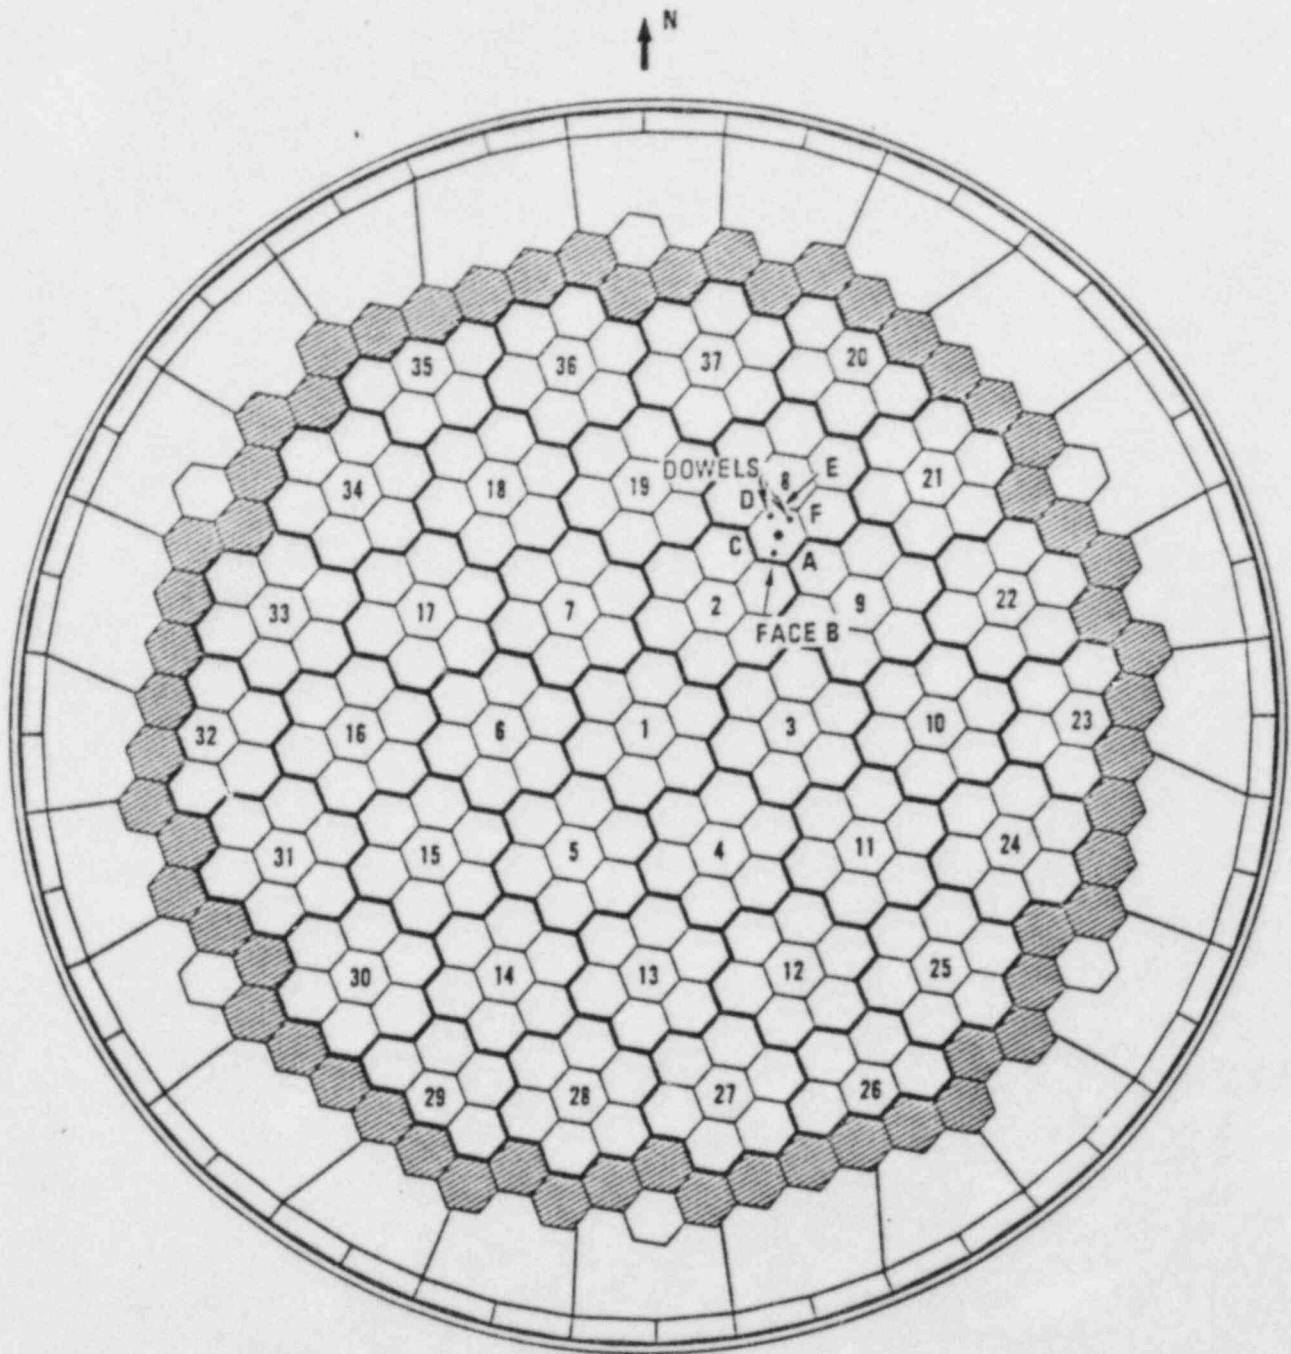
Fig. 3-3. Core location of fuel element 1-2415

*FUEL ELEMENT 1-2415
REGION 8, COLUMN 5, CORE LAYER 6 (ACTIVE CORE LAYER 3)

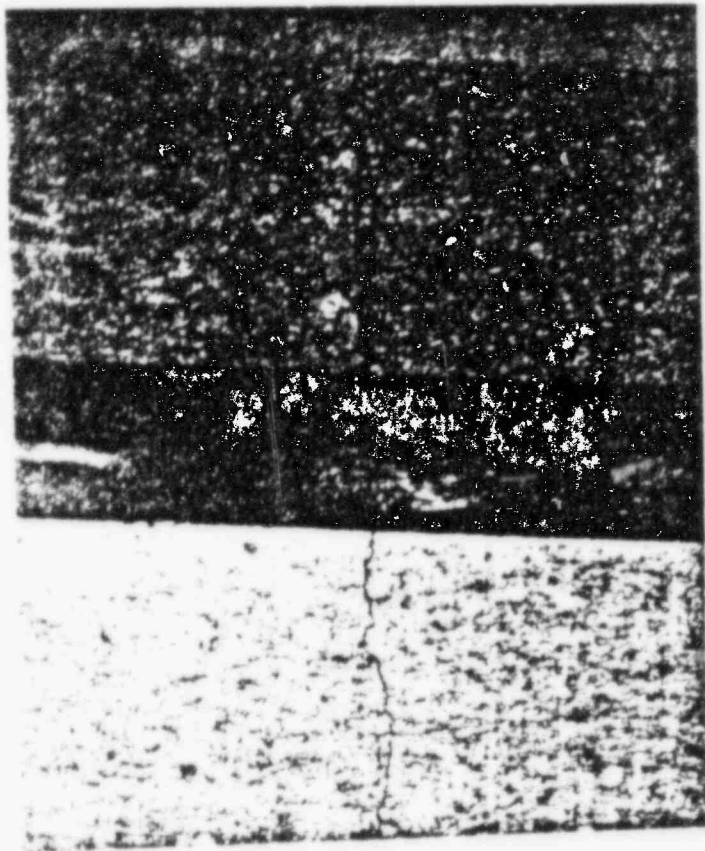
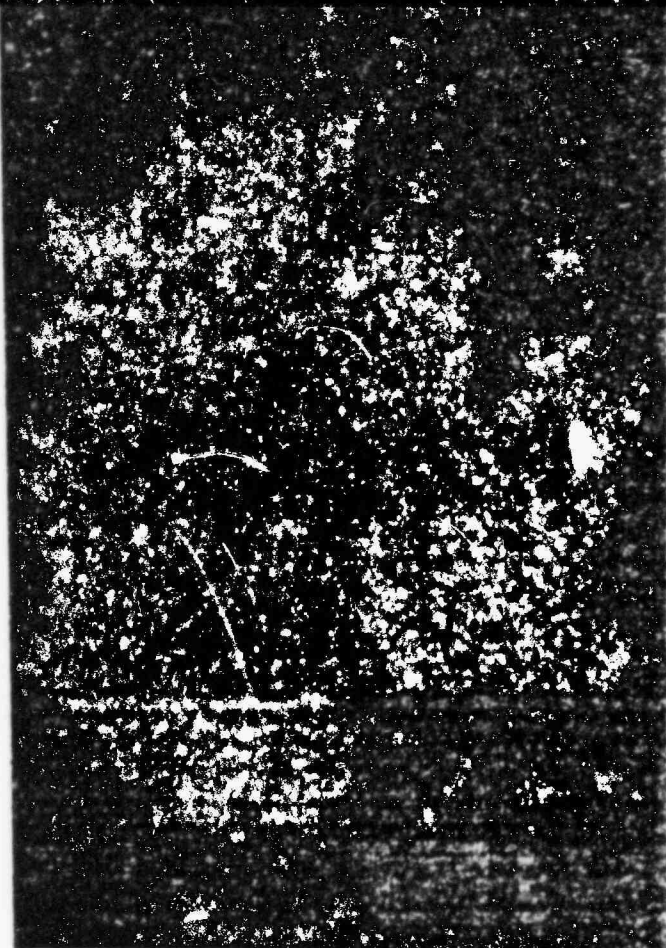
Crack Appearance Enhanced

Crack Appearance
Enhanced

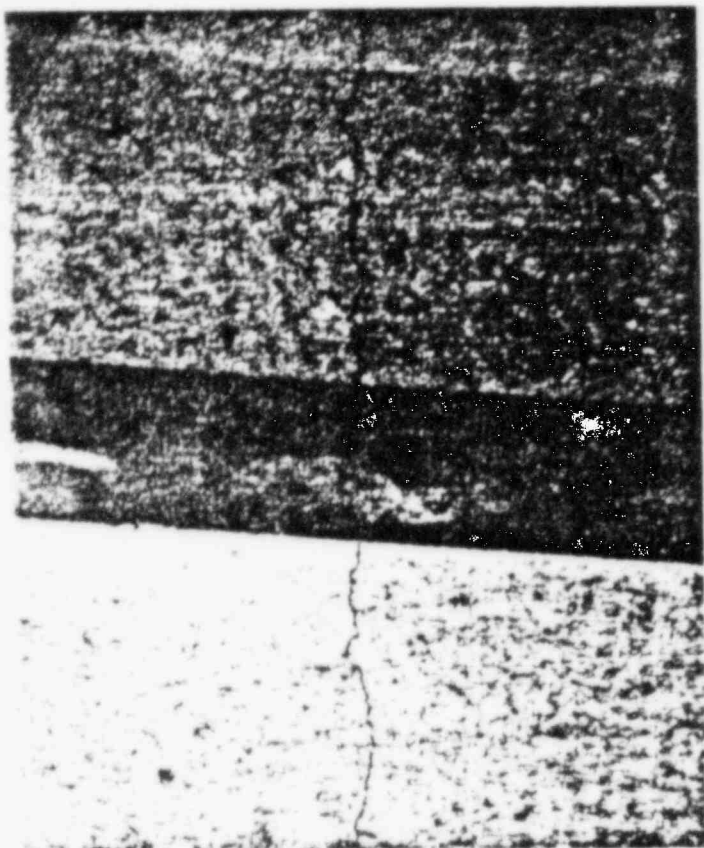
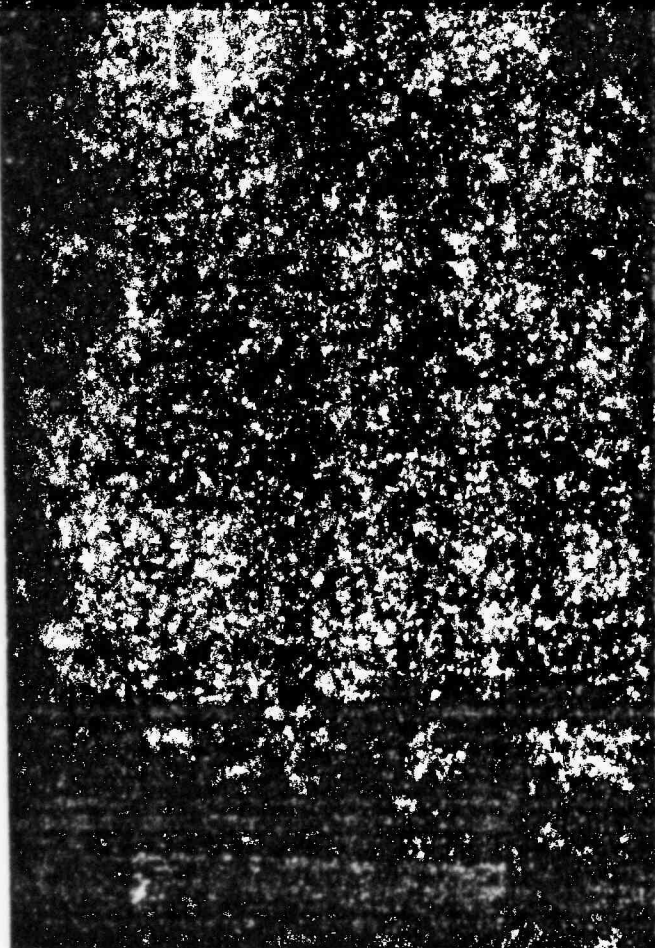
Crack Appearance Enhanced

*Crack Appearance
Enhanced*

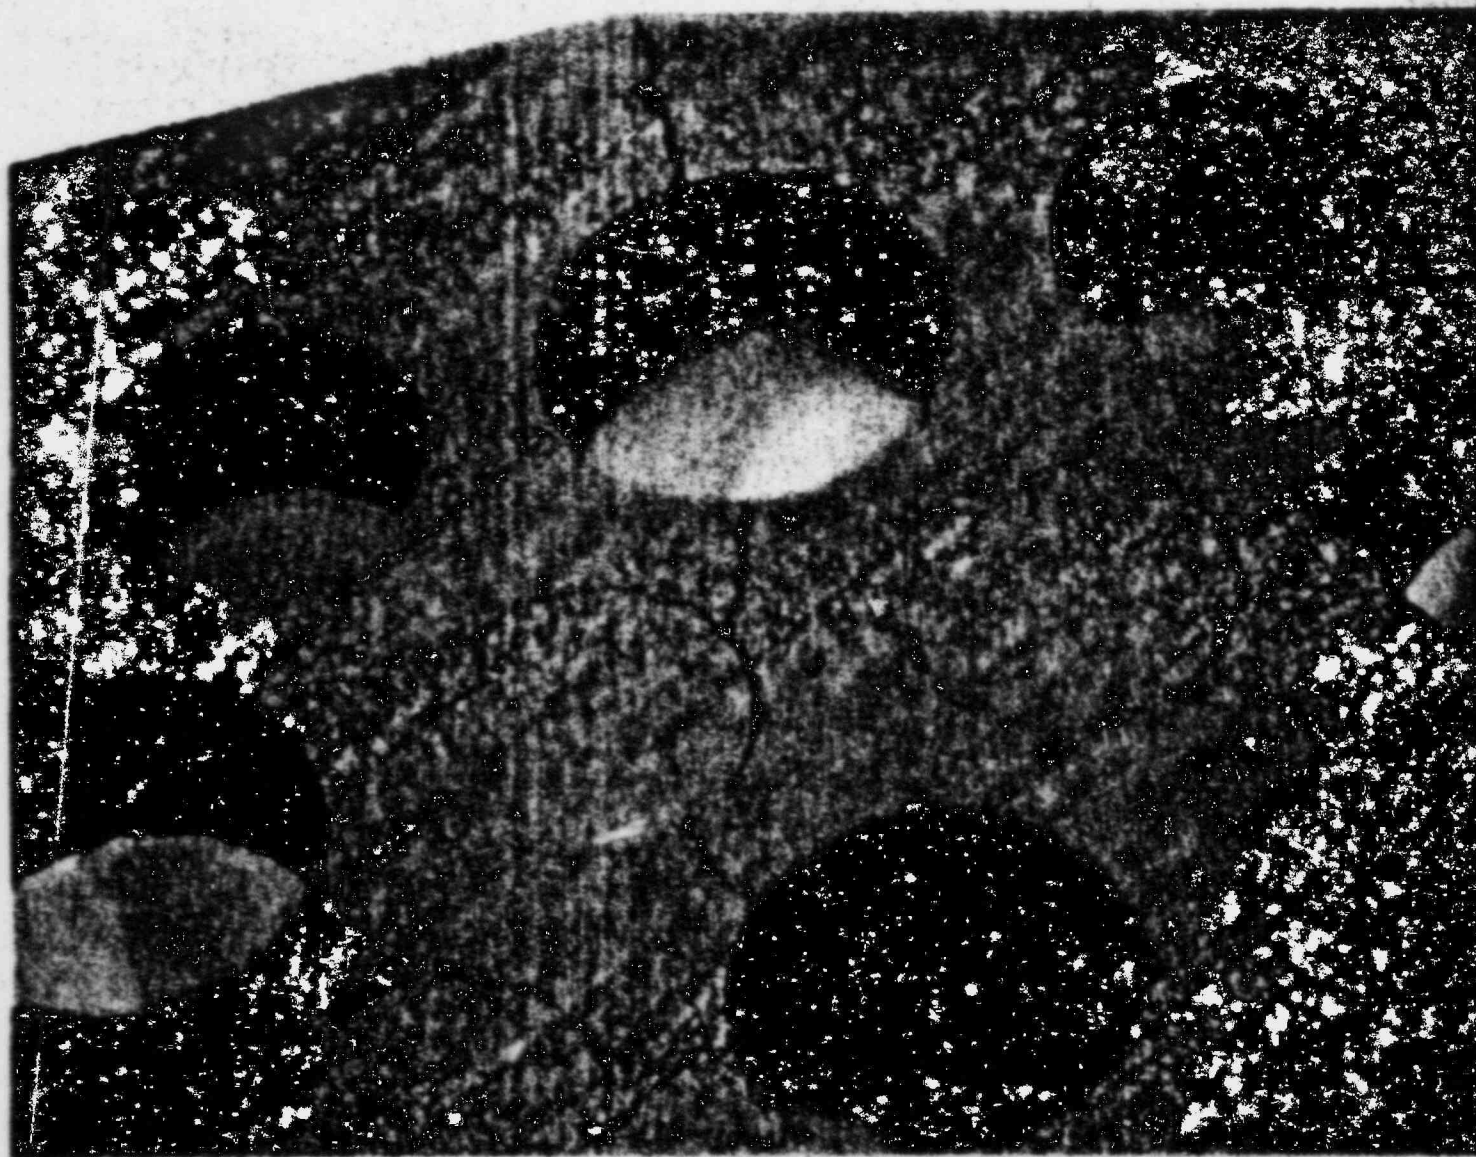
**CRACK PATTERN IN FORT ST. VRAIN
FUEL ELEMENT NO. 1-2416**

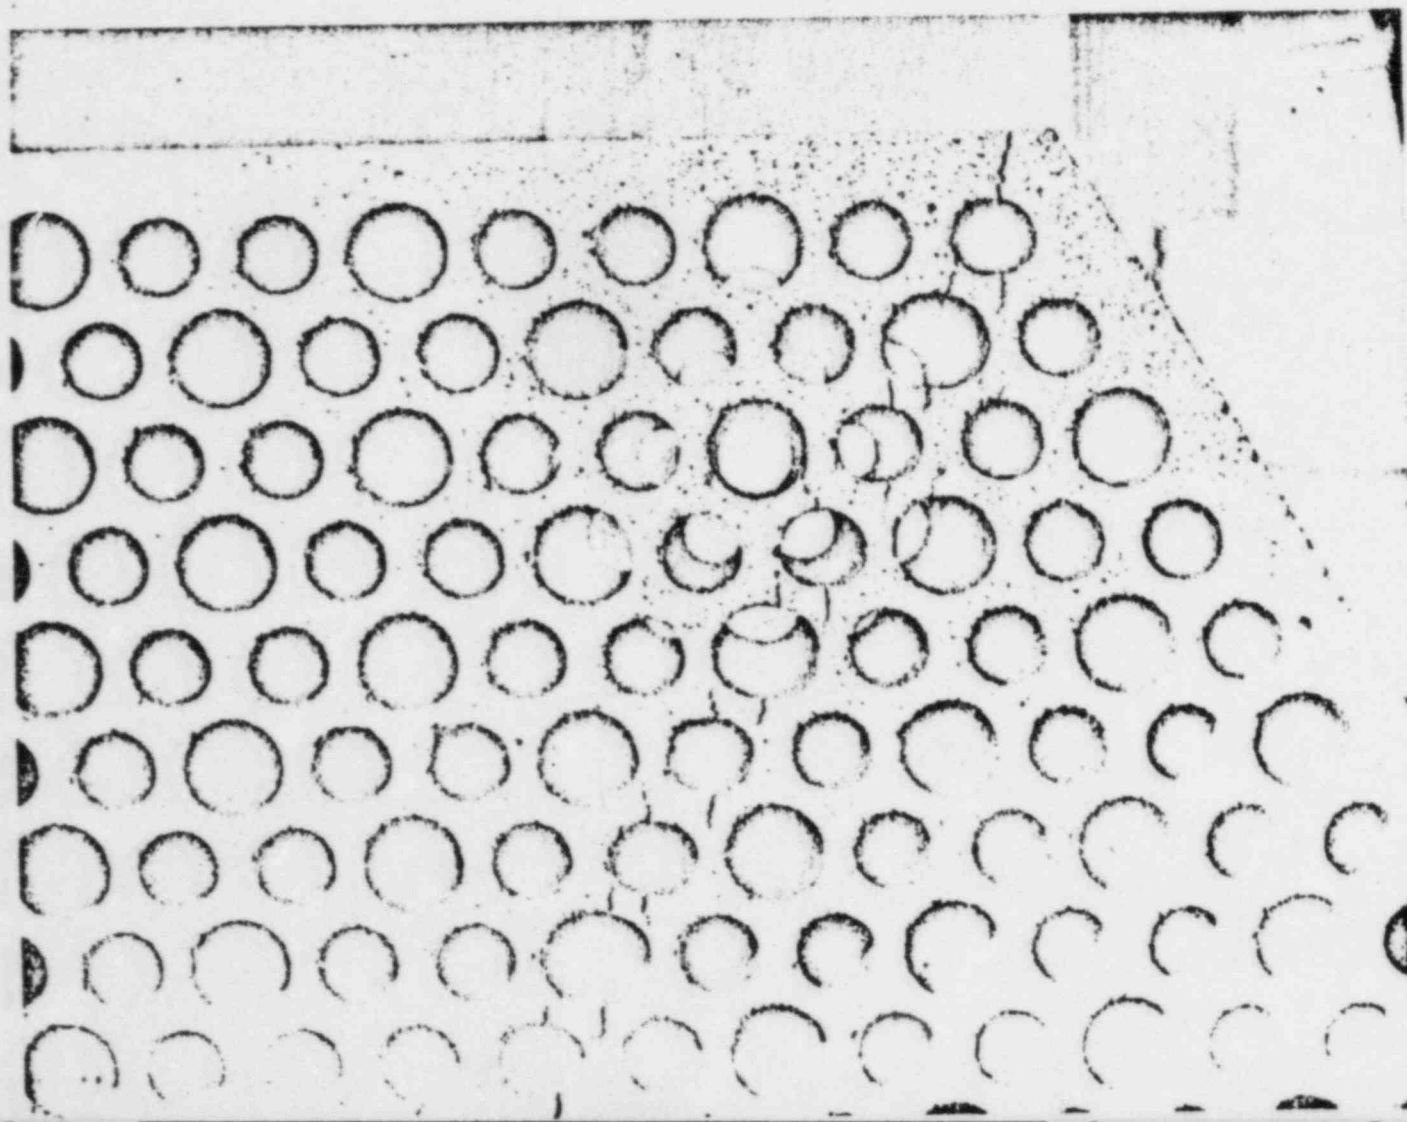
CLOSEUP OF CRACK PATTERN AT TOP REAR CORNER FOR ELEMENT 1-4568 SLAB 6

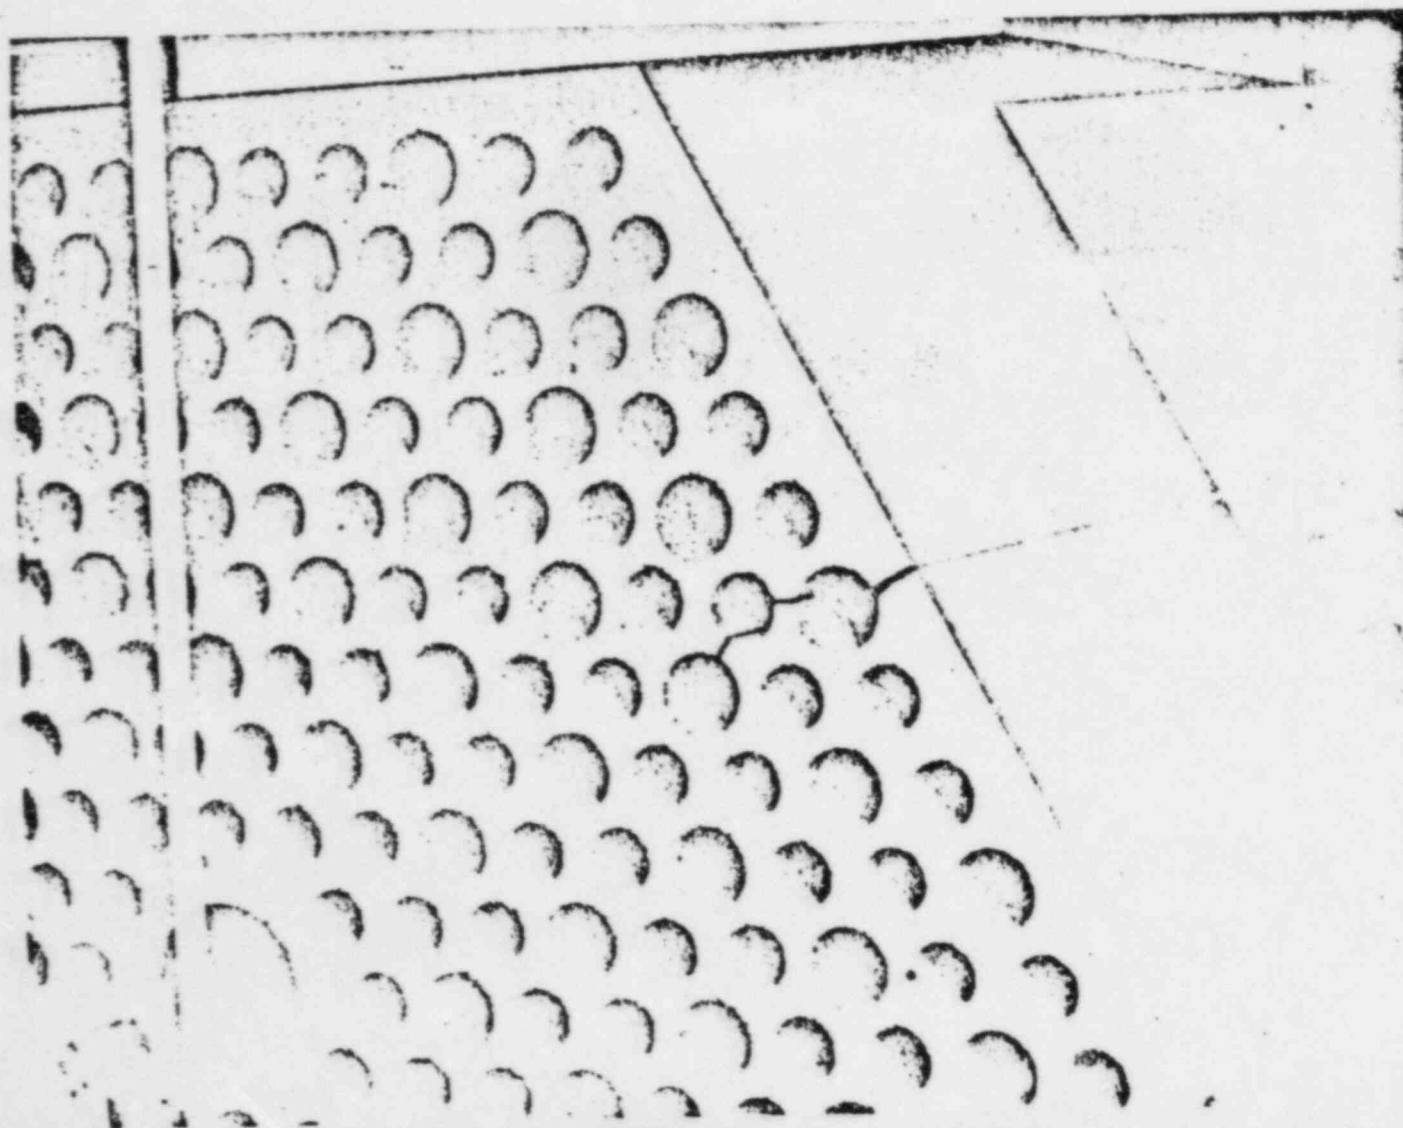
CLOSEUP OF SIMULATED CRACKS FOR ELEMENT 1-4568 SLAB 8 PRIOR TO TEST

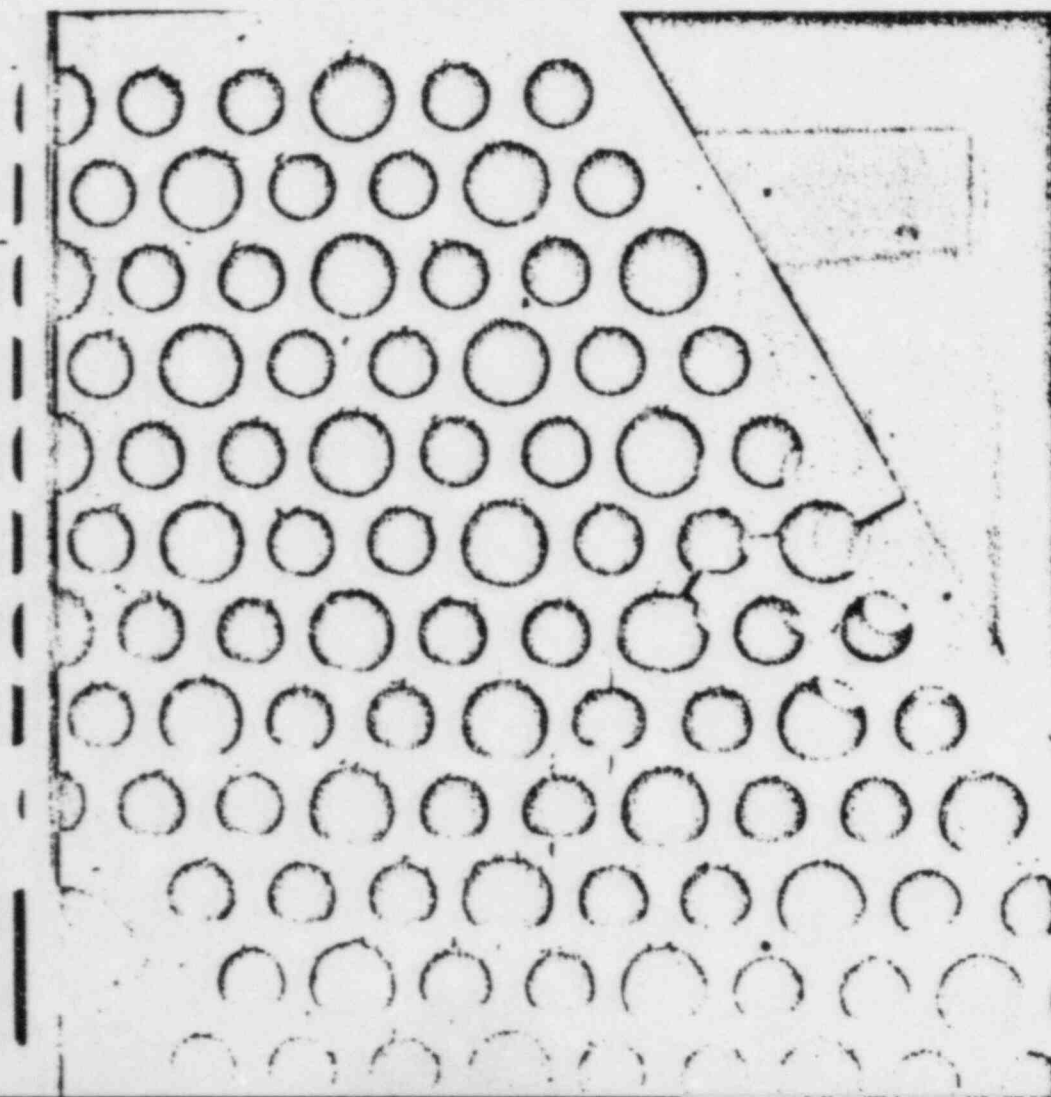
**CRACK PATTERN OF ELEMENT 1-4568 SLAB 8
AFTER INITIAL FAILURE WITH BLOCK STILL UNDER
20,750 LB LOAD**

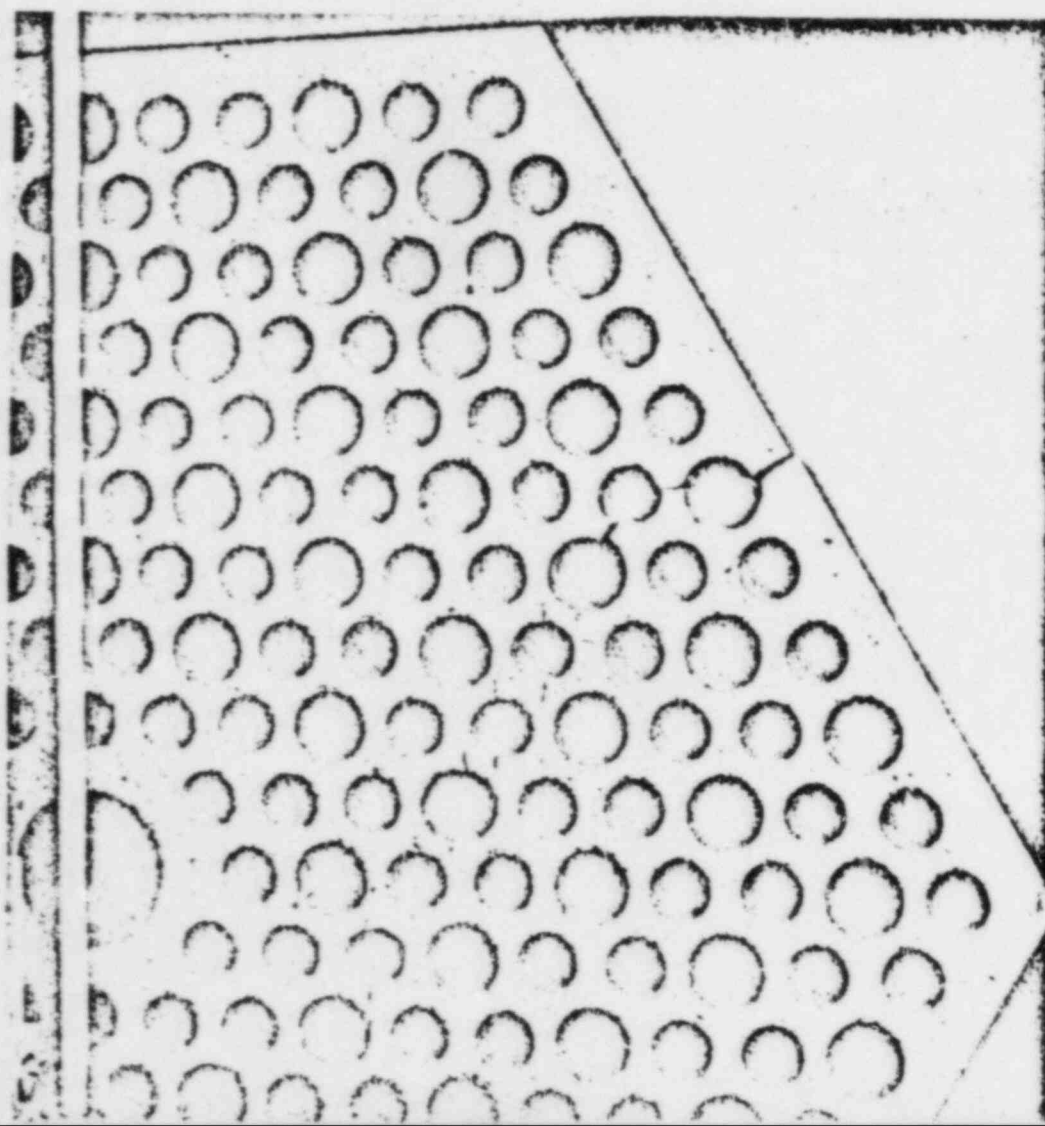
**CRACK PATTERN OF ELEMENT 1-4568 SLAB 8
AFTER INITIAL FAILURE WITH BLOCK STILL UNDER
20,750 LB LOAD**

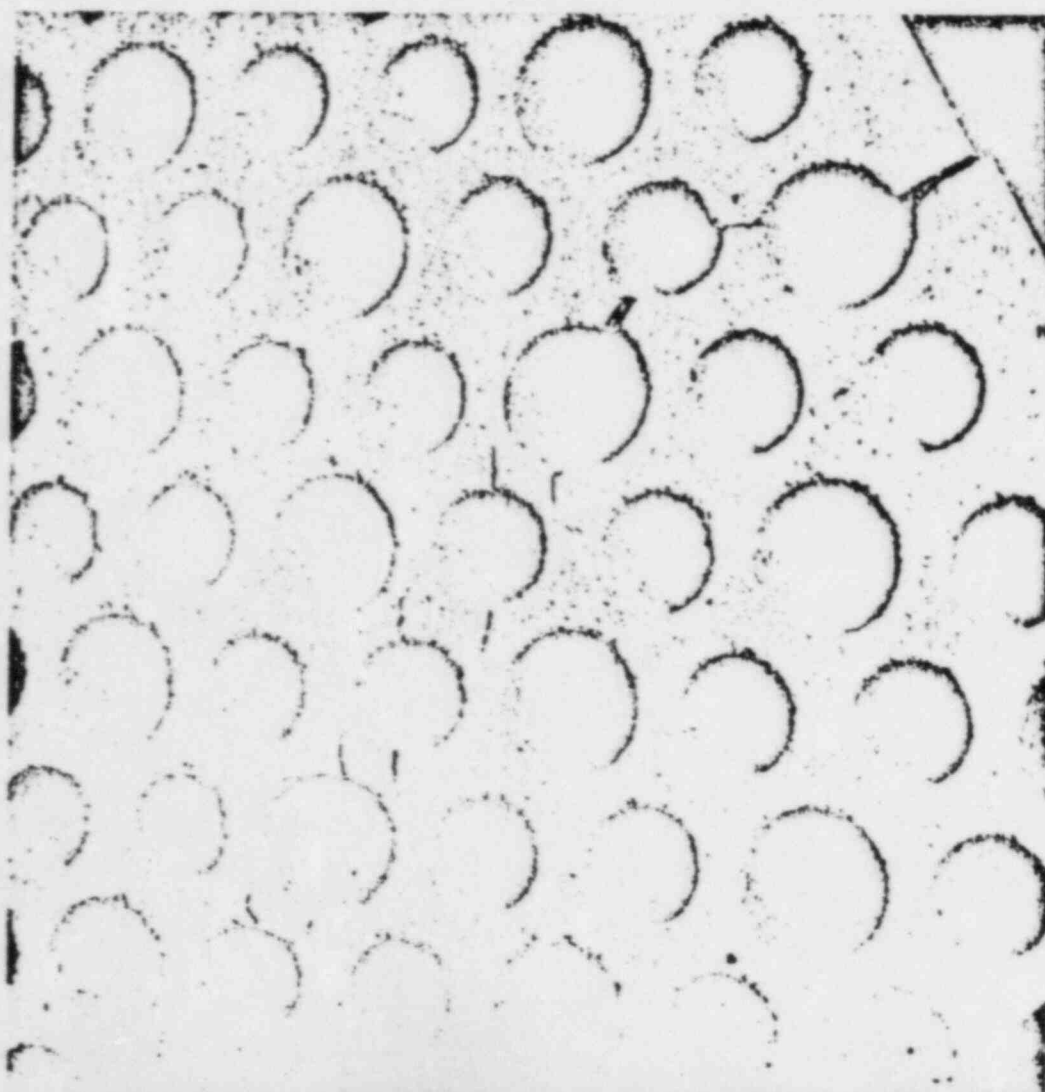
**CLOSEUP OF CRACK TIPS FOR ELEMENT 1-4568
SLAB 8 WITH BLOCK STILL UNDER
20,750 LB LOAD**
