Subject: James A. FitzPatrick Nuclear Power Plant
Docket No. 50-333
Core Spray "A" Metallurgical Analysis

A METALLOGRAPHIC INVESTIGATION OF A
TYPE 304 STAINLESS STEEL SCHEDULE 80 PIPE

AN INVESTIGATION OF FLAWS ON THE
INSIDE SURFACE OF A TYPE 304 STAINLESS
STEEL SCHEDULE 80 PIPE

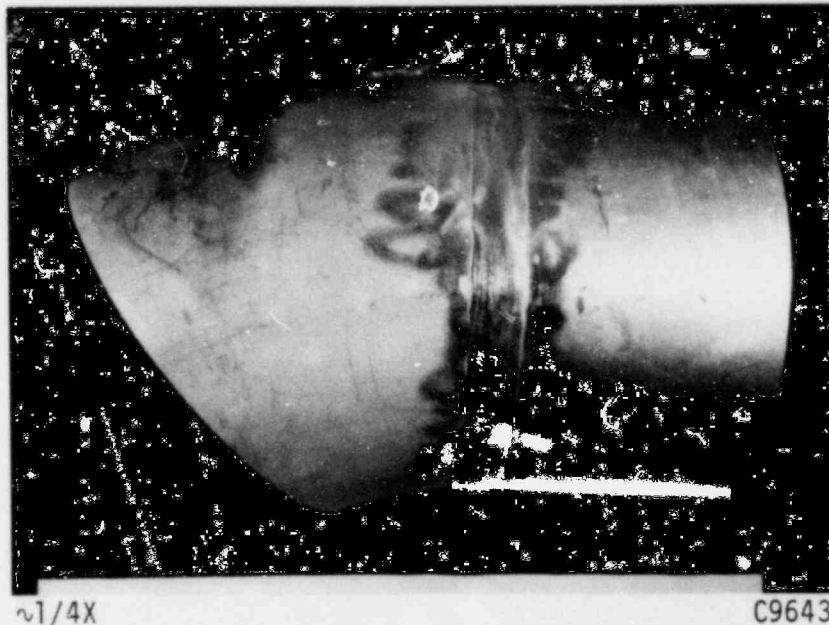
The photograph in Figure 1 shows a portion of the Type 304 stainless steel pipe that contained the linear indication detected by PASNY, that was submitted to BCL for the investigation. That portion of the pipe was approximately 15 inches long; it included about 7 inches of the straight-pipe section and about 7 inches of the elbow section that were joined together by the circumferential weld.

FIGURE 1. PORTION OF THE TYPE 304 STAINLESS STEEL PIPE FROM THE REACTOR CORE-SPRAY SYSTEM THAT CONTAINED THE LINEAR INDICATION DETECTED ULTRASONICALLY

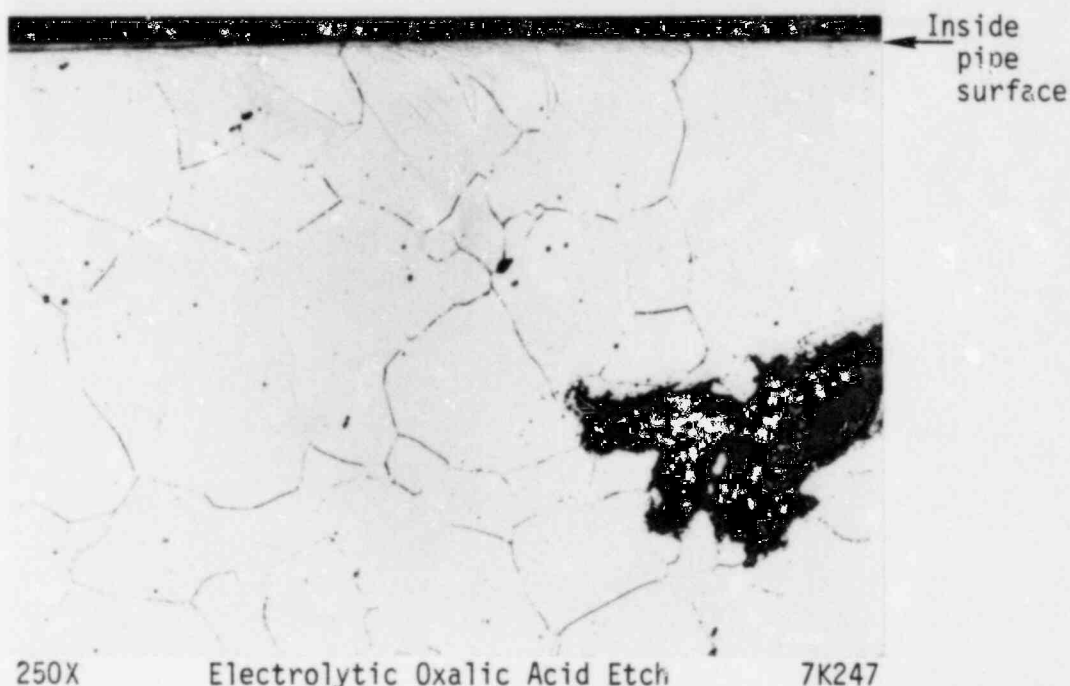
Sensitization was revealed in the cross section through the defect by electrolytic etching using an electrolyte that consisted of 10 percent by weight of oxalic acid in water. (This is an etch commonly used to reveal a sensitized microstructure in stainless steels.) Evidence of sensitization, the presence of fine carbide precipitates in the austenite grain boundaries, is presented in Figure 8. The area shown in Figure 8 was located within Circled Area 4 in Figure 5a. The presence of sensitized material was

FIGURE 8. SENSITIZATION (CARBIDE PRECIPITATE IN THE GRAIN BOUNDARIES) OBSERVED IN THE REGION OF THE LINEAR SURFACE DEFECT

revealed clearly by the etch to a depth of about 0.20 inch below the inside surface of the pipe. Beyond that depth, evidence of sensitization was observed in random grain boundaries.

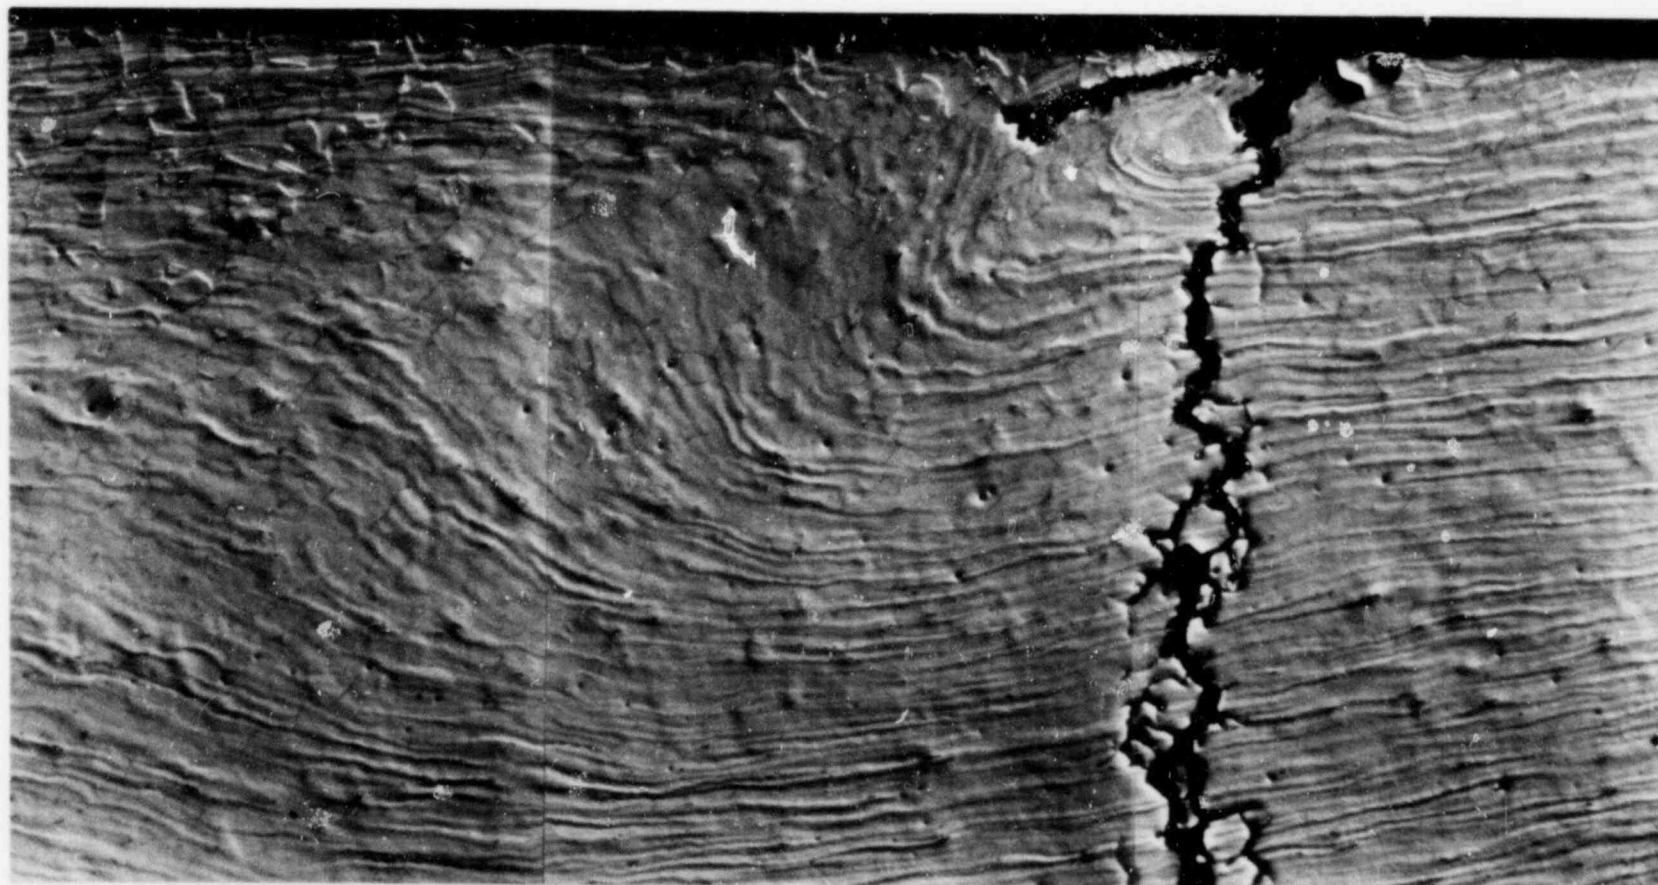
The coring pattern in Figure 9 shows that an interruption of the normal flow of metal occurred around the linear defect in the surface of the pipe during fabrication. The flow pattern around the linear defect was similar to that sometimes observed around seams or laps in billet surfaces. However, inasmuch as the linear defect was on the inside surface of seamless pipe, the origin of the linear defect must have been associated with the piercing or other operation in the process of producing the seamless pipe.

Note in Figure 9 that the cored regions were independent of the grains and the grain boundaries and that the coring had no noticeable effect on the initiation or propagation of the crack.

FIGURE 9. CORING THAT REVEALS THE FLOW PATTERN OF METAL AROUND THE LINEAR SURFACE DEFECT

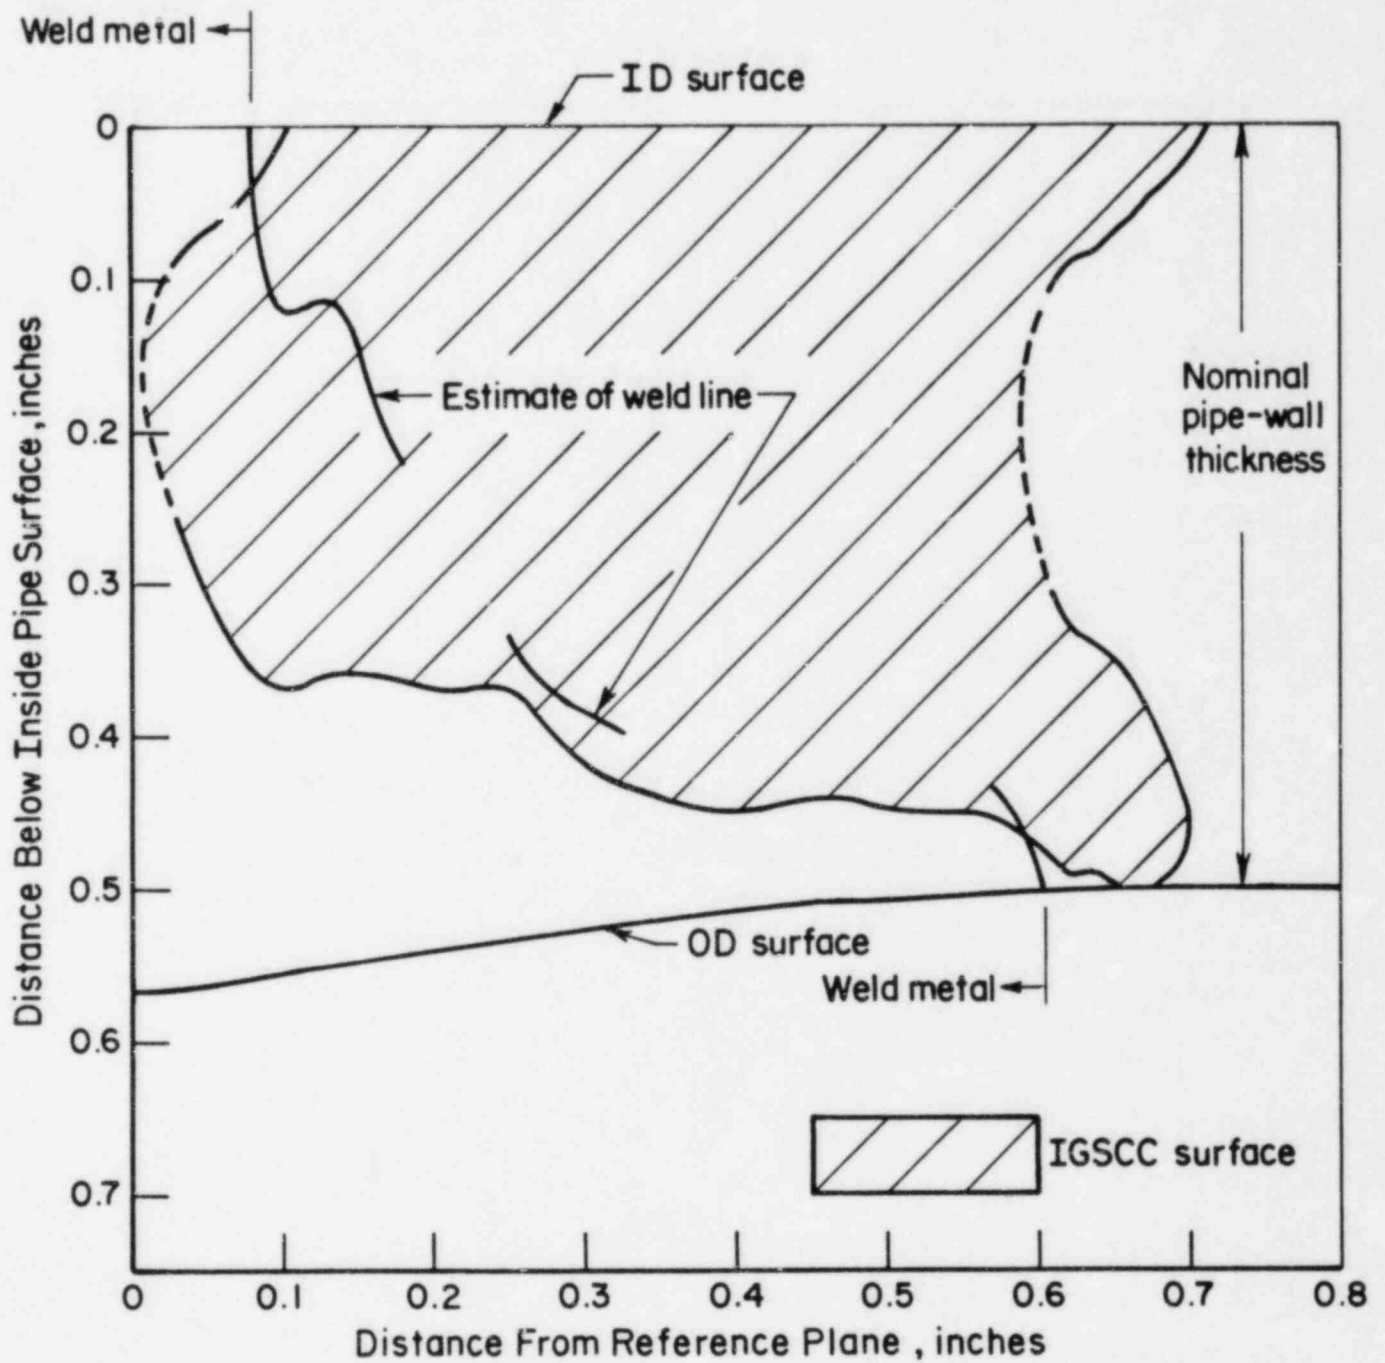
FIGURE 2. PROFILE OF INTERGRANULAR STRESS-CORROSION CRACK AT FLAW NO. 1

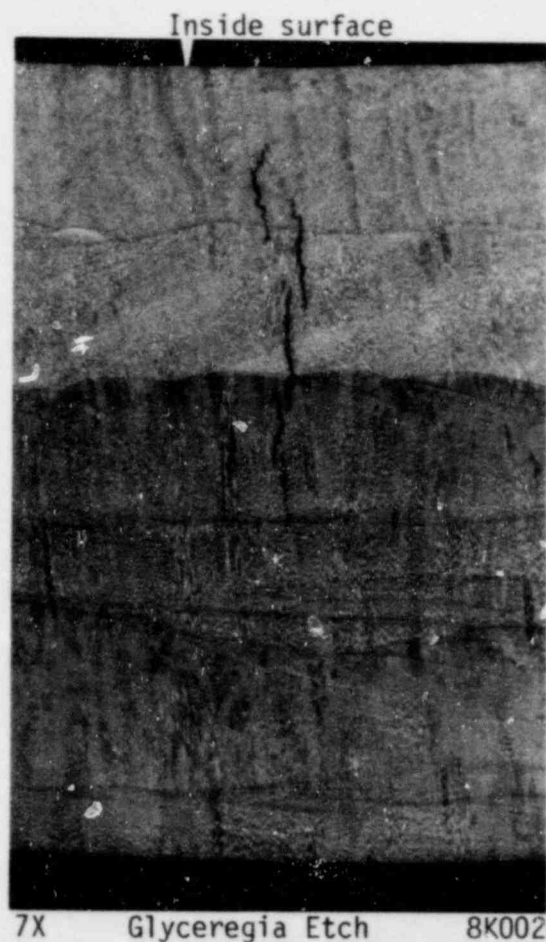
a. IGSCC at the 0.060-Inch Position

b. IGSCC at the 0.290-Inch Position

c. IGSCC Near the Outside Surface of the Pipe at the 0.70-Inch Position

FIGURE 3. THE IGSCC ASSOCIATED WITH FLAW NO. 1 AT SEVERAL LOCATIONS ALONG THE LENGTH OF THE CRACK

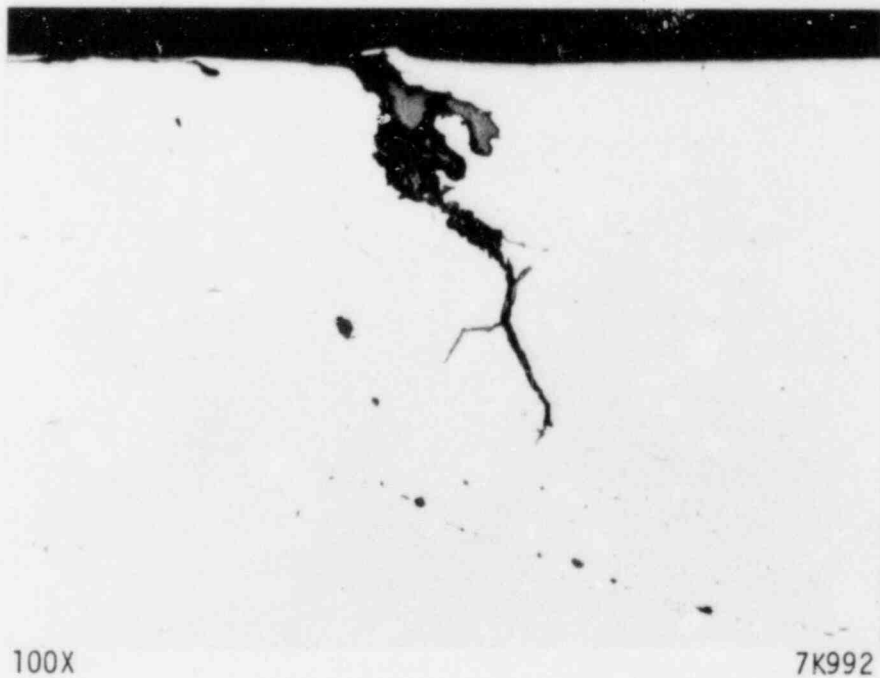
The appearance of the surface flaw at the 0.70-inch position is revealed in Figure 4. The flaw exhibited two surface imperfections that were approximately 0.1 inch apart; those two imperfections are shown in Figures 4a and 4b respectively. A little IGSCC was still evident at the flaw shown in Figure 4b.

a. Surface Imperfection Located About 0.1 Inch from the Imperfection Shown in (b) Below

b. Surface Imperfection and Some IGSCC at the 0.70-Inch Position

FIGURE 4. FLAW NO. 1 NEAR THE END OF THE IGSCC FARTEST FROM THE WELD

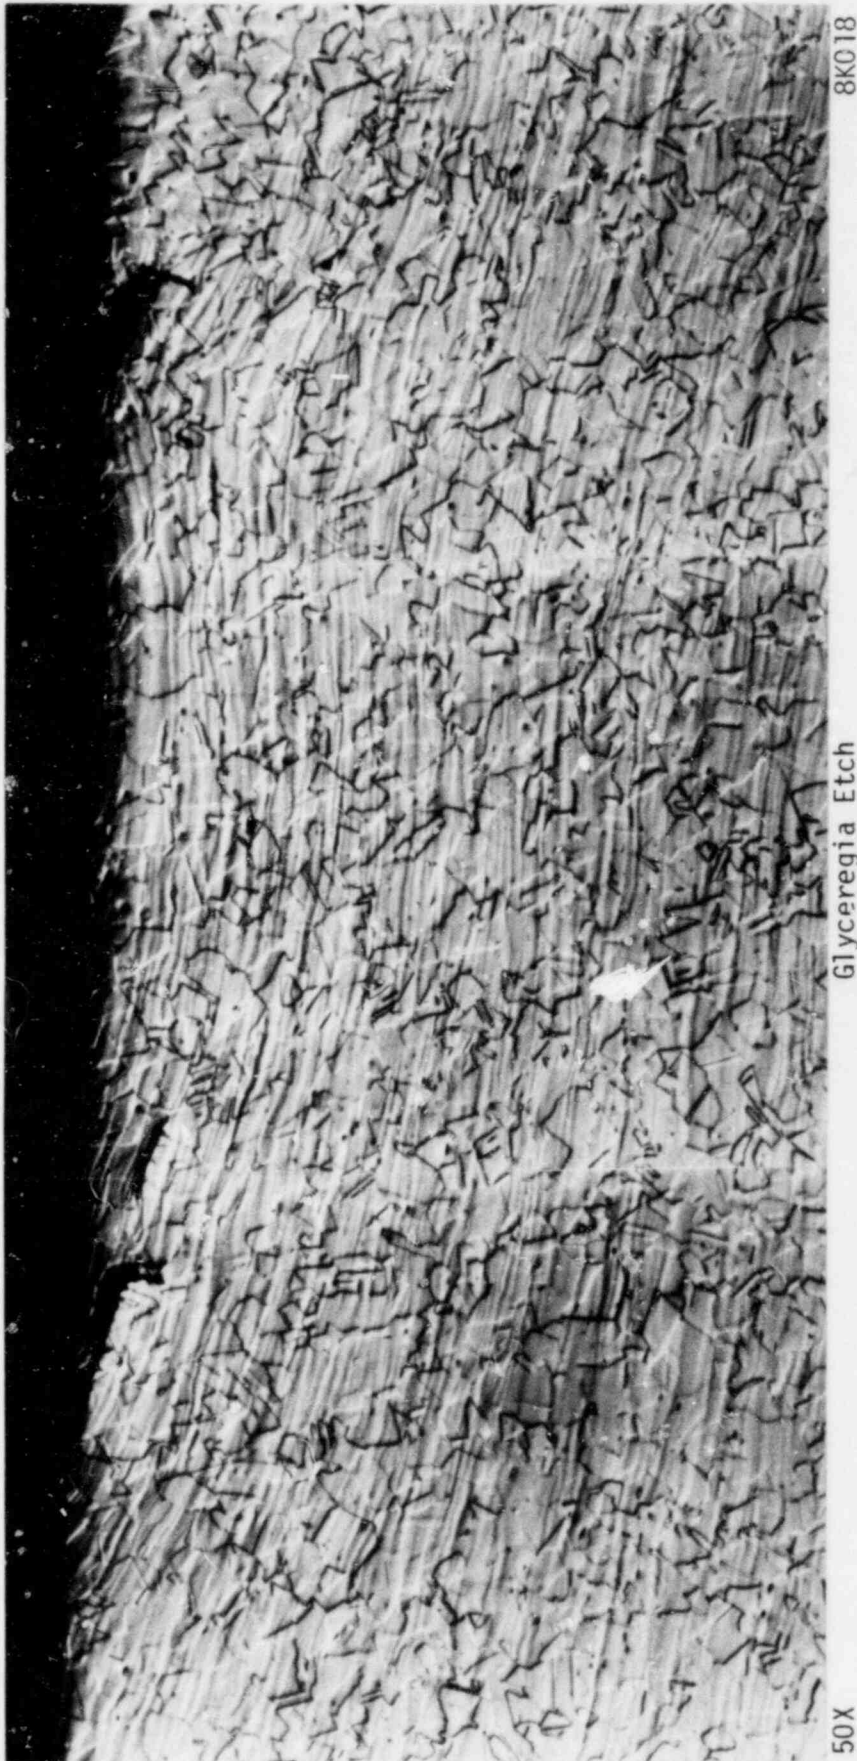
The flow pattern of the metal that developed around the flaw during the fabrication of the pipe was revealed by etching metallographically polished specimens, as is shown in Figure 5 at a magnification of 50X. At

FIGURE 5. THE FLOW PATTERN OF METAL AROUND FLAW NO. 1 AT THE 0.72-INCH LOCATION IN FIGURE 2

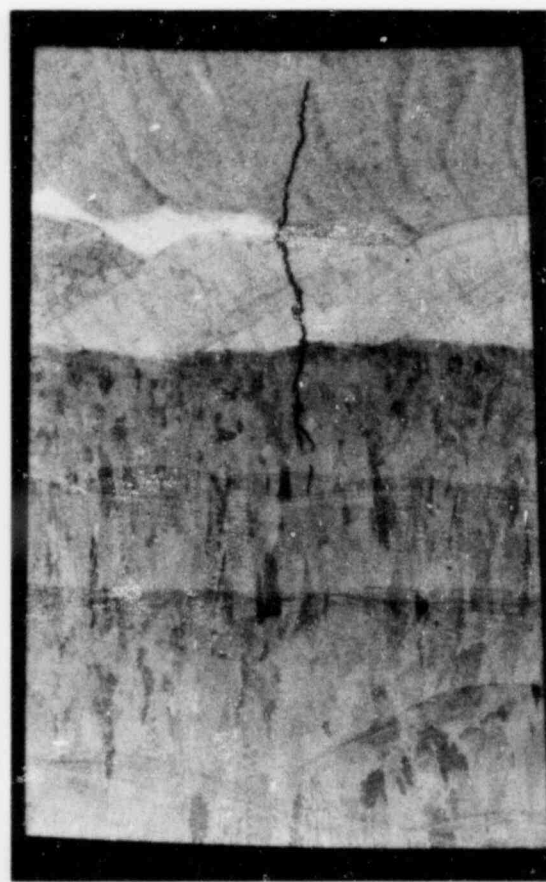
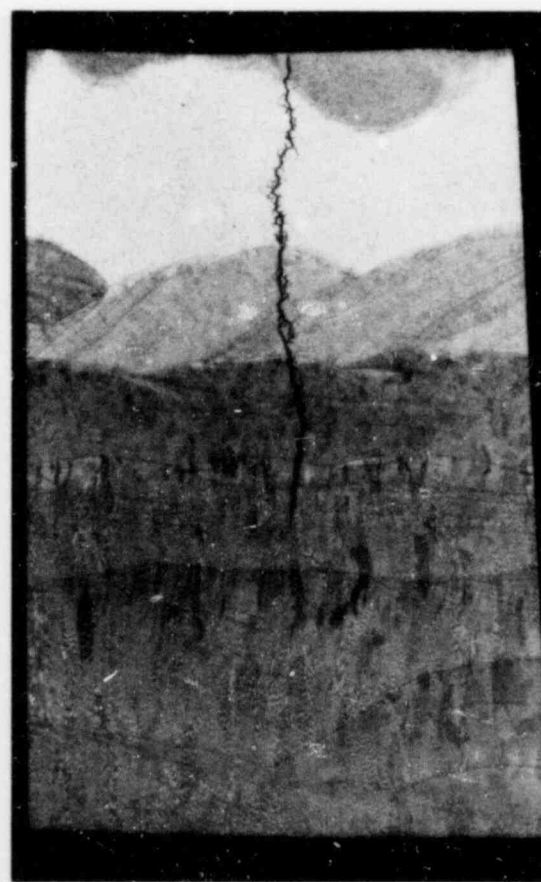
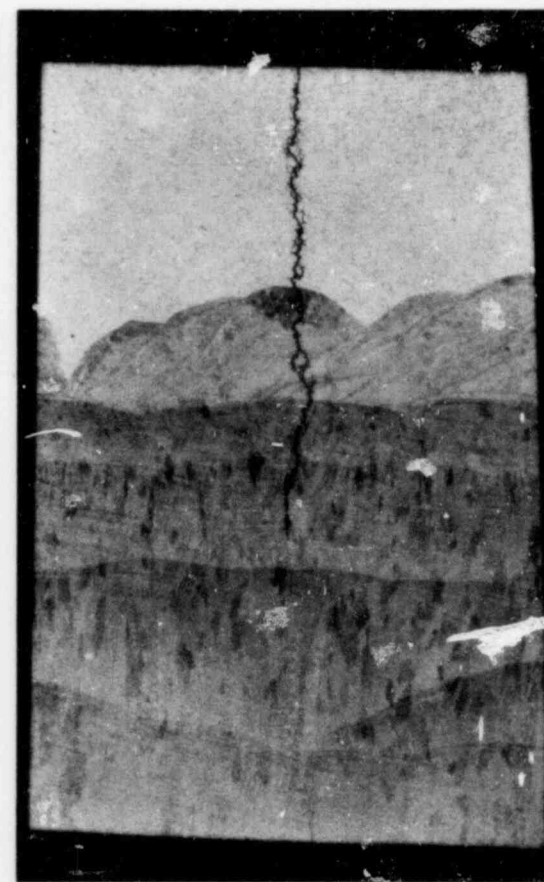
Figure 7 shows the appearance of the IGSCC at a few locations along its length. Figure 7a exhibits the crack at the 0.10-inch position. At that location, the crack was subsurface and was entirely within weld metal except for a very small portion near middepth. At the 0.125-inch position (Figure 7b), the crack was slightly beneath the inside surface of the pipe and had begun to

a. IGSCC at the 0.10-Inch Position

b. IGSCC at the 0.125-Inch Position

c. IGSCC at the 0.161-Inch Position

FIGURE 7. THE IGSCC ASSOCIATED WITH FLAW NO. 4 AT SEVERAL LOCATIONS ALONG THE LENGTH OF THE CRACK

d. IGSCC at the 0.517-Inch Position

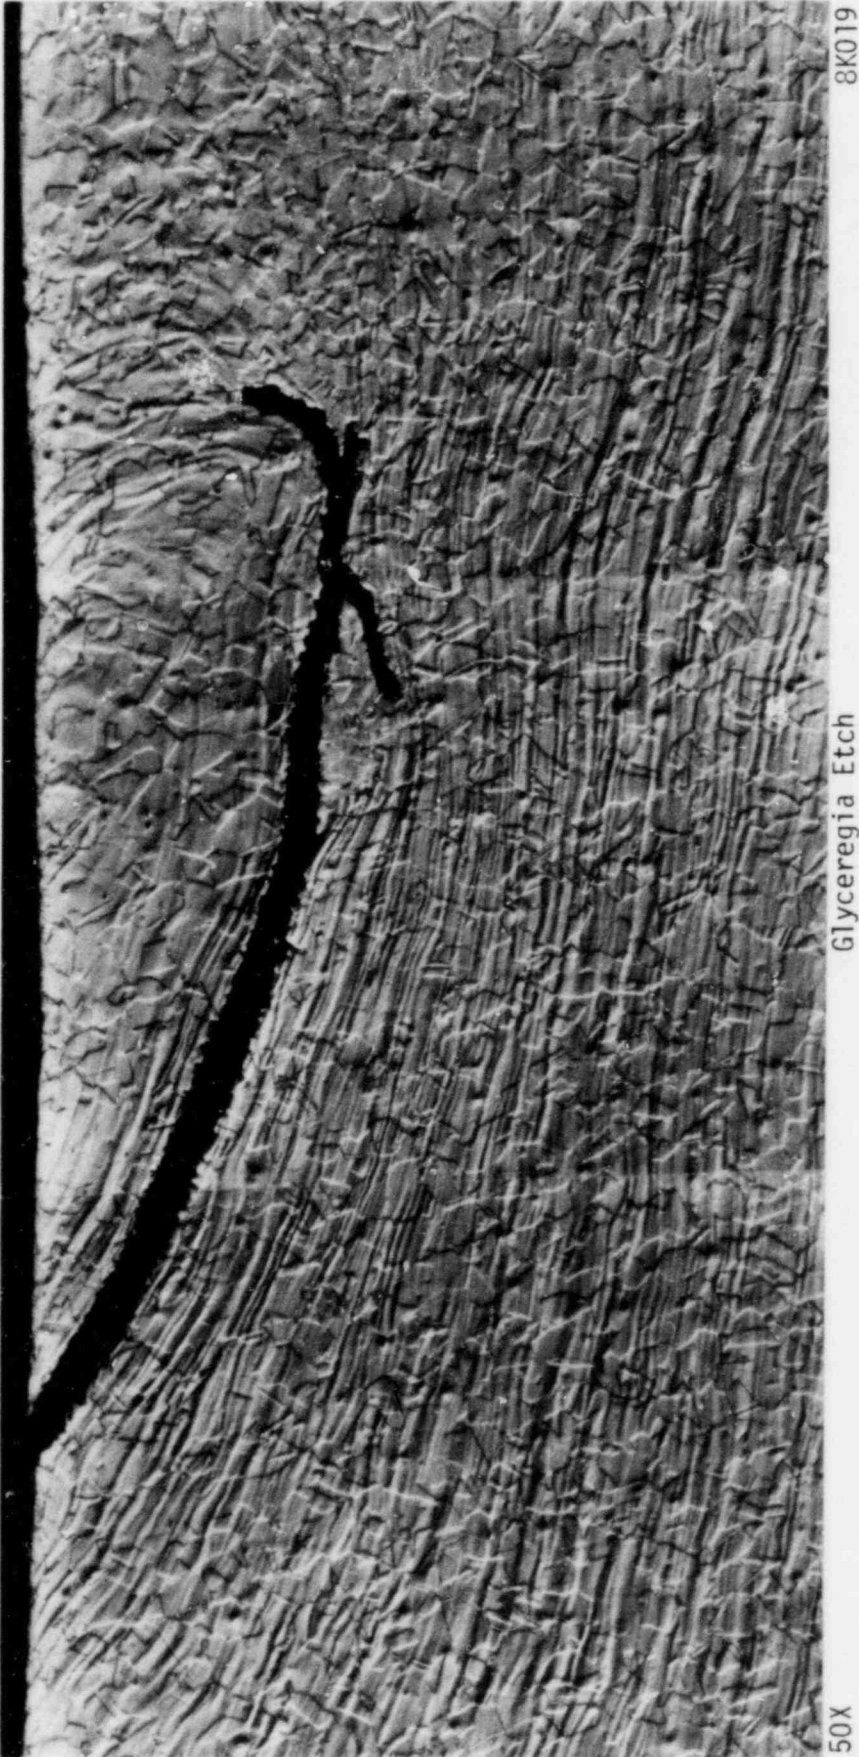
FIGURE 9. THE FLOW PATTERN OF METAL AROUND SURFACE FLAW NO. 2 IN SPECIMEN 2-N-N

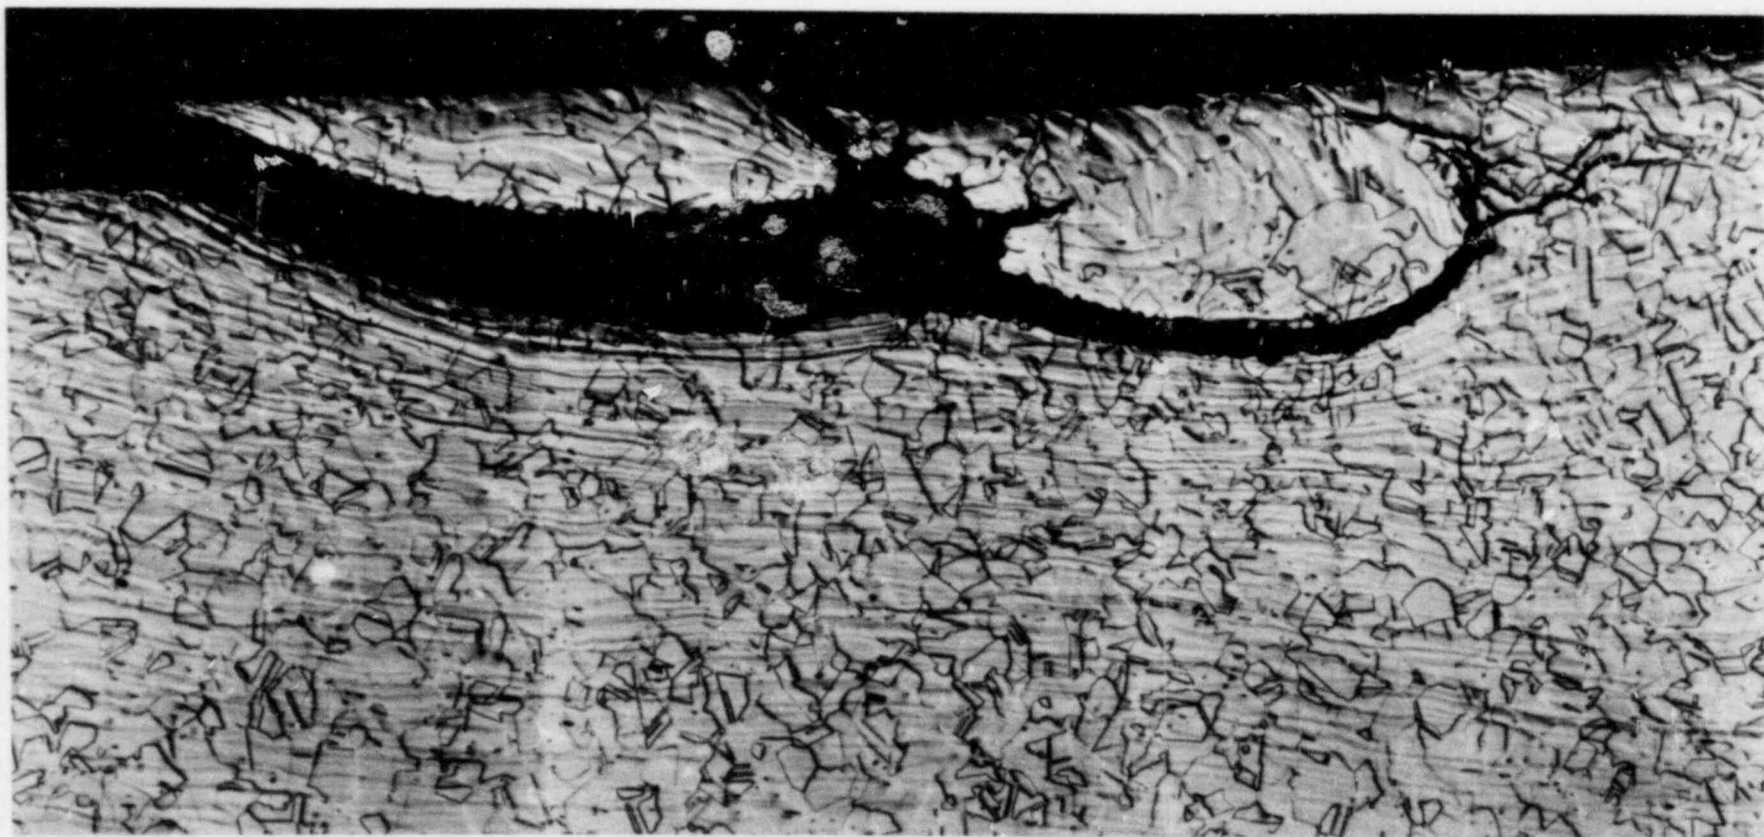
FIGURE 10. THE FLOW PATTERN OF METAL AROUND SURFACE FLAW NO. 2 IN SPECIMEN 2-R-R

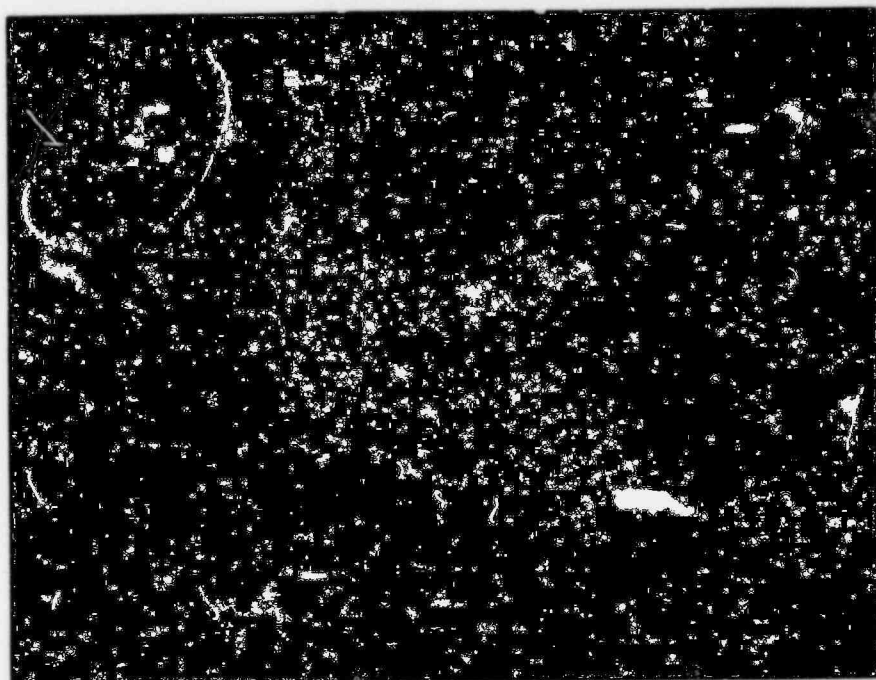
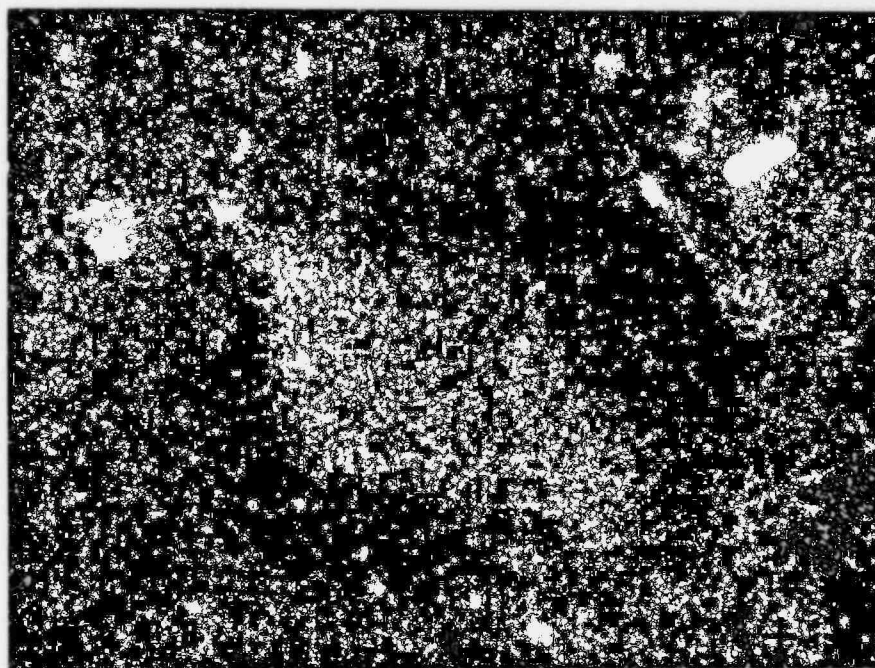
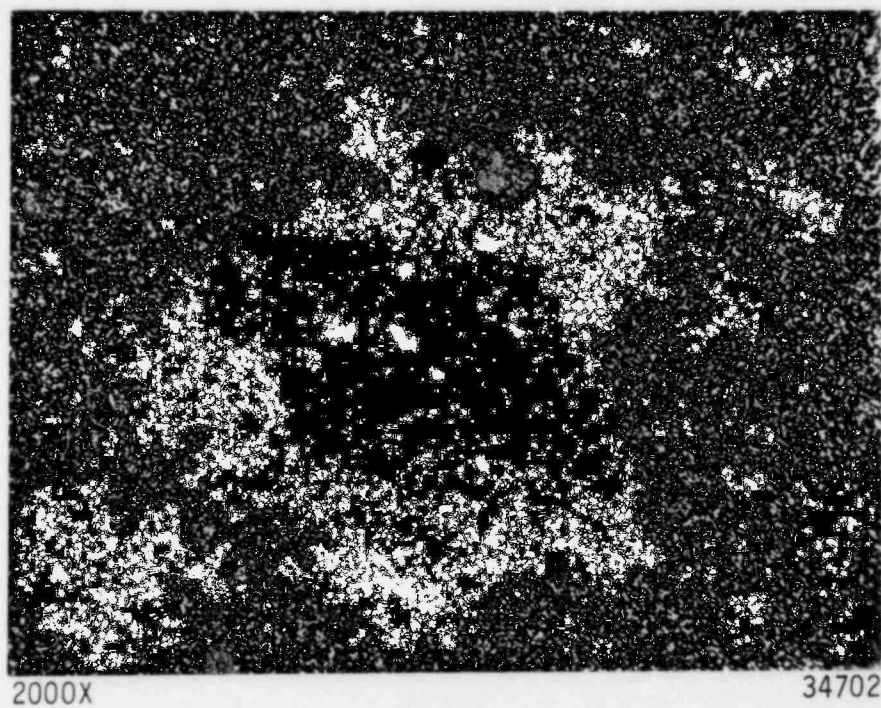
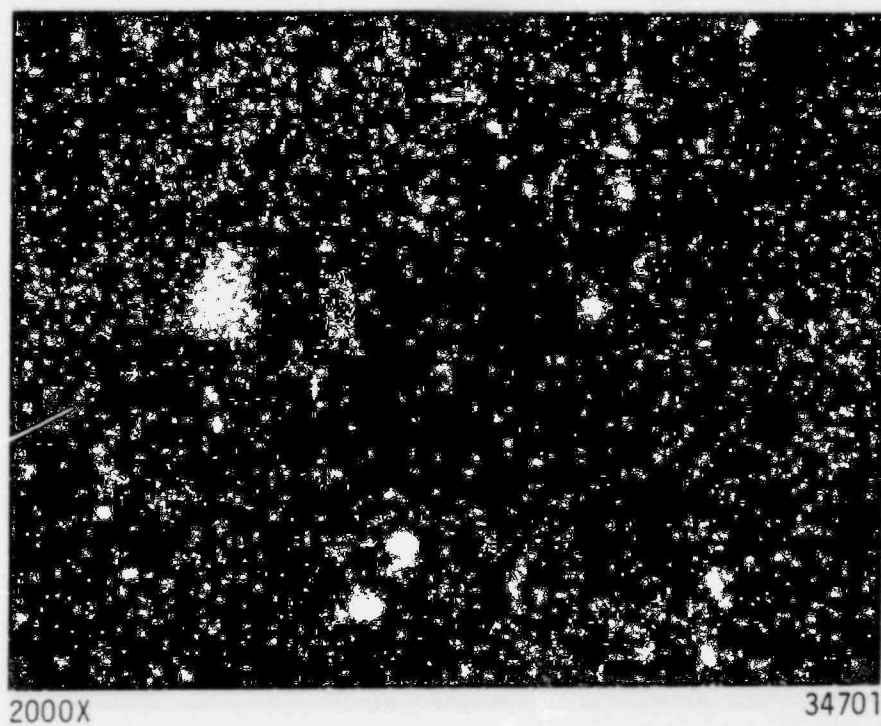
The principal elements detected in the corrosion products in Flaw No. 5 were the same as those elements detected in the corrosion products in Flaw No. 1 and Flaw No. 2. As with those other flaws, variations in the compositions of the corrosion products were evident among different areas that were analyzed.

FIGURE 19. CORROSION PRODUCTS IN FLAW NO. 2 THAT WERE
SUBJECTED TO ELECTRON-MICROPROBE ANALYSES
