SUBJECT: Calvert Cliffs Nuclear Power Plant  
Unit No. 1; Docket No. 50-317; License No. DPR 53  
Licensee Event Report 95-001  
Entry Into Technical Specification 3.0.3 Due to Leaking Emergency Diesel  
Generator Fuel Pump

TITLE (4)  
Entry Into Technical Specification 3.0.3 Due to Leaking EDG Fuel Pump

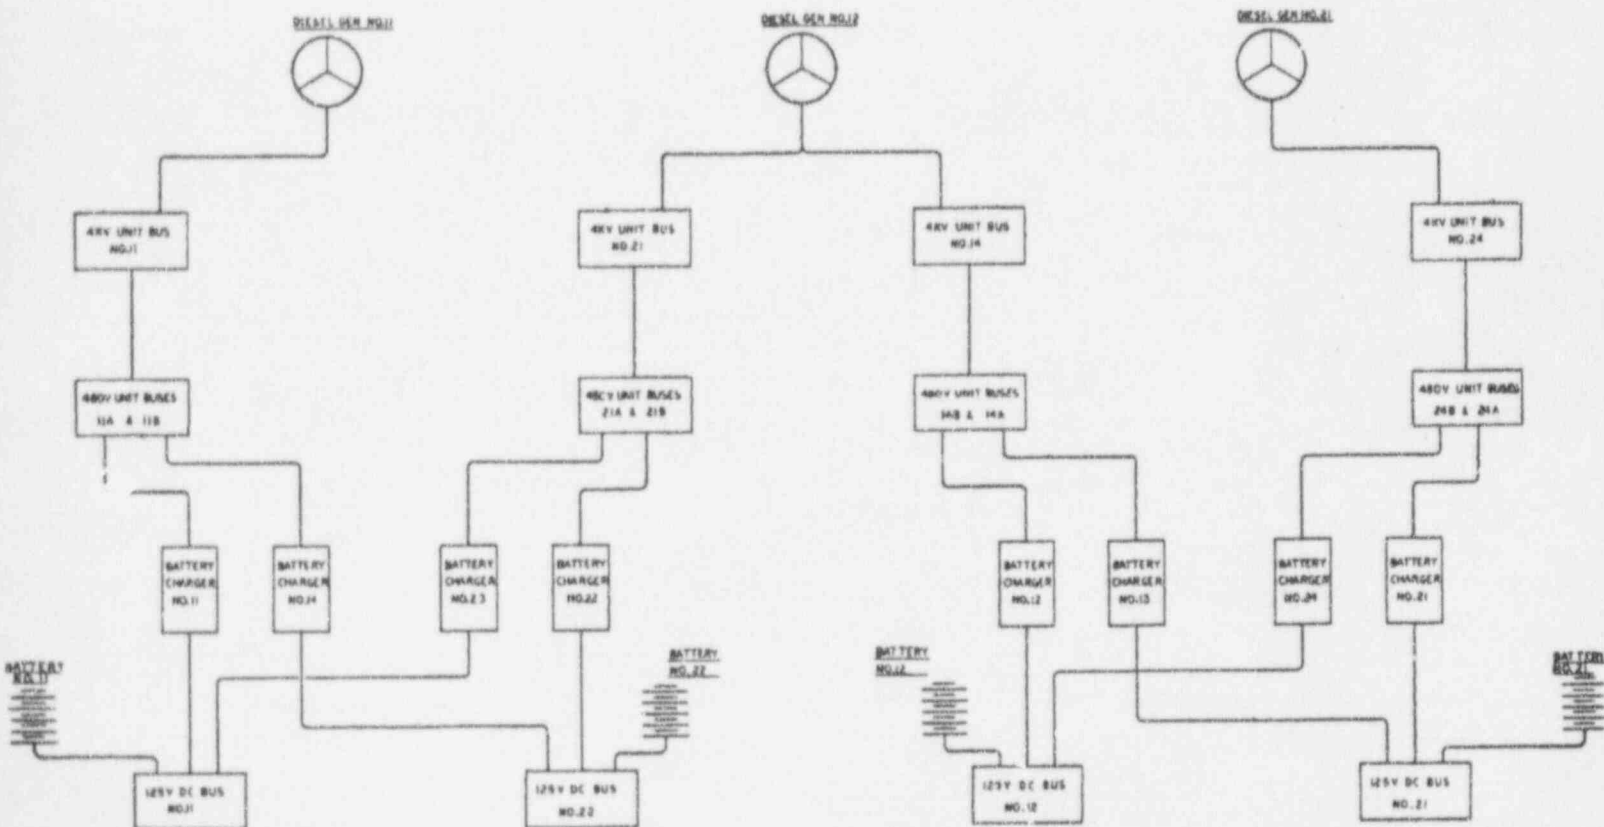
FIGURE 1

Calvert Cliffs Units 1 and 2 have three EDGs between the two units. No. 11 EDG may supply power to either Nos. 11 or 21 4 kV Engineered Safety Feature (ESF) busses. No. 21 EDG supplies power to No. 24 4 kV ESF. No. 12 EDG may supply power to either Nos. 14 or 21 4 kV ESF busses. (See Figure 1.)

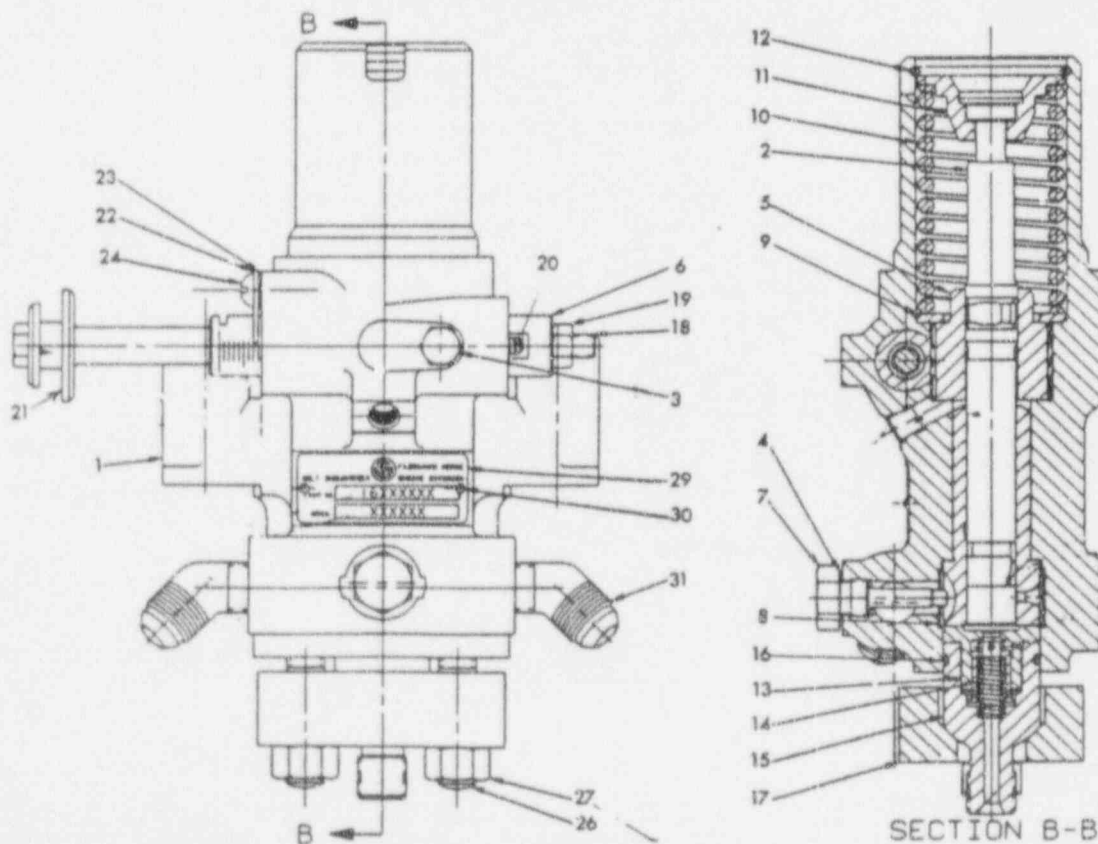
FIGURE 2

The immediate cause of this event was gross leakage from the No. 2 fuel injector pump to No. 12 EDG. Initially, it was believed that the fuel injector pump leaks were the result of internal cracks. However, discussions with a diesel vendor representative, who was onsite for the No. 21 EDG overhaul during the Unit 2 refueling outage, indicated the cause of the leakage was that the drain from the fuel injector pump was not draining properly.

The plunger and barrel assembly of the fuel injector pumps are designed to pass some amount of fuel by the plunger as the pump operates. The fuel that bypasses the plunger assembly is drained off at the bottom of the pump body. (See Figure 2.) The fuel passes through drain lines and into a common header containing the drained fuel oil from other fuel injector pumps. With the drain line not draining properly, fuel oil built up in the body of the pump and eventually started leaking from the area where the control rack plunger enters the fuel pump.

The cause of the drain lines not draining properly is not positively known but is suspected to be accumulation of deposits inside the drain lines from years of service.

Both Cylinder 2 and 10 fuel injector pumps that were found leaking were replaced and No. 12 EDG was restarted, loaded and run for one hour to verify the new pumps were performing satisfactorily.

All of the drain lines from all of the fuel injector pumps on all of the EDGs were cleaned out. Long-term corrective actions to ensure this event does not occur again in the future are currently being investigated.
