DIABLO CANYON NUCLEAR PROJECT
JOB # 7177
SPEC # 8711

QUALITY ASSURANCE REPORT
OF

Crack in Steam Generator Feedwater
Nozzle to pipe weld
(Generator No. 1-2)

CRACK IN STEAM GENERATOR FEEDWATER NOZZLE TO PIPE WELD (GENERATOR NO. 1-2)

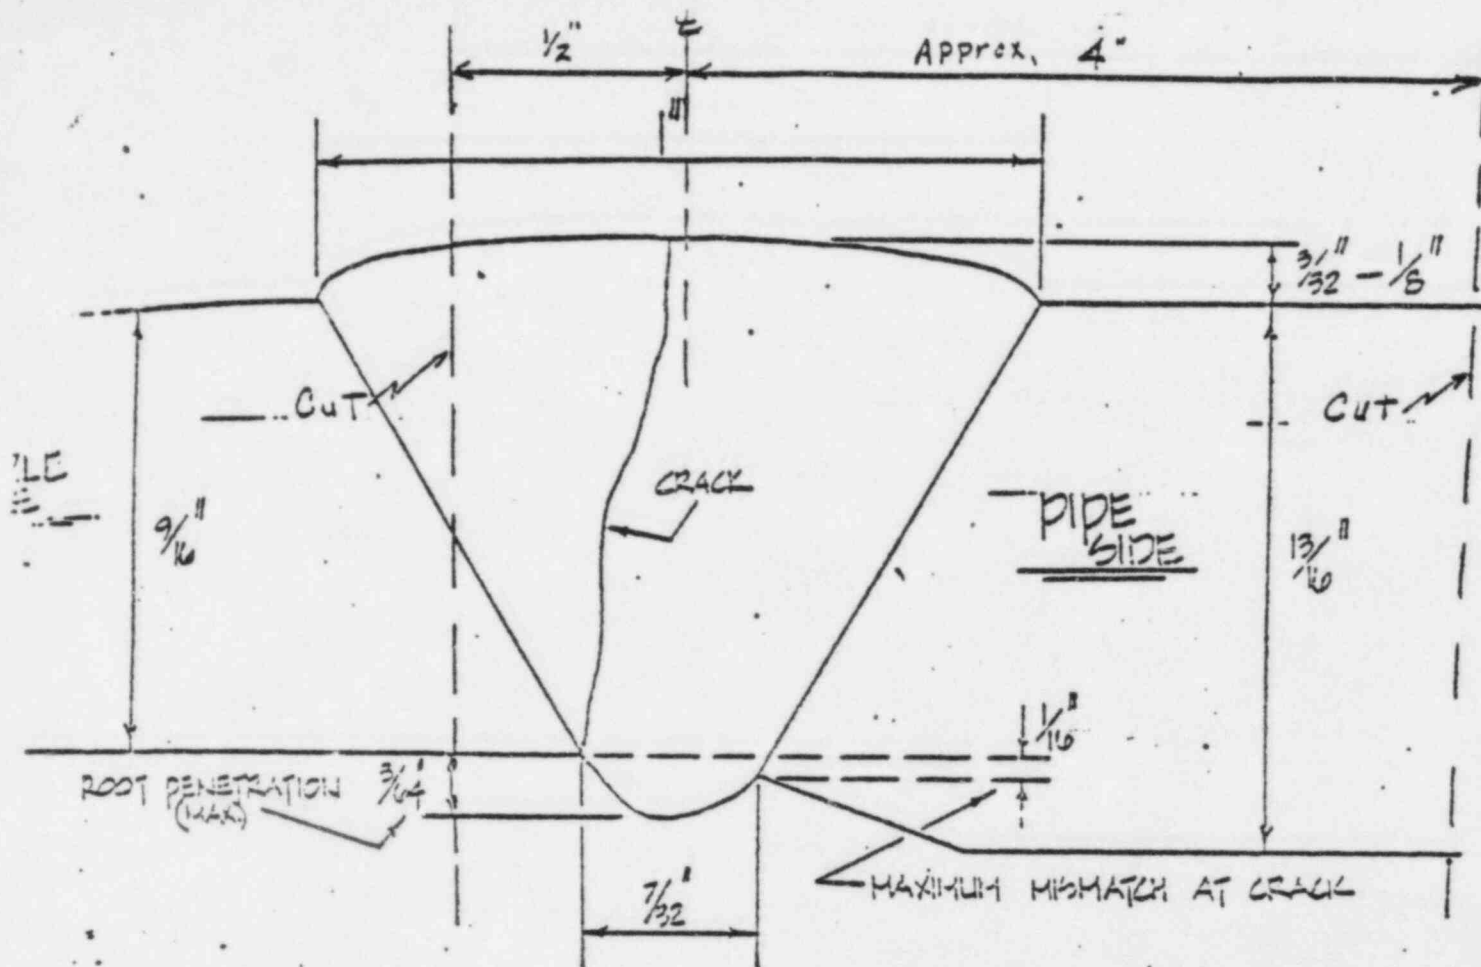
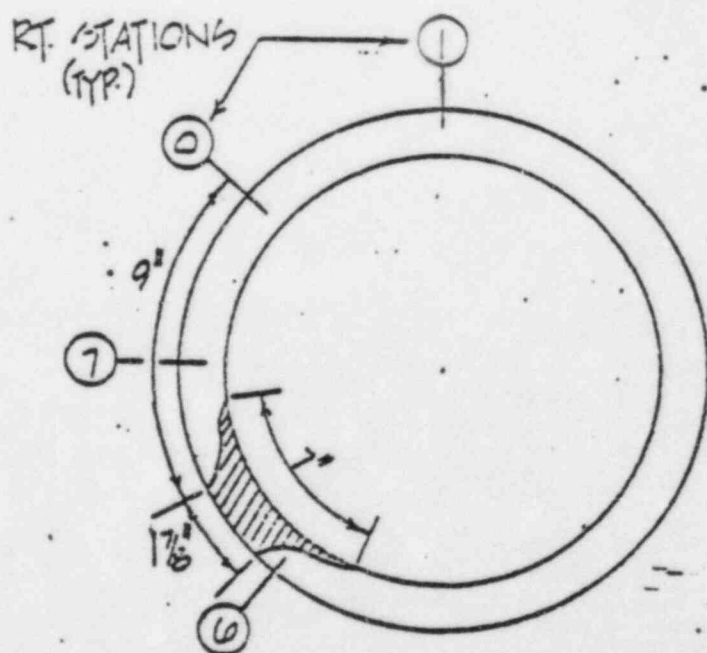
DR 3366 Rev I
ATTACHMENT # 2

The piece was examined visually and by liquid penetrant on the O.D. and I.D. and a sketch made to reflect the observations. (Sketch Attached)

1. WALL THICKNESS MEASR. ARE APPROXIMATE
2. REF. TO DR. 3366 REV. A
3. STEAM GENERATOR 1-2
F.W. #212
VQ. 500145
LINE # KU-555-16 IV

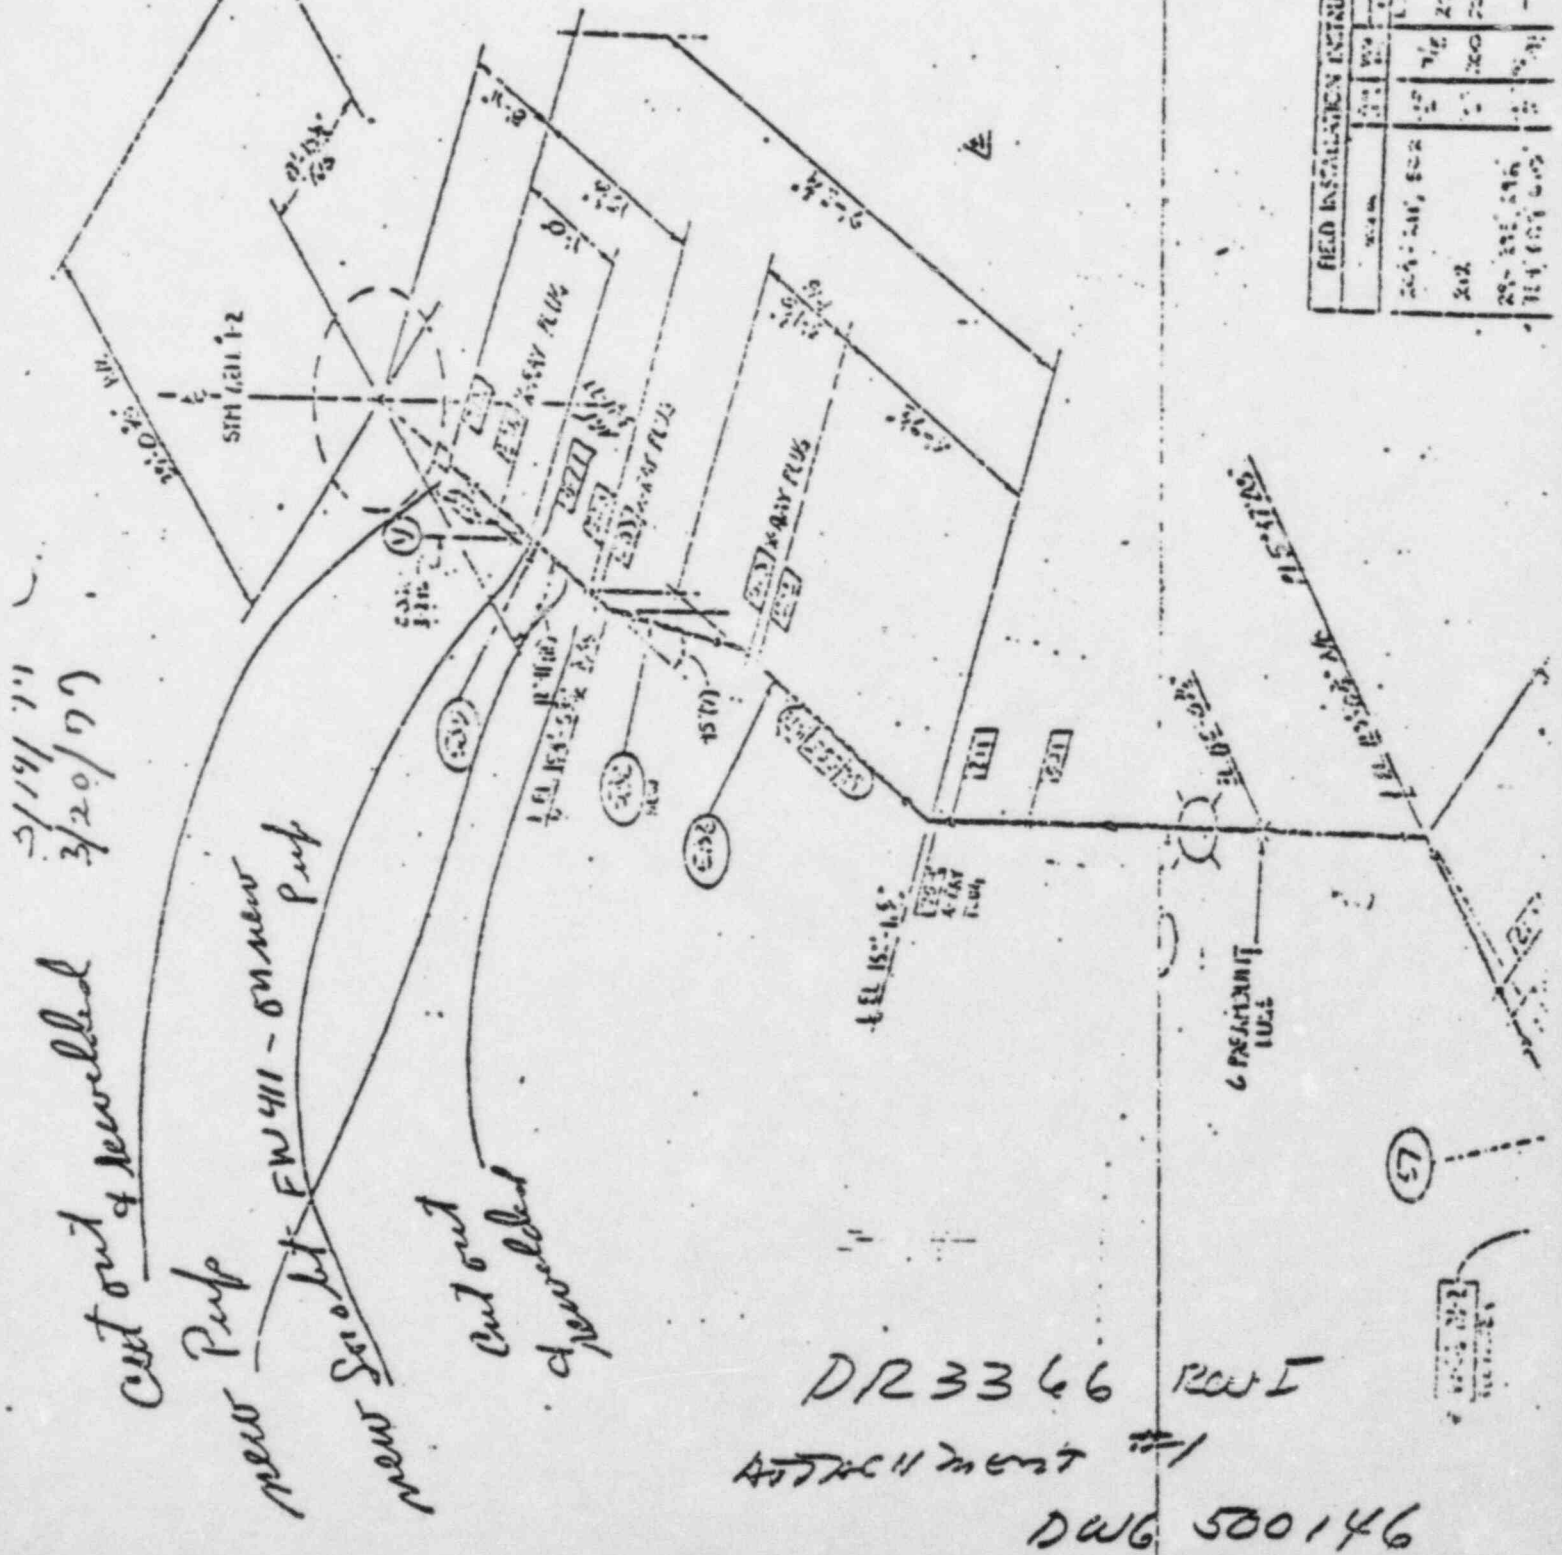
Attachment #1

Cut out & new welded

new Sewer bit FW411 - on new Pump

- A. Cut out weld and reweld.
- B. Prior to weld cut-out:
 1. Map weld area with U.T. to determine size and location of indication.
 2. X-ray for an analysis.
 3. Remove weld material with indication for further analysis.
 4. Cut out spool 580 (F.W. #503 to 212).
- C. Reweld procedure: (Rewritten)
 1. Weld F.W. #503 using procedure 4/5 and 88/89
 2. Weld F.W. #212 using procedure 200 or 204 (See Attached Sheet #2 for additional requirements).
 3. Install soc-o-let on new spool using F.W. #411 so vent can be reinstalled.

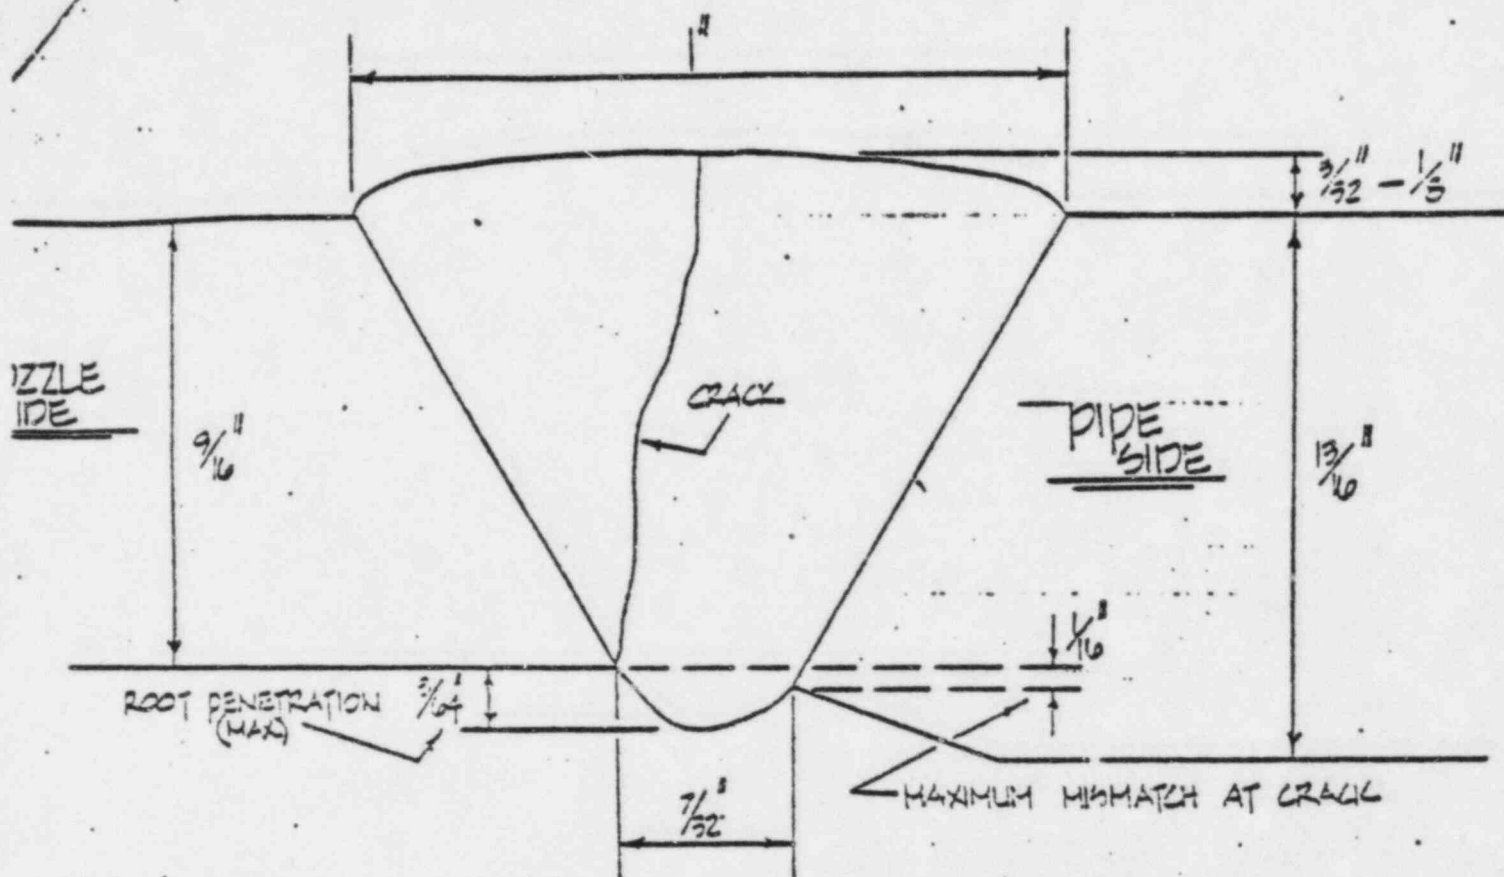
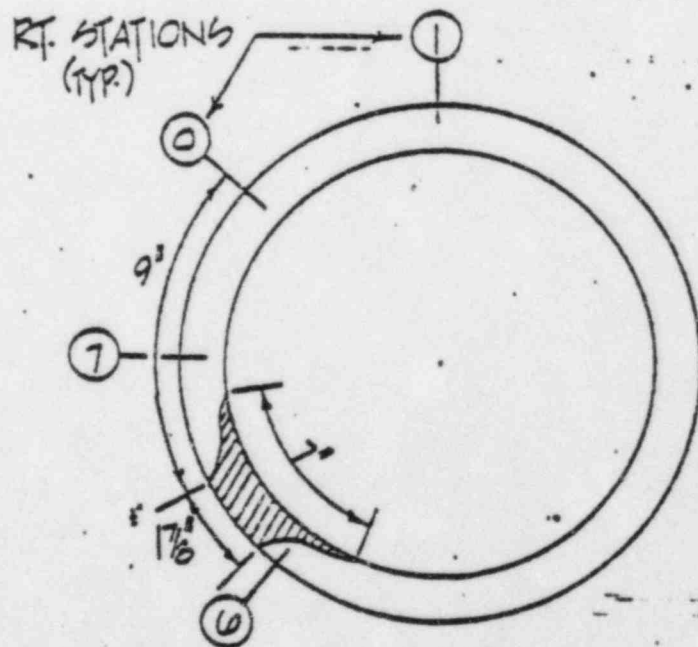
(JOINT DETAIL)
FOR RE-WELD
OF FW 212

1. WALL THICKNESS MEASR. ARE APPROXIMATE
2. REF. TO DR. 3366 REV. A
3. STEAM GENERATOR 1-2
F.W. #212
W.D. 80014U
-LINE # KU-553-10 IV

1. Preheat to 250°F minimum.
2. Maintain interpass at 250°F minimum, 500°F maximum until weld is complete and post weld heat treatment begins.
3. M.T. root pass; ESD-250.
4. R.T. after root and 2 layers weld added ESD-207. Repair if required and re-R.T. before completing weld.
5. Post weld heat treat at 1100°F minimum, 1150° maximum hold for 1 hour minimum, AT temperature..
6. Following post weld heat treatment, perform R.T.; ESD-207 and M.T.; ESD-209.
7. P.G.&E. will perform U.T. of final weld and maintain records.

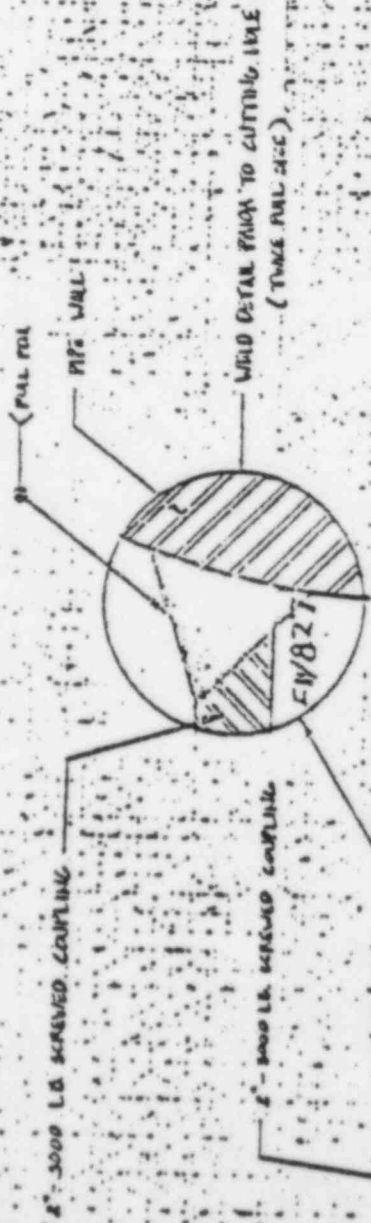
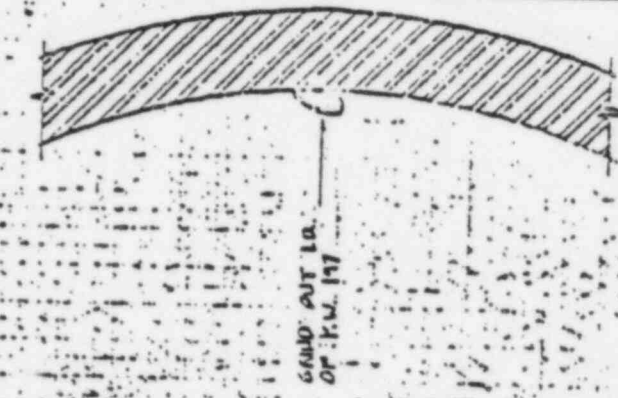
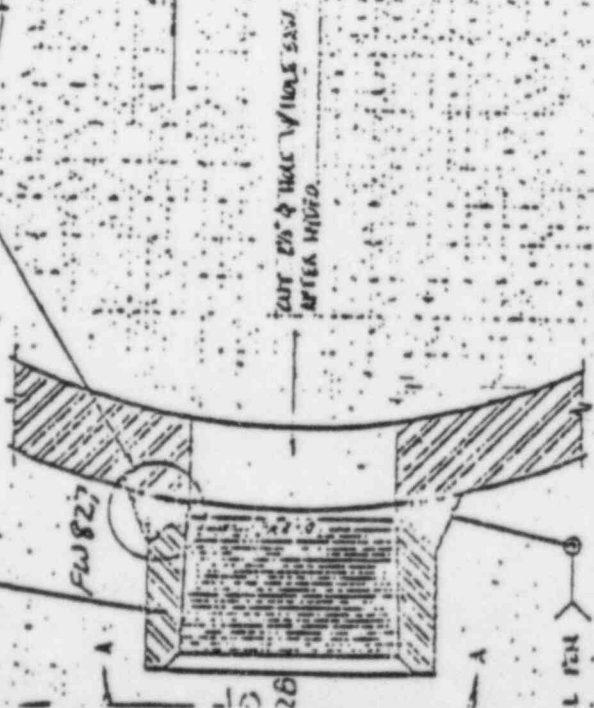
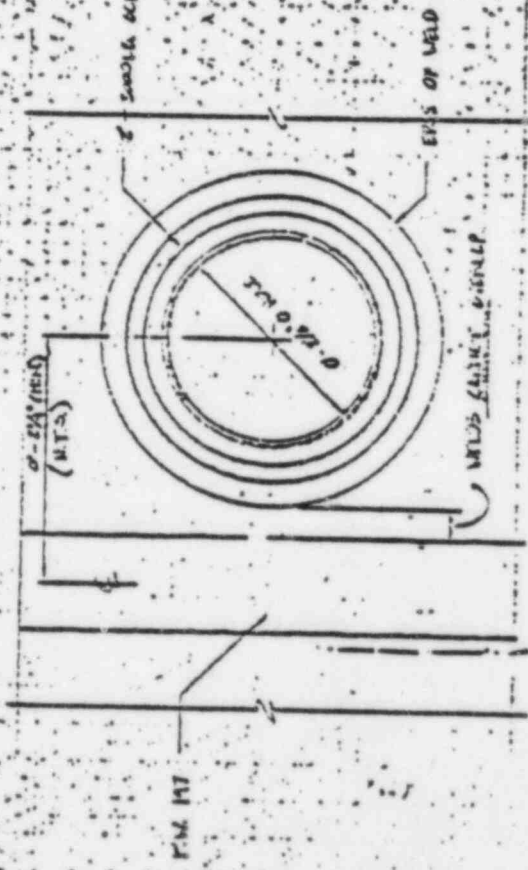
SECTION THRU PIPE NEAR F.W. 147

The review revealed a questionable indication in F.W. #197 on the feedwater lead to Steam Generator 1-1. The indication appears to be a burn through which contains linearly oriented voids. The accompanying radiographic report accepted the weld but did not indicate the presence of the burn through. Further investigation revealed that a second set of radiographs, shot at a later date, exist. This set also shows the burn through which was recorded on the radiographic report as acceptable (see copies attached).

1. Weld a 2" threaded coupling to the pipe as shown on the attached sketch using weld procedure 88/89 or 92/93. (FW # 927).
2. M.T. per ESD-209.
3. Post weld heat treat the weld - ESD-218.
4. Perform a hydrotest on the weld prior to drilling into the pipe.
5. Following satisfactory completion of the hydrotest, cut the hole through the pipe wall with a hole saw (Ref. ESD-230) NOTE: Additional reinforcement of 2" opening is not required per P.G.&E. calculations
6. Using an extended shaft grinder with a cone shaped rock, grind the burn through flush with the pipe surface.
7. Radiograph the area to assure complete removal of unacceptable indications.
8. Install threaded plug and seal weld (F.W. #828).
