Report Issued: AUG 26 1977

Report 411-77.55

PACIFIC GAS AND ELECTRIC COMPANY  
DEPARTMENT OF ENGINEERING RESEARCH

FAILURE ANALYSIS OF CRACKED FIELD WELD NO. 212  
DIABLO CANYON UNIT 1, STEAM GENERATOR 1-2  
NOZZLE-TO-PIPE WELD

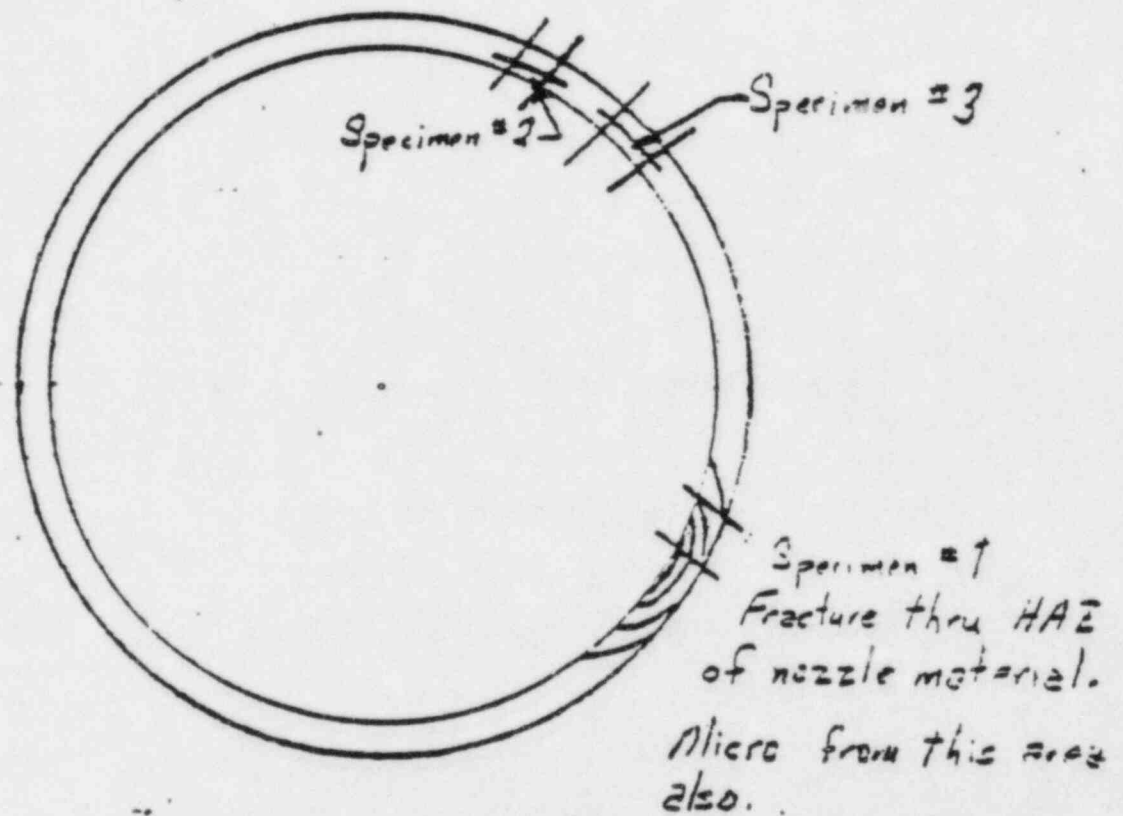
As a result of the above findings, a spool piece containing a major portion of the weld, a small section of the nozzle I.D. adjacent to the weld root, and several inches of pipe were removed for analysis. Figure 1 is a sketch of the spool piece received for analysis; included is the crack path and a sketch of the shape of the crack.

Figure 1. Schematic diagram of failed nozzle illustrating the locations from which samples were removed.

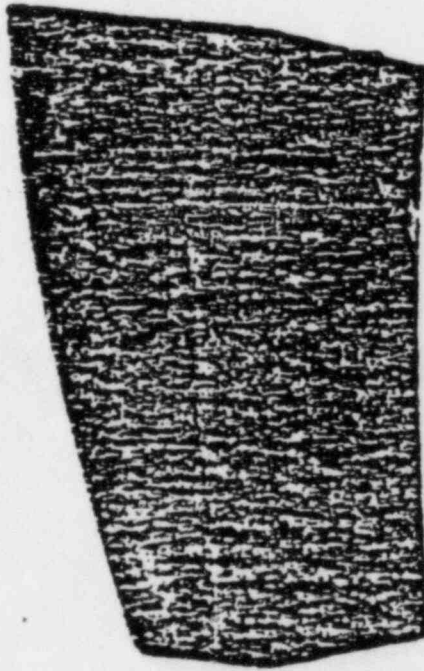
The surface of the main fracture was almost flat, originated along the edge of a weld bead, grew approximately perpendicular to the surface and contained markings that ran parallel to the original edge, Figures 2 and 3. These markings appeared to be "beachmarks" denoting positions of the crack during its growth. The fracture surface appeared to be oxidized and was dark in color near the origin edge. Using SEM, the main fracture surface was found to be oxidized, to exhibit some evidence of mechanical damage (rubbing) and, at a distance from the origin, to contain secondary cracks, Figure 4. The presence of the visual beachmarks and the secondary cracks indicate that cyclic loading had a role in the generation of the fracture.

Figure 3 Specimen #1, showing fracture surface with parallel markings originating along one side of weld bead; 3X.

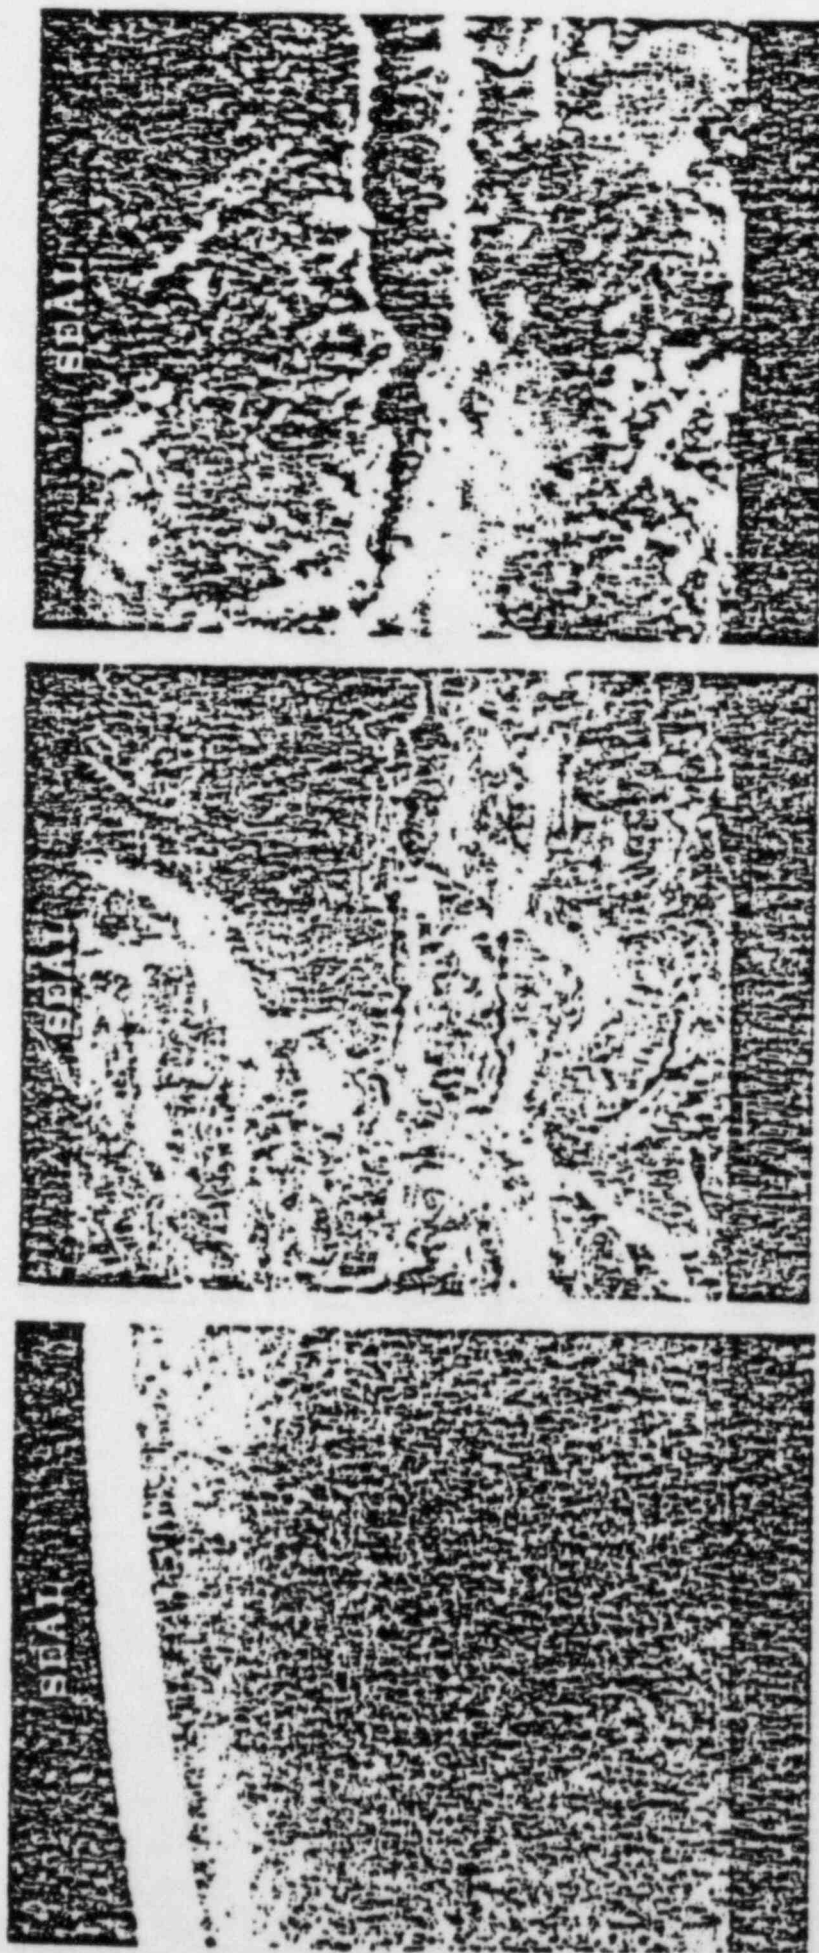
Figure 4. Surface of main fracture which was in the heat affected zone (HAZ) of the nozzle, Specimen #1, showing oxidized surface with crack branching. a. 20X (50595). b. 500X (50594). c. 2000X.

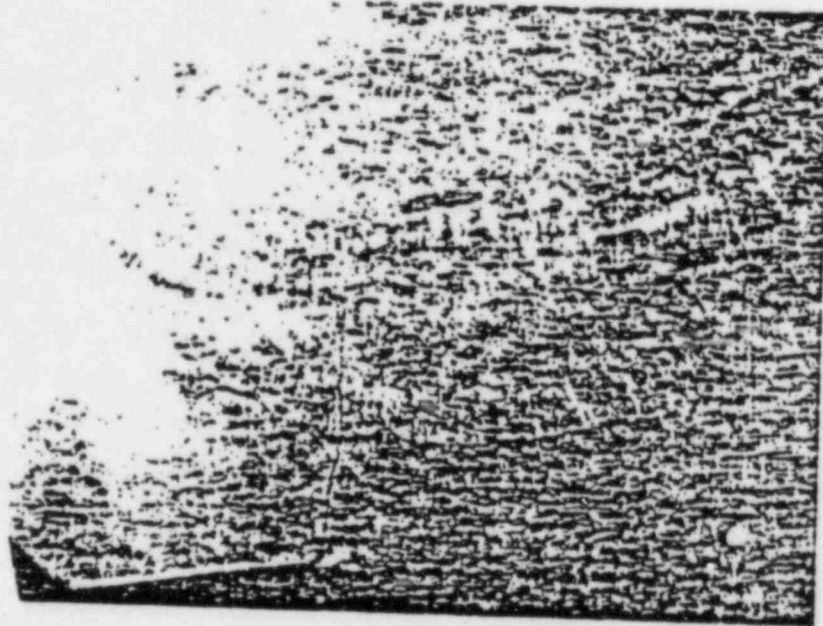
Examination of several polished cross-sections taken through the crack showed the fracture initiated in small regions of lack of fusion along the fusion zone and in small, up to 0.015-inch deep, cracks at the root of grinding scratches adjacent to the fusion zone on the nozzle side of the weld. The crack propagated through the heat-affected zone and then through the weld metal in the V-shaped section of the weld, Figure 5. The crack cross-section in the heat-affected zone was very flat and straight, indicating little ductility; once into the weld the crack tended to branch

Figure 5. Polished cross section of the main fracture. The pipe is on the bottom left, the weld root is bottom center and the nozzle is bottom right. The bottom of the picture is the pipe I.D. The small bright dots are micro hardness indentations. 7 x magnification.

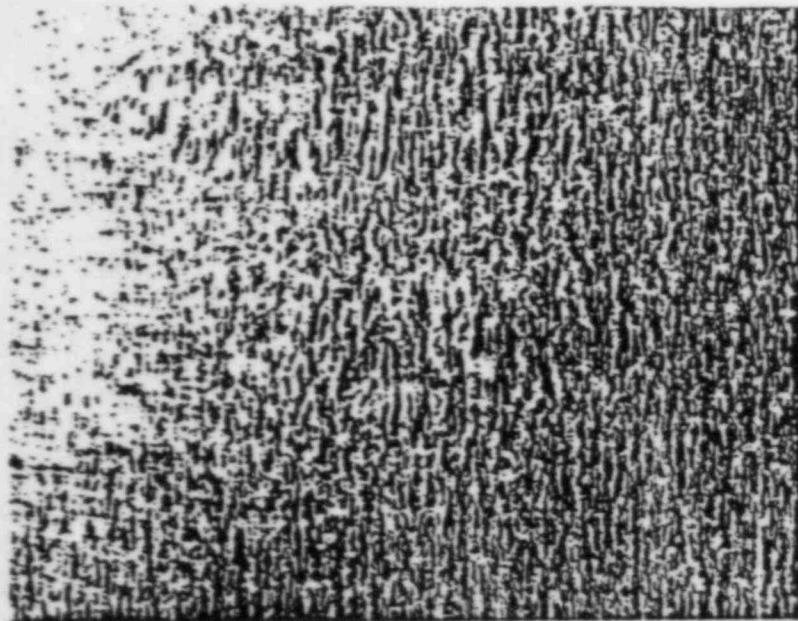
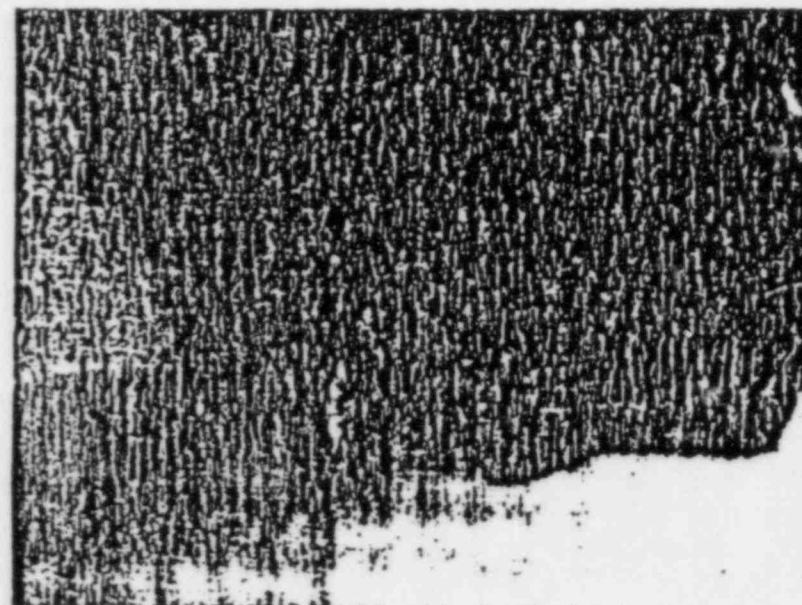
Examination of the small cracks adjacent to the main fracture, Figures 6, 7, and 8, illustrated that the cracks originate in slight depressions in the surface, grew perpendicular to the surface and at an oblique angle to the rolling direction (as revealed by the inclusion stringers), were filled with oxide, were transgranular, and exhibited some crack branching. No evidence of plastic deformation was observed. EDXA microprobes verified that the material in the cracks was probably oxide, that the base metal was carbon steel, and that the inclusion stringers were manganese sulfide, Figures 10-12.

Figure 6. Cross section of Specimen #3, Figure 1, which shows small secondary cracks similar to those noted adjacent to the main fracture. The tilted view shows the coincidence of the cracks with grinding marks on the pipe and nozzle I. D., as well as in the unground weld.

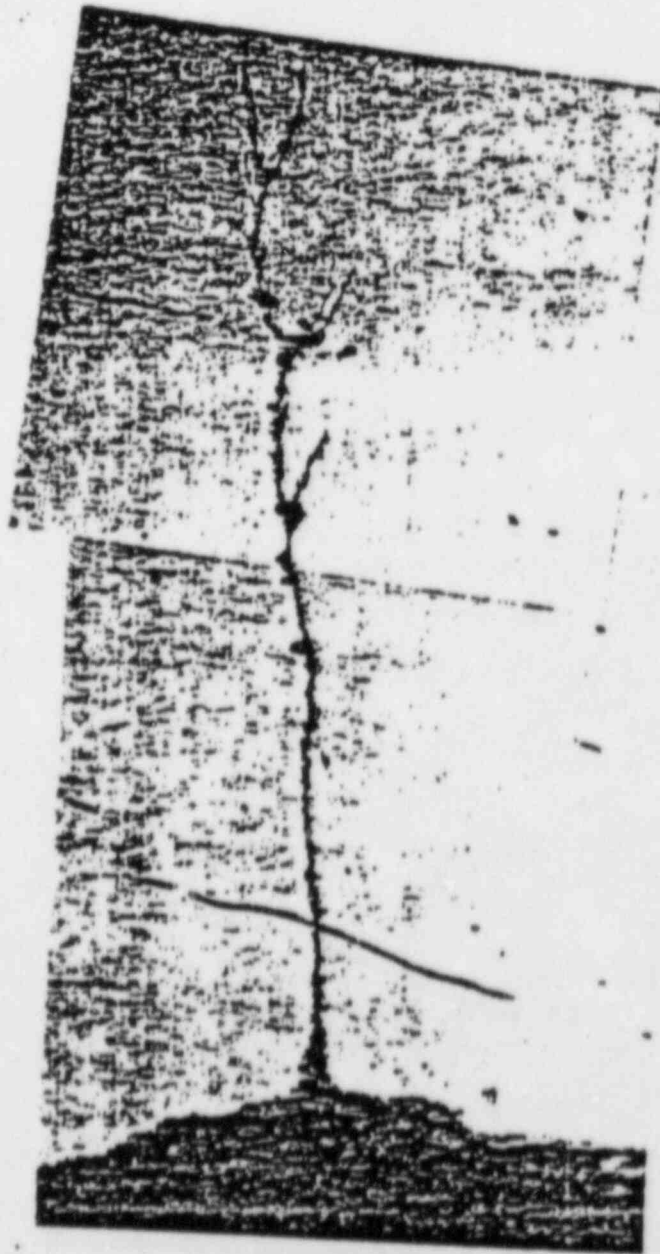
Figure 7. Polished cross section from main fracture area showing a crack, filled with oxide, with crack branching and sulfide inclusion stringers; 450X.

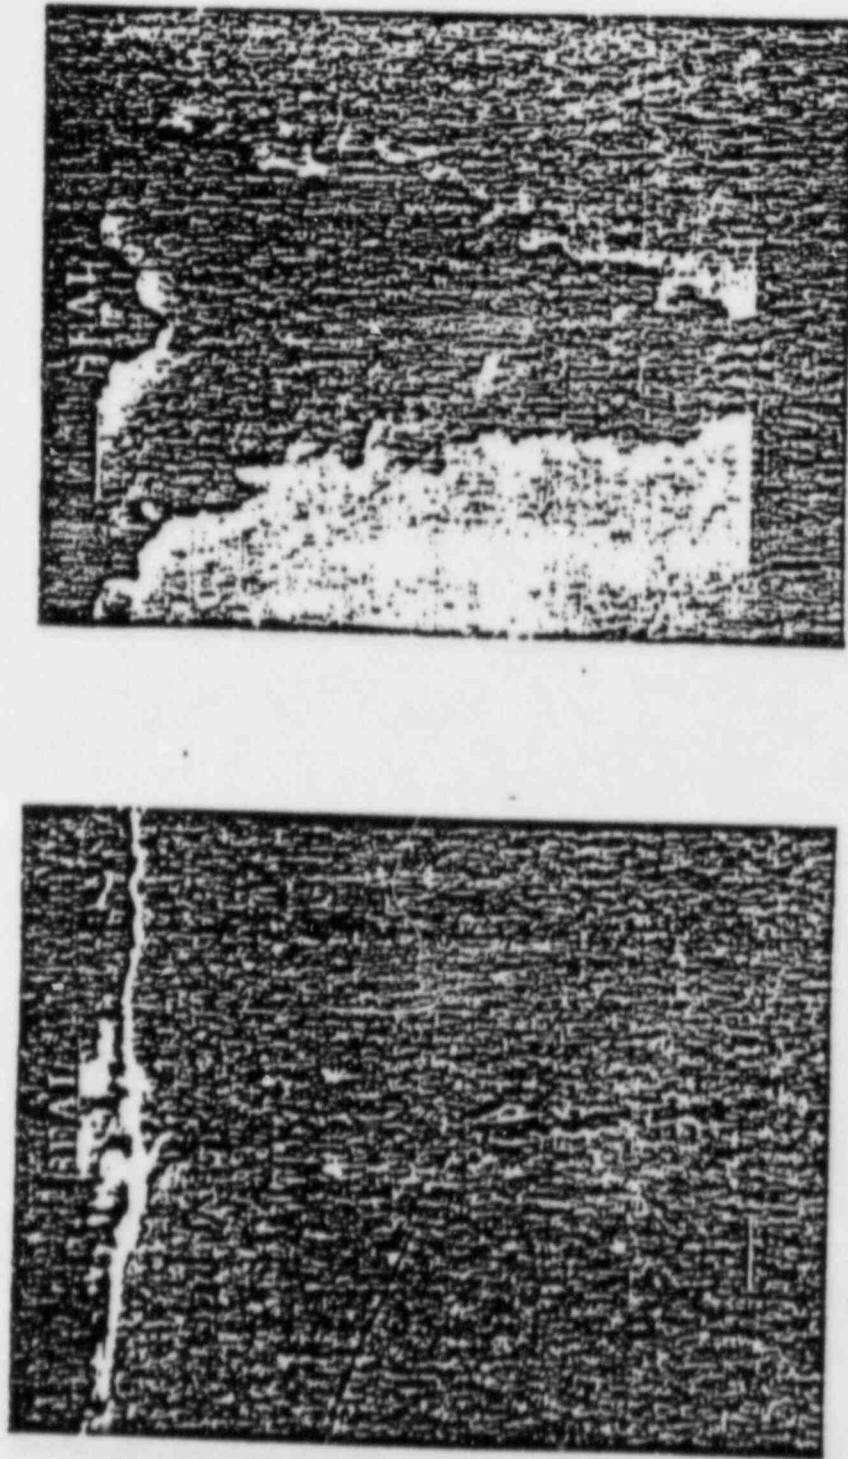
a. b.  
Figure 8. Details of polished cross section shown in Figure 7 a. 1000X.  
(51136). b. 5000X (51138).

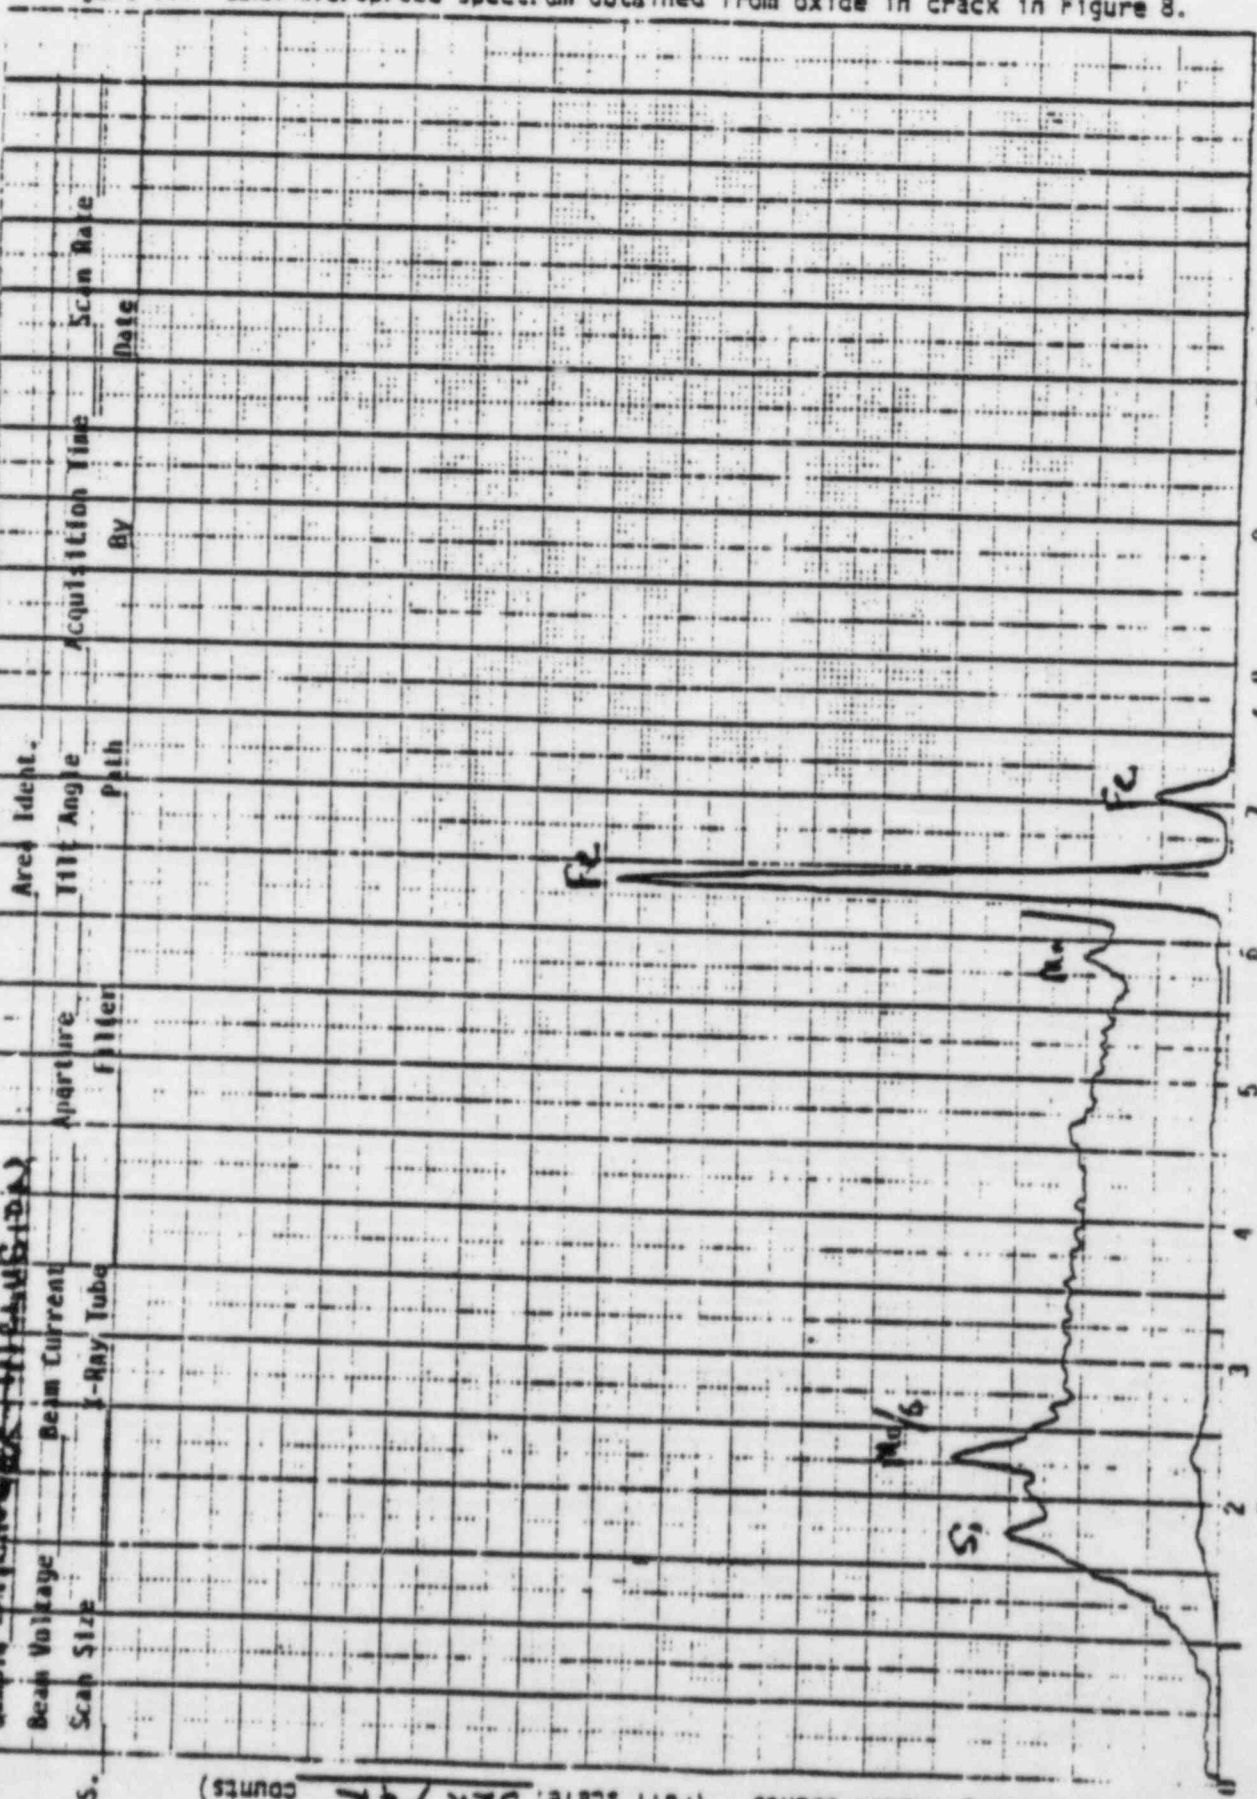
Figure 11. EDXA microprobe spectrum obtained from oxide in crack in Figure 8.

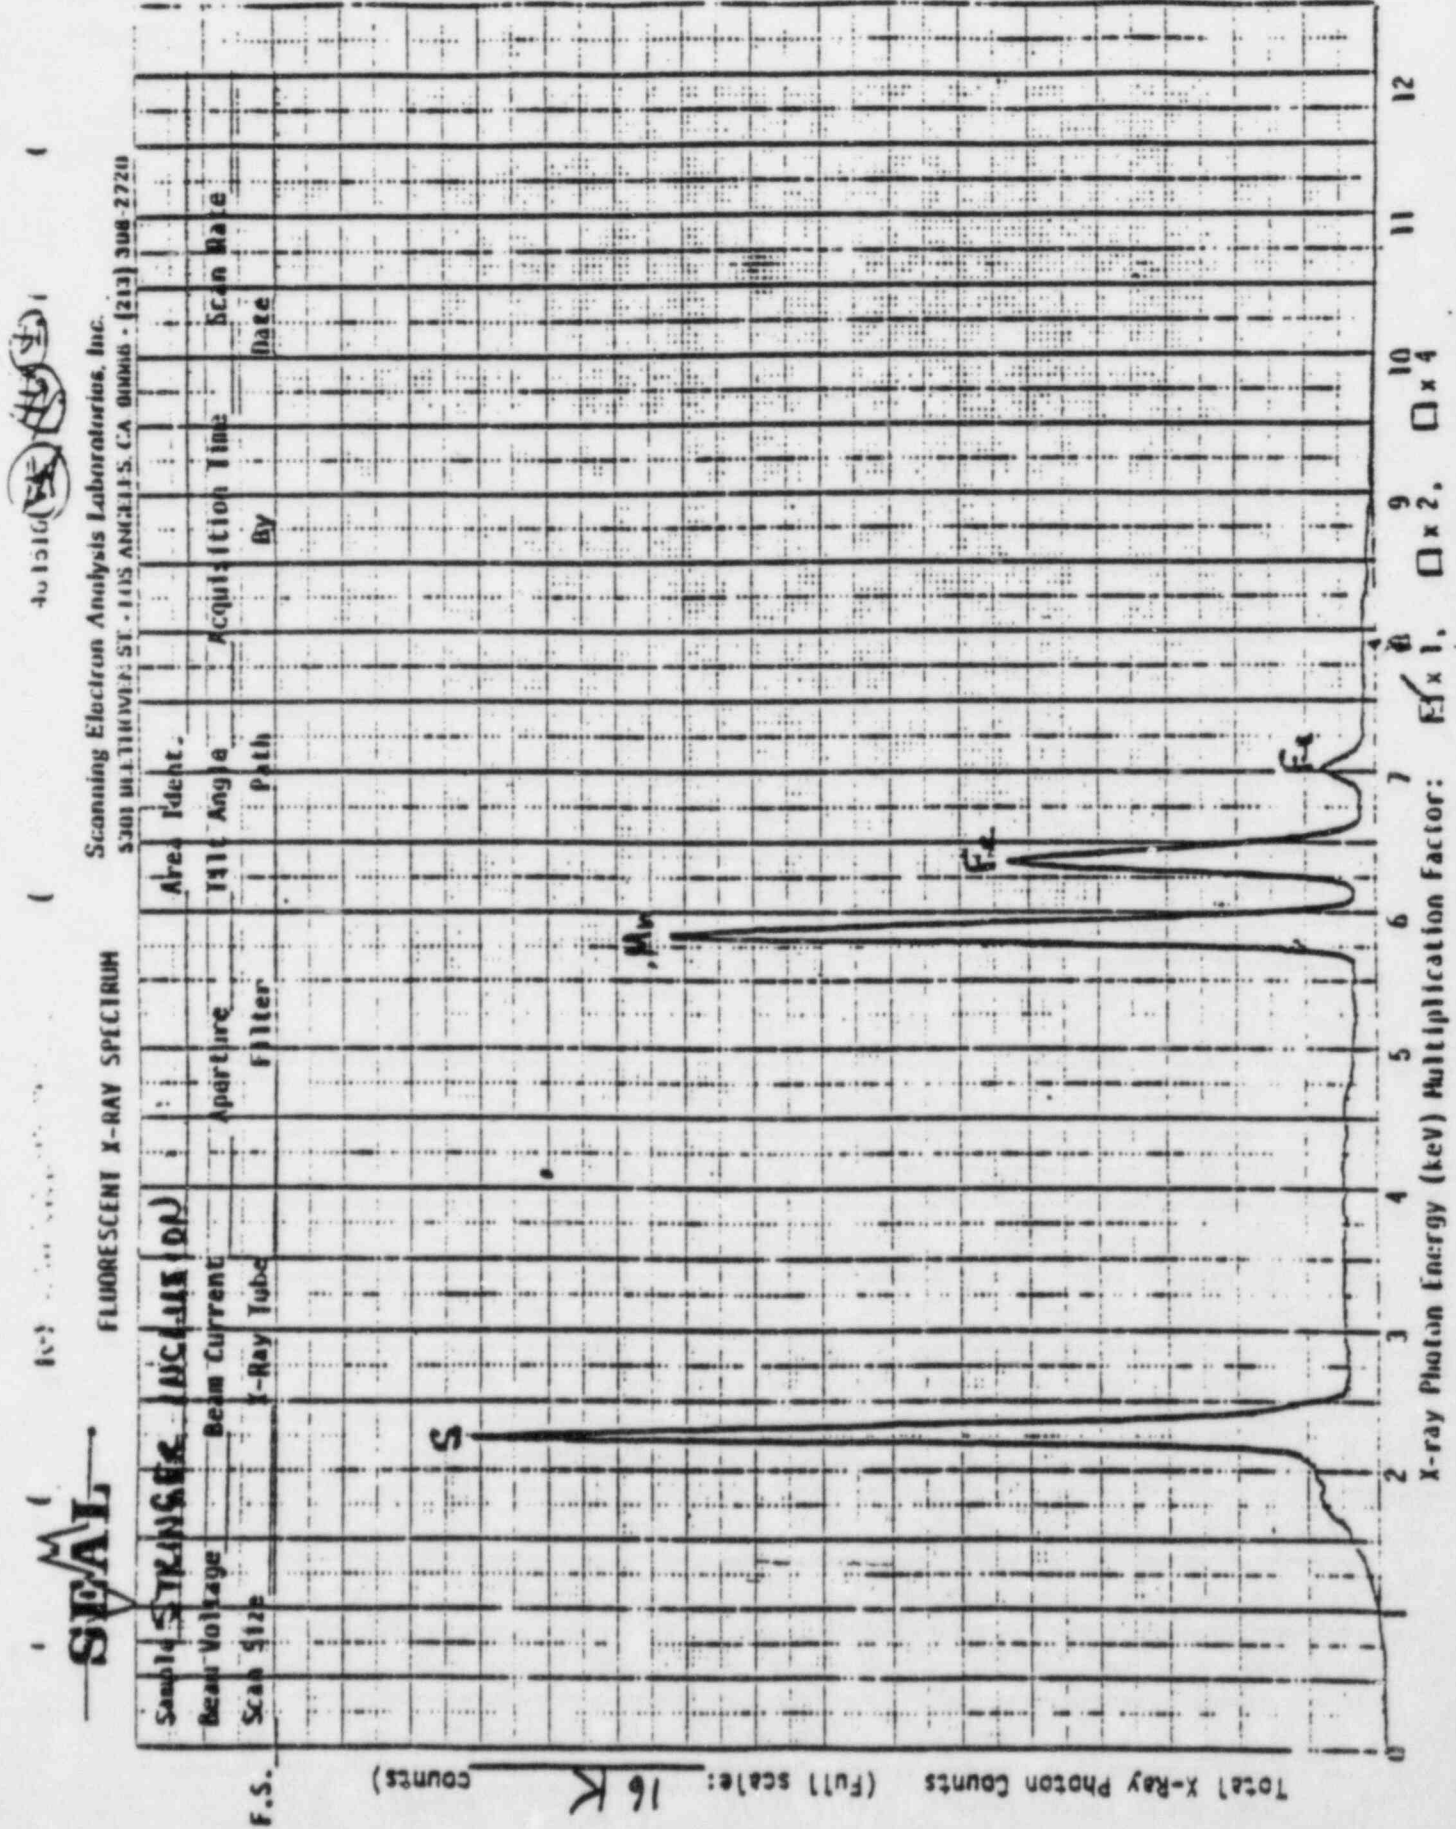
Figure 12 EDXA microprobe spectrum obtained from inclusion stringer Figure 8.
