Metallurgical Examination  
Cracked Field Weld No. 212  
Feed Water Pipe to Nozzle; Steam Generator 1-2.

Pacific Gas & Electric Co.  
Diablo Canyon Nuclear Project

Pullman Power Products Co.  
Williamsport, Pennsylvania

Date: 6/23/77

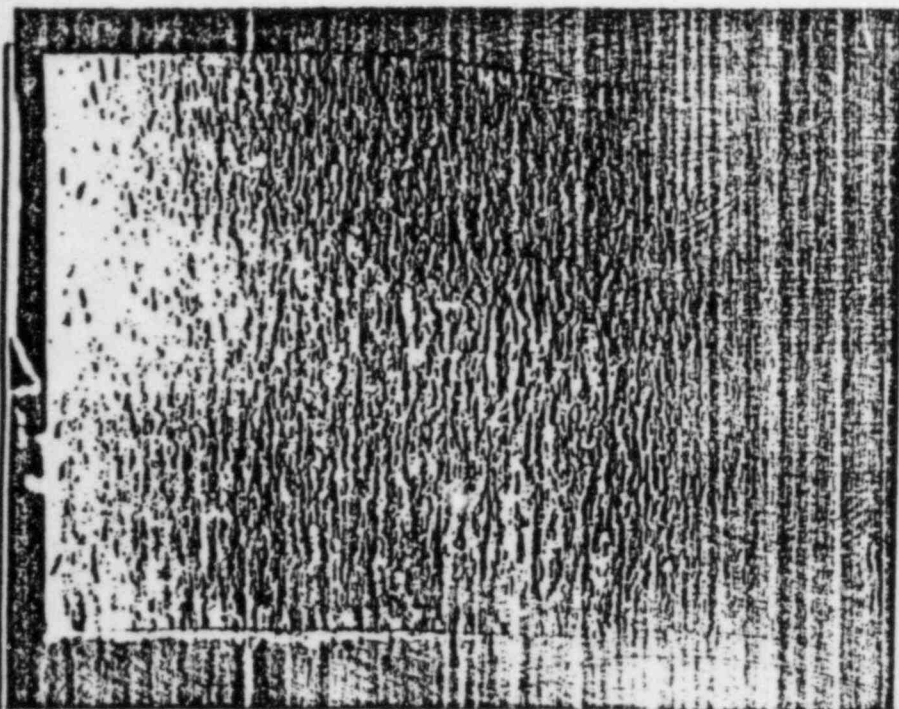
One represented by about 1/2 inch of the circumference contained the full depth, "front" face of the crack as viewed toward the pipe component. An enlarged photograph showing the "front" face is displayed in Fig. 1 Page 8. This surface had been fully protected from post atmosphere affects by the application of a lacquer. The coating was removed for photographing.

Noteable in Fig. 1, or the "front" face of the crack cross section is the distinct, variously "shaded" areas. There appears to be four in number as illustrated in the accompanying sketch.

Fractured or cracked areas showing these distinctions are typically associated with fatigue failures caused by the imposition of cyclic stress.

From this photograph the clear indication is that crack initiation took place in the root of the weld in the forged nozzle and ultimately propagated to failure through the weld deposit in at least 3 stages as shown in the sketch. (The cycling involved could have resulted either from multiple hydro-testing or from cyclic exposure during hot functional testing. These facts were not contained in the reported history cited above).

In the photograph of the fractured surfaces (Fig. 1) the first distinct area is the root of the weld joint. Close visual examination by macroscopic means showed sporadic small areas (light areas in the photograph) which were relatively bright or "shined".

Crack "Front" Face; Viewed Toward  
Pipe Component.

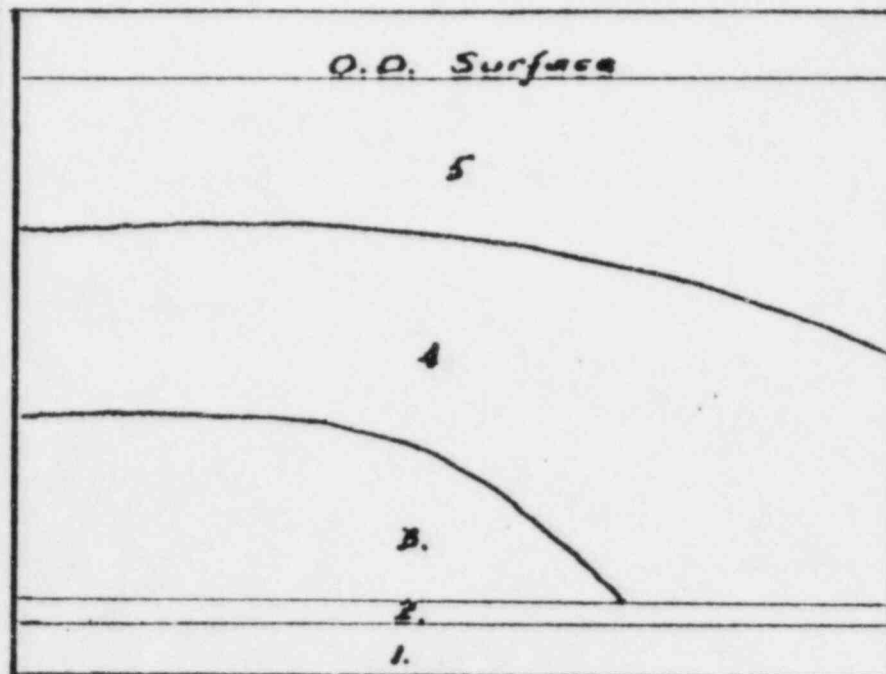
1. K-insert, weld reinforcement.
2. Remanent weld bevel land; probable crack initiation region. Refer to photomicrograph, Fig. 2.
3. 2nd-crack stage.
4. 3rd-crack stage.
5. Final stage, thru wall penetration.

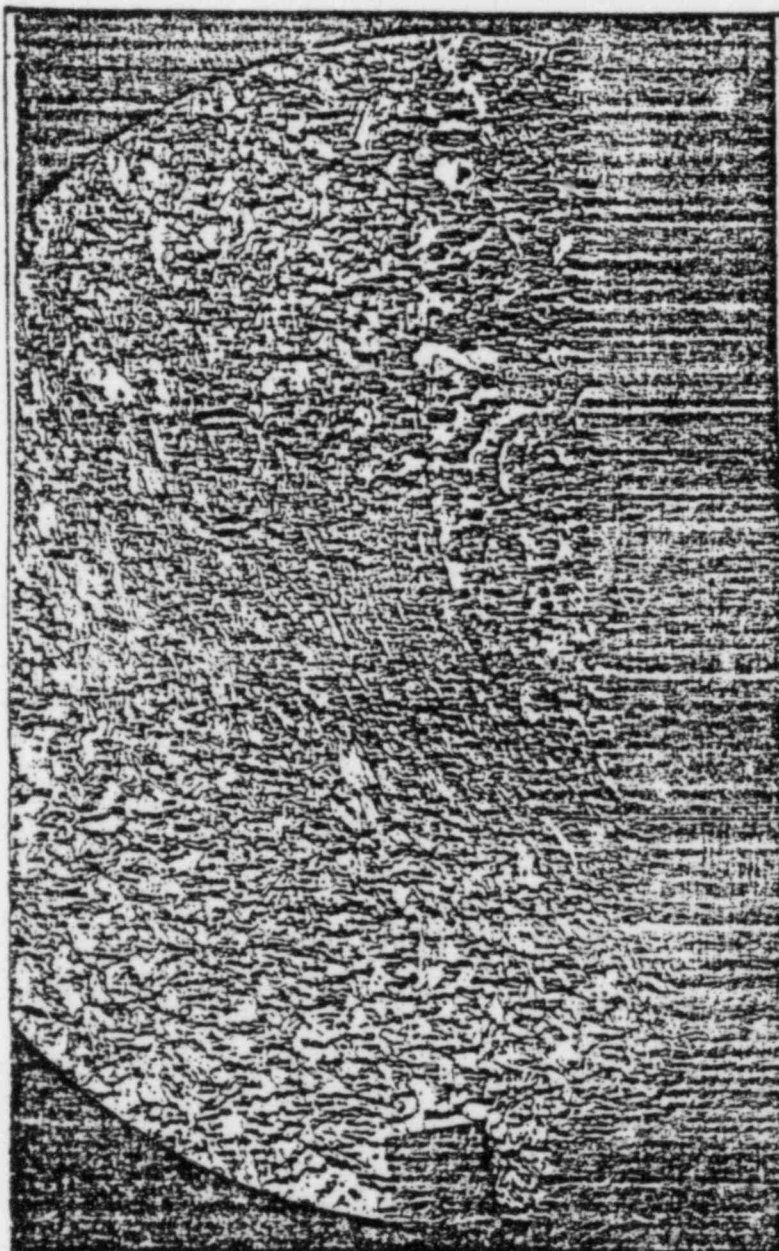
Photomicrograph  
Crack Evidence in Initial Weld Bevel Land

Fig. 2 is a photomicrograph of the metallic structure which was found to exist in one of these areas. The indication is that these are associated with remanent, weld bevel "land" material of the forged nozzle component. The suggestion is that, crack initiation stemmed from this locus; also that the initiating defects were localized, incipient root cracks through the land area.

What is not clear from this examination is the cause for the defects. In the history of the field fabrication of this particular weld (cited above) the fact that repetitive preheating and cooling was permitted to take place on four separate occasions before the weld was completed, could be one factor. Thereby inordinately high thermal stresses could have resulted in incipient cracks.

1. The crack failure in the FW212 resulted from crack like defects which apparently existed in the weld bevel land.
2. The cause for the crack defects is not clear. They are believed, however, to have resulted from the welding process and probably portend the affects of repetitive preheats and cooling applied before welding was completed. Imposition of high thermal stress, especially in the early stages of welding, is a plausible explanation.

- A. Remanent weld  
bevel land in  
forged nozzle.
- B. K-insert, weld  
I.D. Reinforce-  
ment.

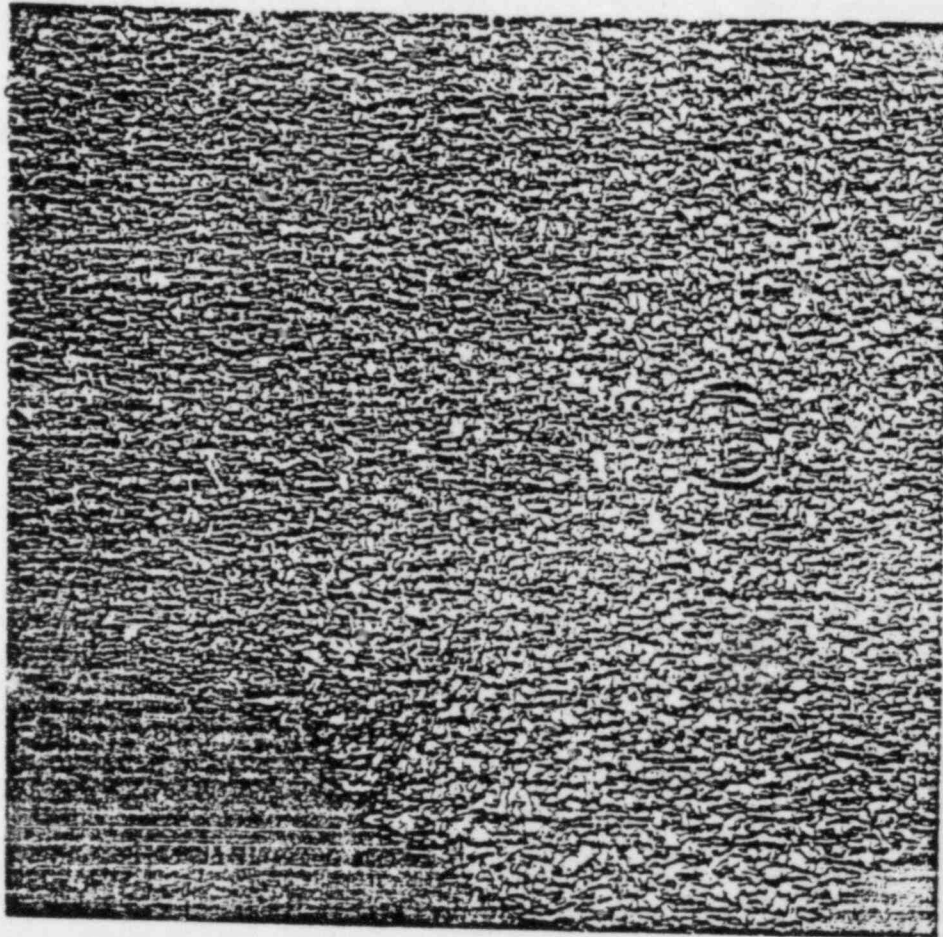
Fig. 3 or the photomicrograph of the uncracked weld joint (localized at the root weld in nozzle forging) shows the normally expected microstructure; good penetration; and no evidence for lack of fusion or cracking. Certain evidence of small cracks are shown to exist in the I.D. surface of the forging. But there is no reason to believe these or like defects could have contributed to ultimate failure, once the weld was completed and stress relieved.

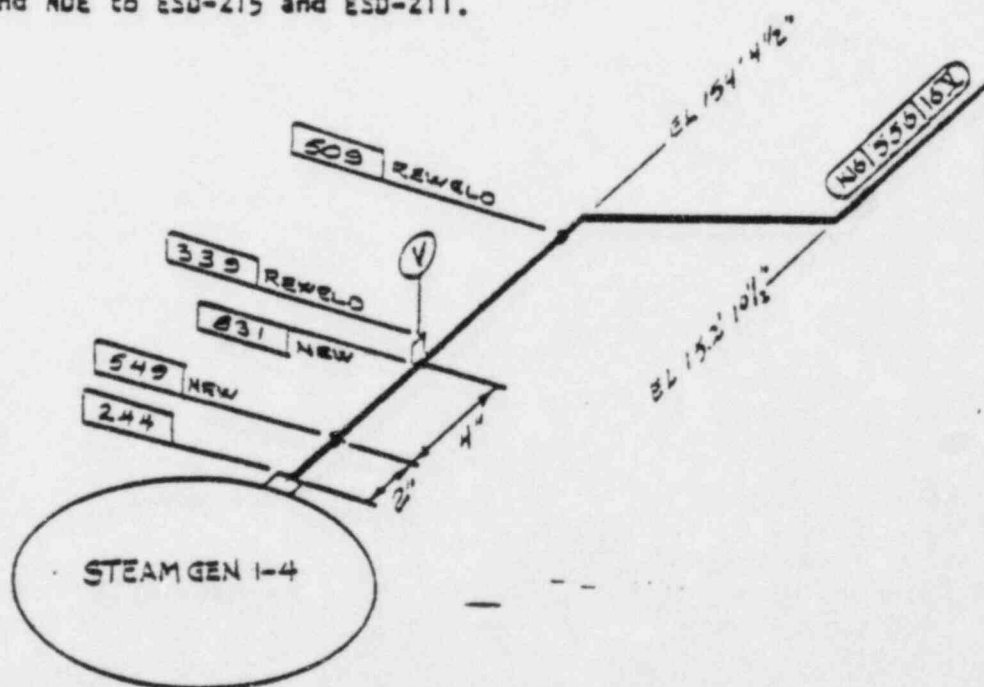
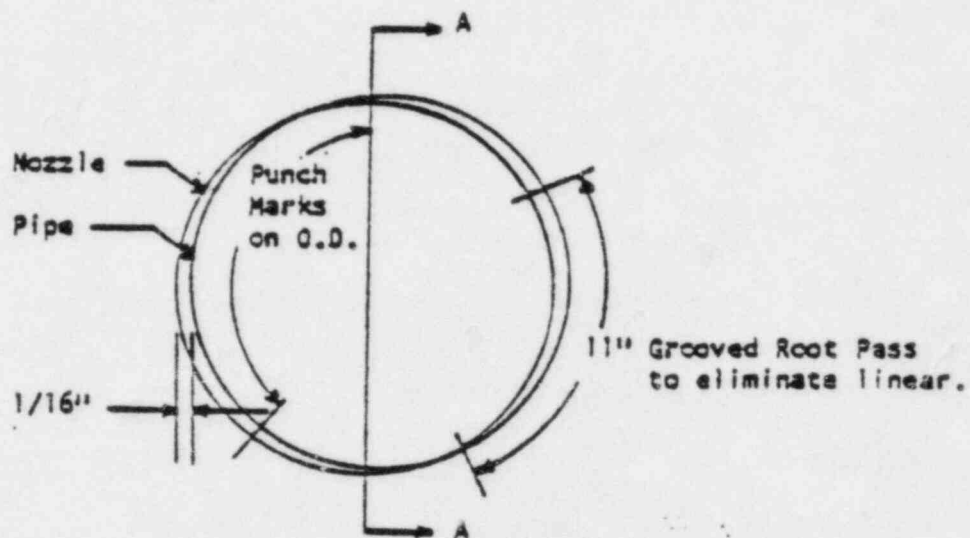
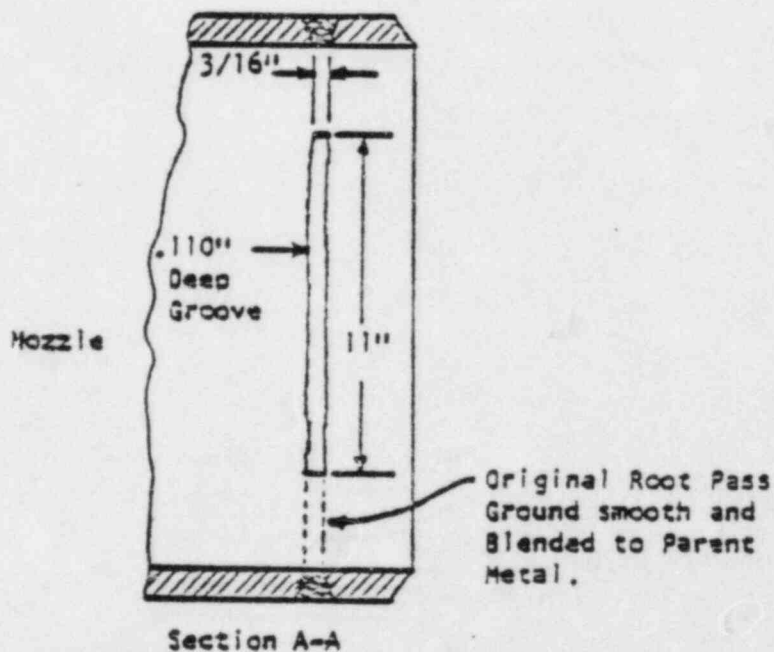
Findings at F.W. 244

NOTE: Average Wall Thickness = .580" to .600"  
Remaining Wall At Groove = .450"  
Punch Marks On The O.D. = .047" Deep  
(Punch Marks are directly on the fusion line of F.W. 244 to  $1/8''$  inside the fusion line .047" deep.)

We recommend that the root pass be ground and polished to blend with base metal surfaces. Particular care should be taken to avoid the removal of base material. Then re-examine the I.D. with liquid penetrant, if acceptable, proceed to "Recommended Disposition", Step 7 of D.R. 3453, Revision 1.

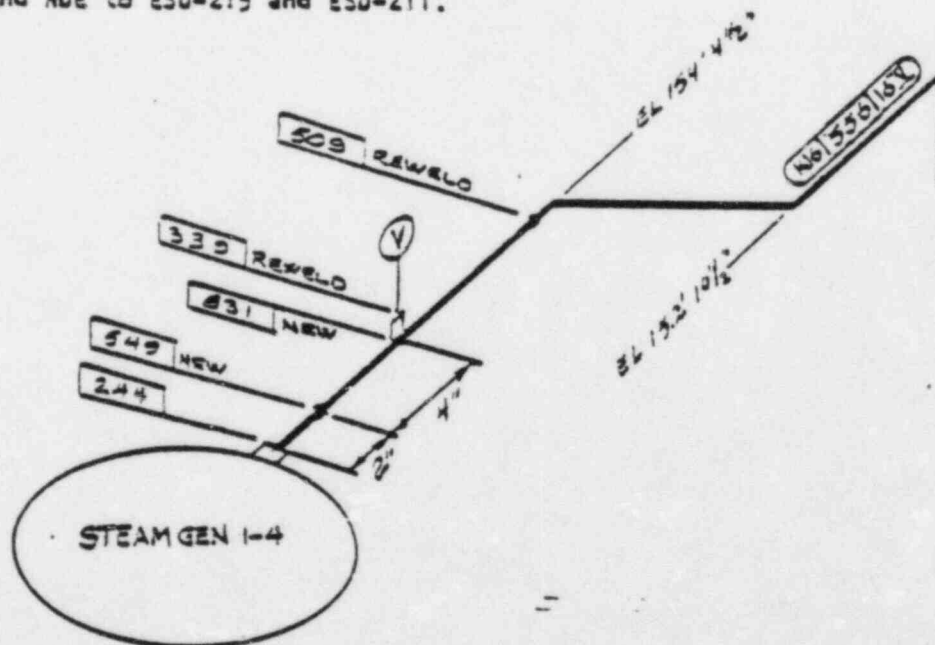
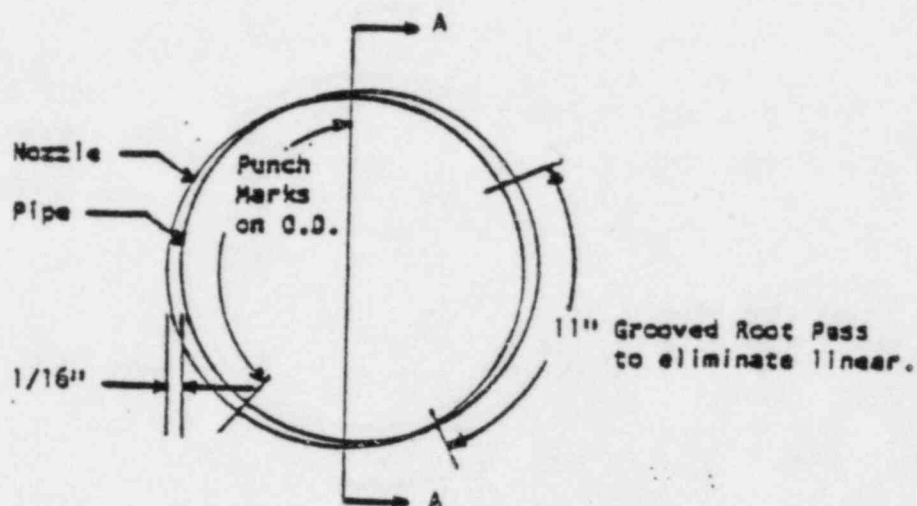
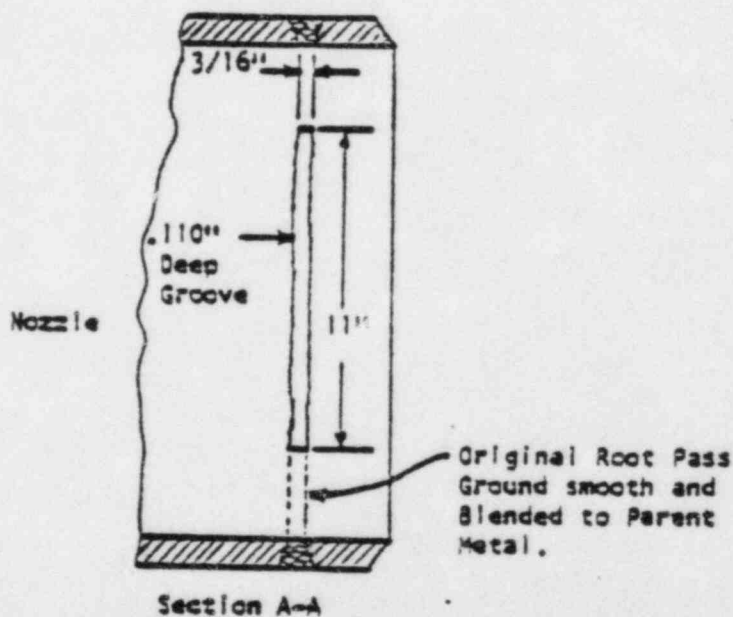
Findings at F.W. 244

NOTE: Average Wall Thickness = .580" to .600"  
Remaining Wall At Groove = .450"  
Punch Marks On The O.D. = .047" Deep  
(Punch Marks are directly on the fusion line of F.W. 244 to  $1/8''$  inside the fusion line .047" deep.)

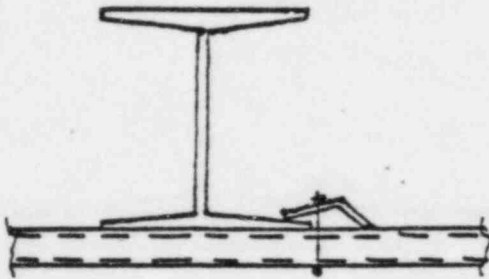
Correct. Notice Line contact at toe and heel of plate. When bolt is tongued properly, clamp should not be easily displaced.

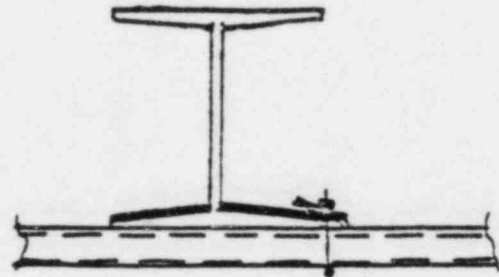
Incorrect. Line contact but not at toe. When tongued, this tends to slip off the steel marker.

In both the examples above, the plate is "cockeyed." One is correct, and if installed correctly, should not be easily moved. On the other hand, the incorrect installation could slip easily. This fact can be checked by consulting engineering manuals from either Unistrut, Superstrut, or other brand names.
