Catawba - RN System Corrosion in Stainless Steel Welds

Metallurgical Analysis Report

Metallurgical Analysis Report #1812

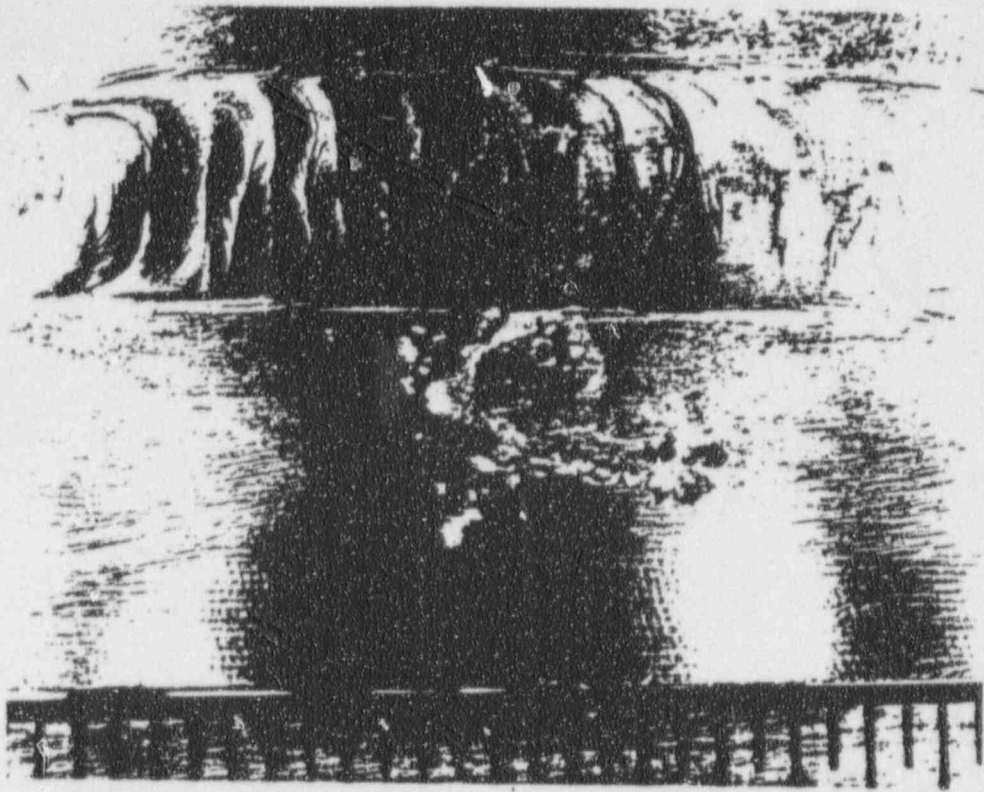
- One sample had a distinct pinhole on the OD, 1/16" from the weld toe (Figure 1). Smaller pinholes were nearby, indicating the pit had tunnelled. The pit site was covered by a tubercle on the ID, which was sampled for bacteriology. Circular traces up to 3/4" diameter indicated where two other tubercles had been located; pitting was visible at one site. Those two tubercles formed ~3" away on either side of the leak, on the same side of the weld.

Figure 1 OD appearance of a butt weld leak showing pinholes near toe of weld. One butt weld leaker showed a crack on the OD rather than a pinhole. Gauge = 1/16". Ma-3327.

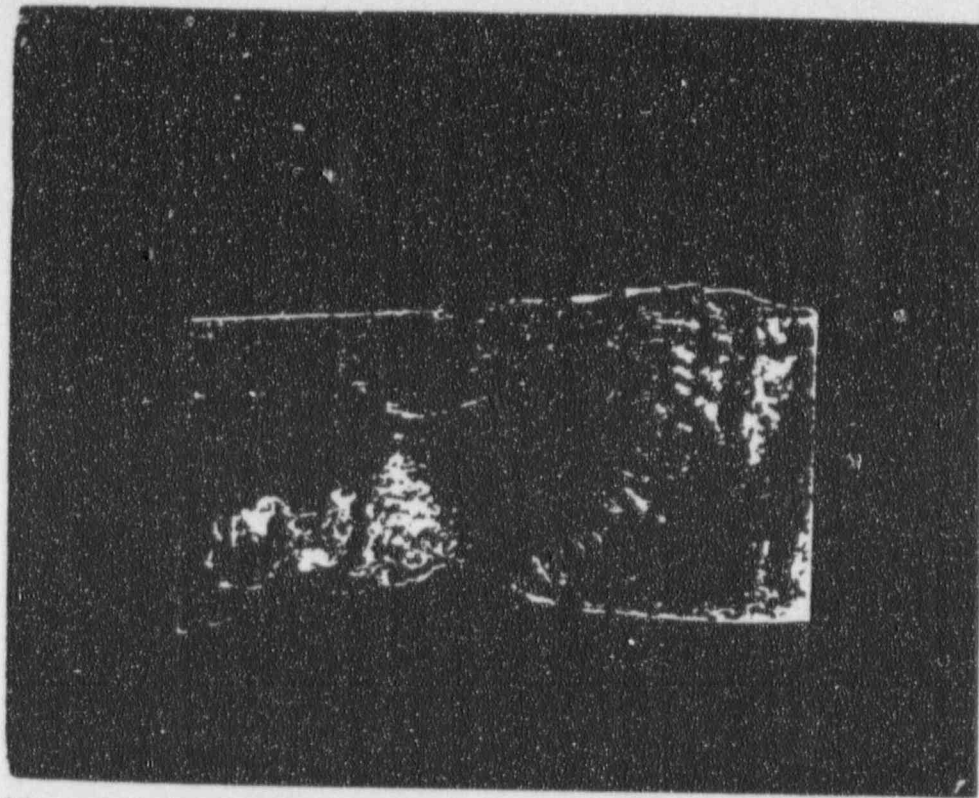
The samples containing one and three tubercles/traces showed cavernous subsurface pits at the leak sites (Figures 3-4). The pits had pinhole ID penetrations. One tunnelled to the OD; the other progressed about halfway through-wall, at which point transgranular cracking became the propagation mode (Figures 5-6). A non-leaking tubercle site revealed a small round cavernous pit 1/16" deep.

The ID openings were 3/16" to 3/8" from the ID toe of the weld. The massive pit in Figure 3 covered ~1/4" axially and was probably similar in circumferential length. The opening of the pit/crack was in straw-tinted oxide on the far side of the blue tint band.

Figure 3 Mounted/etched cross-section through pit in Figure 1 showing cavernous subsurface pits. Pits began at ID (top) and tunnelled toward OD. Pinhole ID and OD penetrations. (5X) Ma-3342.

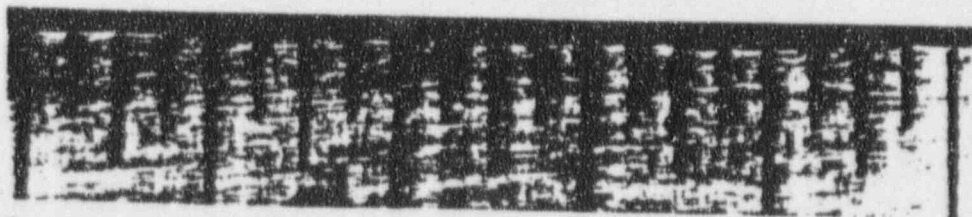
The crack network below the pit shown in Figure 4 was bent apart to reveal the crack surfaces. No chloride was detected; some sulfur-containing material was found near the crack tips. The interior surface of the cavity had a faceted appearance.

Figure 4 Cross-section (as saw-cut) through butt weld HAZ where tubercle trace appeared. Leak was located at this site but pit penetrates only halfway through wall. Gauge = 1/16". Ma-3341.

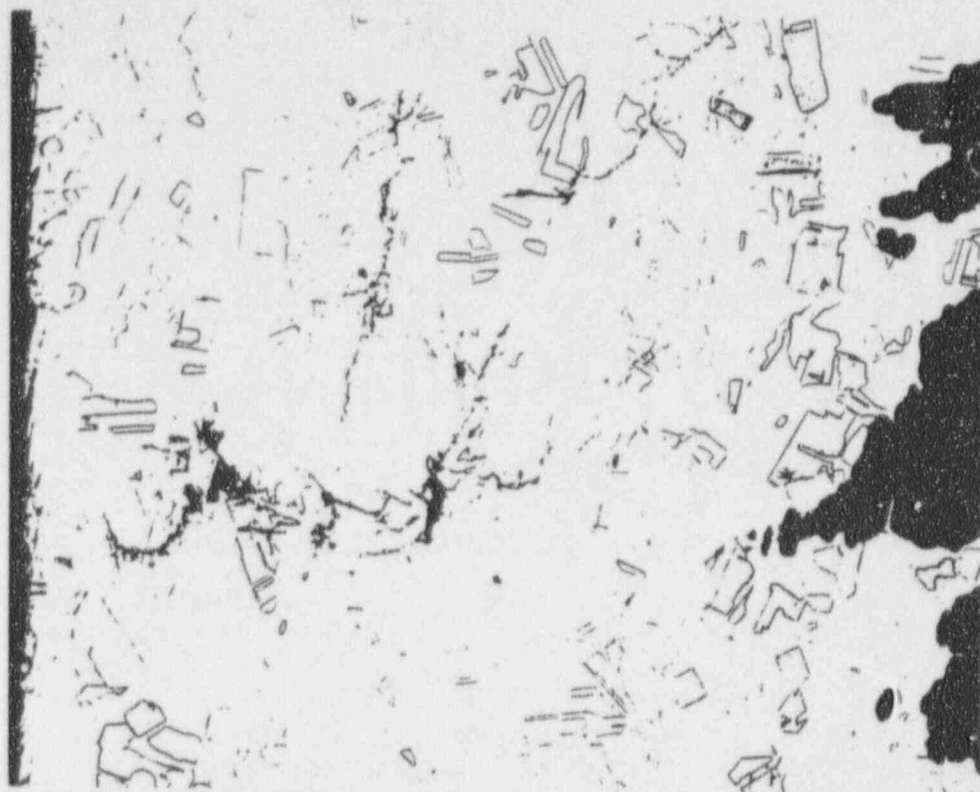
Figure 5 Detail of pit in Figure 4 after metallographic preparation. Crack network is visible between irregular bottom of pit and OD wall. Cracks are branching and transgranular. (32X) Oxalic acid. Mi-3319.

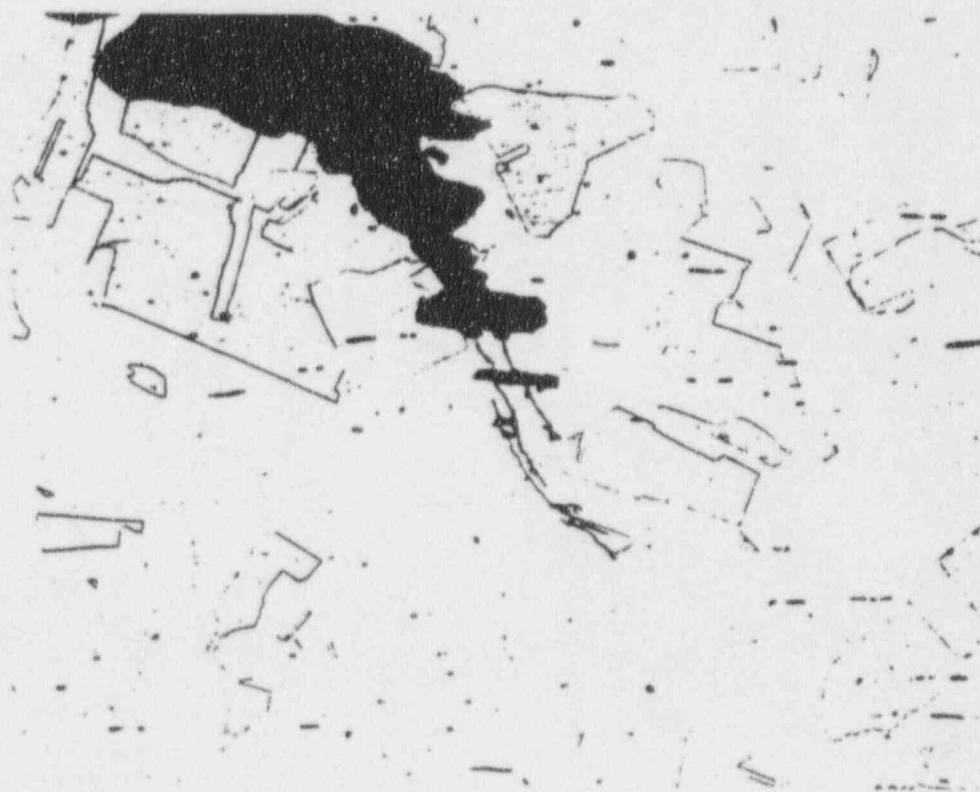
Figure 6 Detail of one arm of pit in Figure 5 showing cracks growing directly from the pit itself. Cracks are the same as those in the large network shown above. (100X) Oxalic acid. Mi-3321.

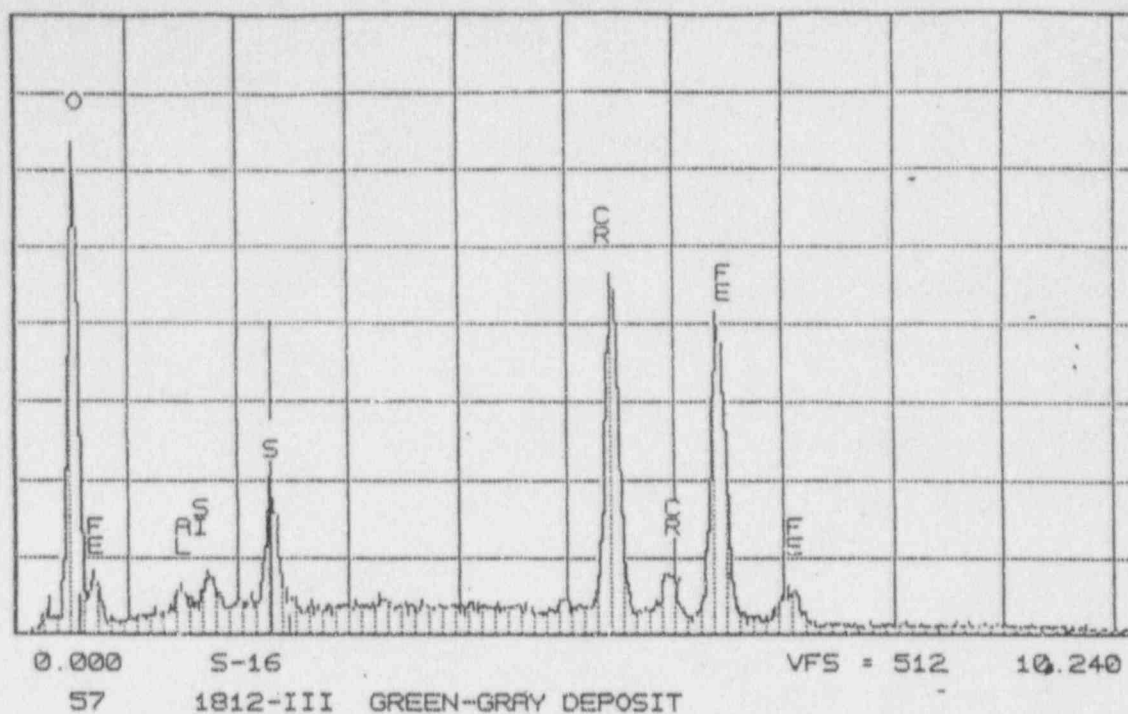
The composition of a removed tubercle and the deposit at a tubercle trace were checked qualitatively using EDS (energy-dispersive spectroscopy). The tubercle was lightweight, frail, and full of hollow areas. Sulfur was identified in both the tubercle and trace, along with metal oxides and sediment (Figure 7). The sulfur was most readily detectible in the green-gray portion of the tubercle.

Figure 7 Typical EDS spectrum produced by greenish-gray material at center of tubercle. A distinct sulfur peak is present along with sediment and metal oxides.

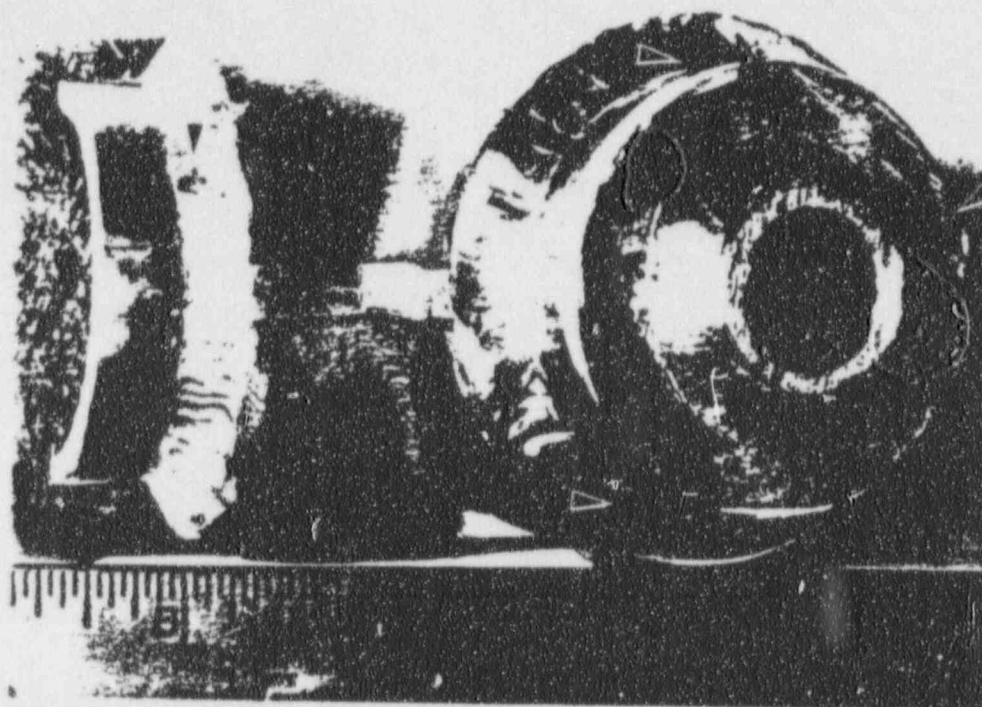
Typical leaks are shown in Figure 8 - occurring near the center of the bead and leaving a rusty streak on the OD. Figure 9 shows three leaks in 442-25 spaced ~120° apart and the neighboring leak in 442-23.

Figure 9 Section of tee showing leak on underside of 2RN442-23 (left) and 3 leaks on 2RN442-25 (one hidden) which attached the reducing insert. Ma-3351.

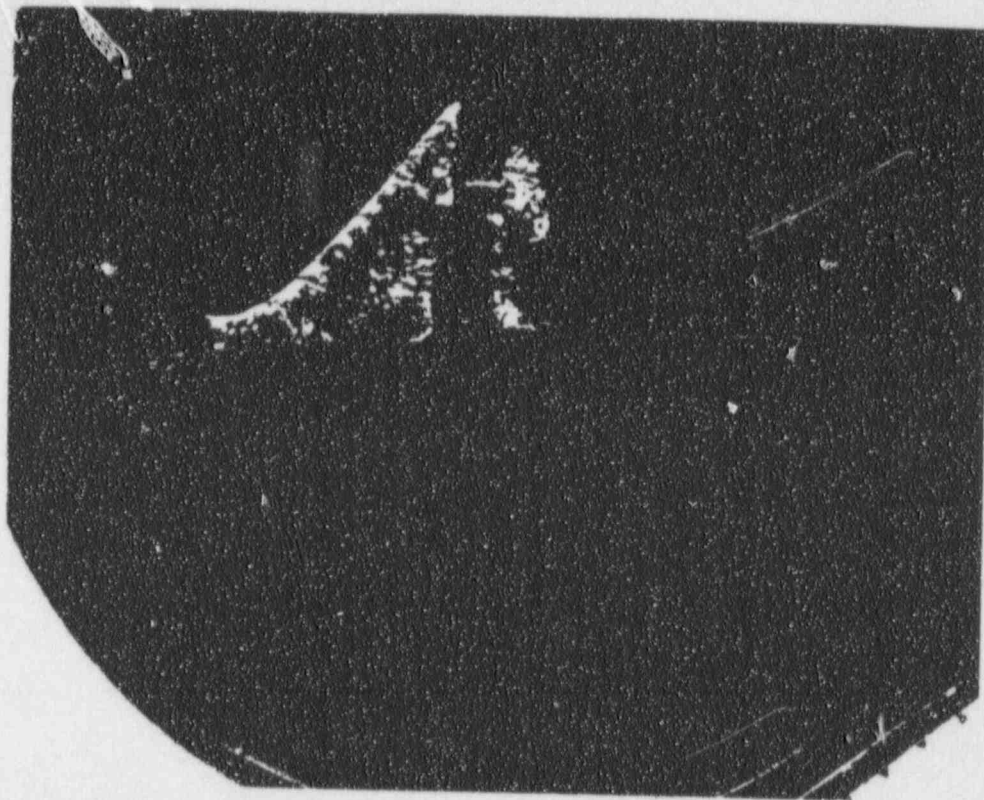
The one atypical leak occurred in 2RN442-15, where pitting took an intergranular path through the forging (Figure 13). The weld root was sound and was unattacked. A tunnelling pit extended from the intergranular attack to the weld, and subsequently corroded by the same preferential attack seen in most socket welds (Figure 14). A thin network of grain-boundary carbides was seen around the pit in the forging, indicating sensitization. The pipe had larger but discontinuous carbides and a much smaller grain size than the forging.

Figure 13 Cross-section through 2RN442-15 showing pitting attack through elbow; weld root is unattacked. "Finger" from pit connects to weld metal at $\sim 2/3$ through-wall; see detail below. (3X) Oxalic acid. Ma-3353.
