Florida Power

CORPORATION
Crystal River Unit 3
Docket No. 95-302

Subject: Licensee Event Report (LER) 95-006-00

FACILITY NAME (1) CRYSTAL RIVER UNIT 3 (CR-3)										DOCKET NUMBER (2) 0 5 0 0 0 3 0 2					PAGE (3) 1 OF 0 6									
TITLE (4) General Knowledge Deficiency Causes Level Instrumentation To Be Subjected To Low Temperatures Resulting in Challenge To Design Basis																								
EVENT DATE (5)			LER NUMBER (8)				REPORT DATE (7)			OTHER FACILITIES INVOLVED (6)														
MONTH	DAY	YEAR	YEAR	SEQUENTIAL NUMBER	REVISION NUMBER	MONTH	DAY	YEAR	FACILITY NAMES N/A				DOCKET NUMBER(S) 0 5 0 0 0											
0	4	1	7	9	5	9	5	0	0	6	0	0	0	5	1	7	9	5	N/A	0	5	0	0	0
OPERATING MODE (9)		1		THIS REPORT IS SUBMITTED PURSUANT TO THE REQUIREMENTS OF 10 CFR §: (CHECK ONE OR MORE OF THE FOLLOWING) (11)																				
POWER LEVEL (10)		1 0 0		20.402(b)				20.405(c)				50.73(a)(2)(iv)				73.71(b)

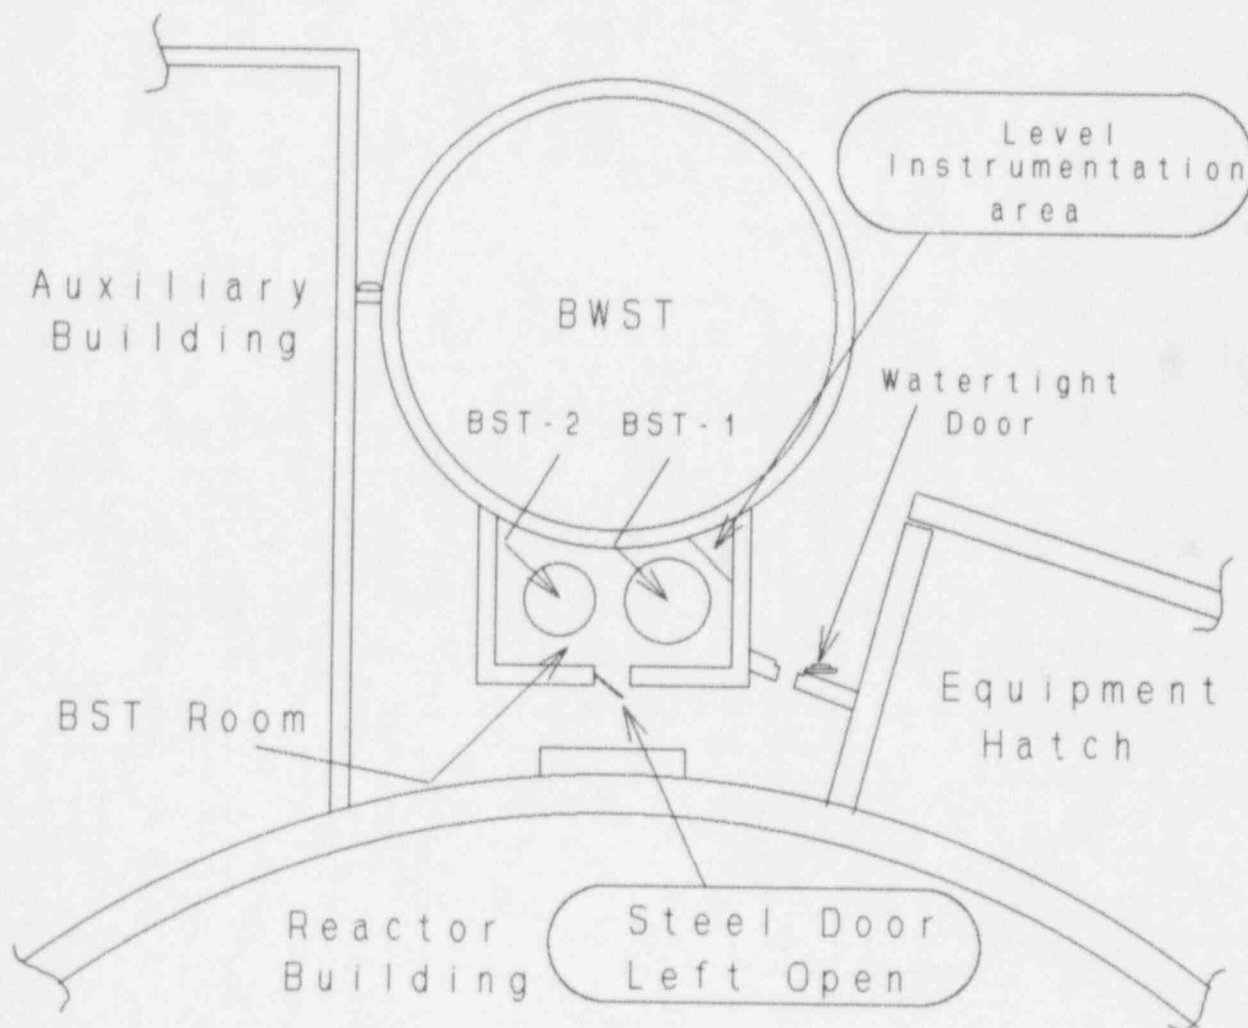
FIGURE 1

FPC Engineering personnel determined that during a period between January 31, 1995 and February 17, 1995, the steel entrance door to the BST room was left open (see Figure 1). The BST tank room contains two currently unused tanks (BST-1 and BST-2), and various tank level instrumentation components, including those of the Borated Water Storage Tank [BP,TK] (BWST). The 420,000 gallon BWST is adjacent to the BST tank room.

The cause of this event was a general knowledge deficiency in that FPC personnel were not aware of the requirement to keep the BST room door closed to ensure that the temperature would be maintained within the error calculation limits.

The entrance door to the BST room was verified to be closed and a Problem Report was generated.

Signs will be posted on the entrance door to the BST room to remind personnel that the door must be closed when exiting the area.
