LOUISIANA
POWER & LIGHT

SUBJECT: Waterford 3 Steam Electric Station
Docket No. 50-382
Construction Adequacy of WSES-3 Basemat

1. a) How many nonconformance reports were issued on the basemat? b) How many relate to poor concrete placement practices? c) What were corrective actions taken? d) Provide justification to substantiate your position that these practices could not have lead to the development of cracks or localized porous zones which may be the cause of water intrusion.

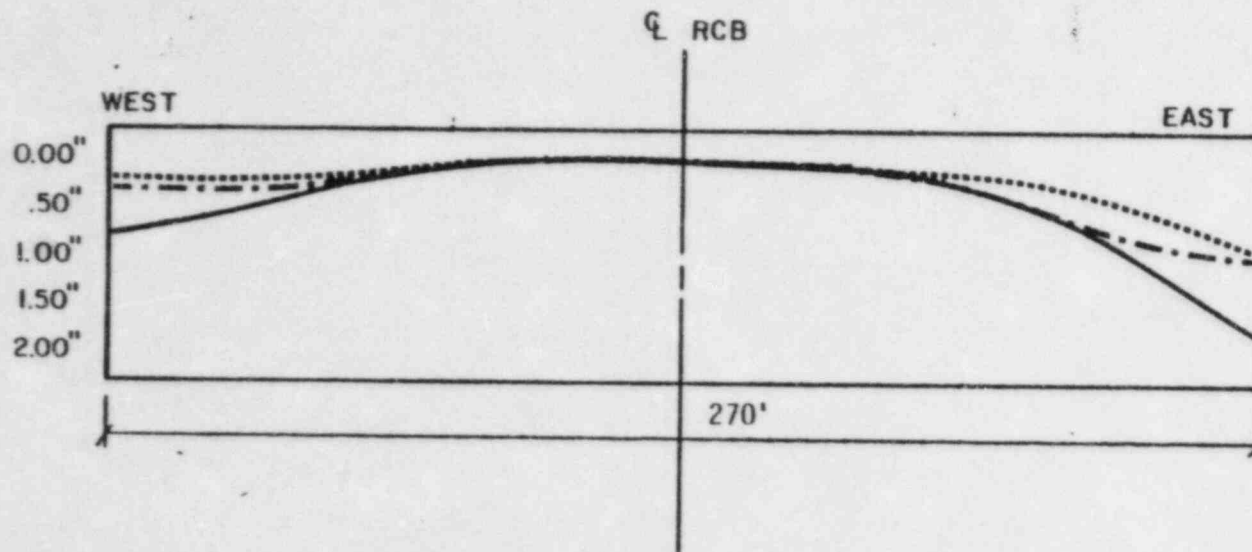
Attached is a graph (Figure ES-3) reflecting the contours obtained from the maps generated on April 22, 1977, November 10, 1977, and October 9, 1979. These curves reflect a before mat (ring wall) loading, after ring wall placement and a majority of concrete construction complete. These contours do reflect a convex mat with maximum differential of two inches (2").

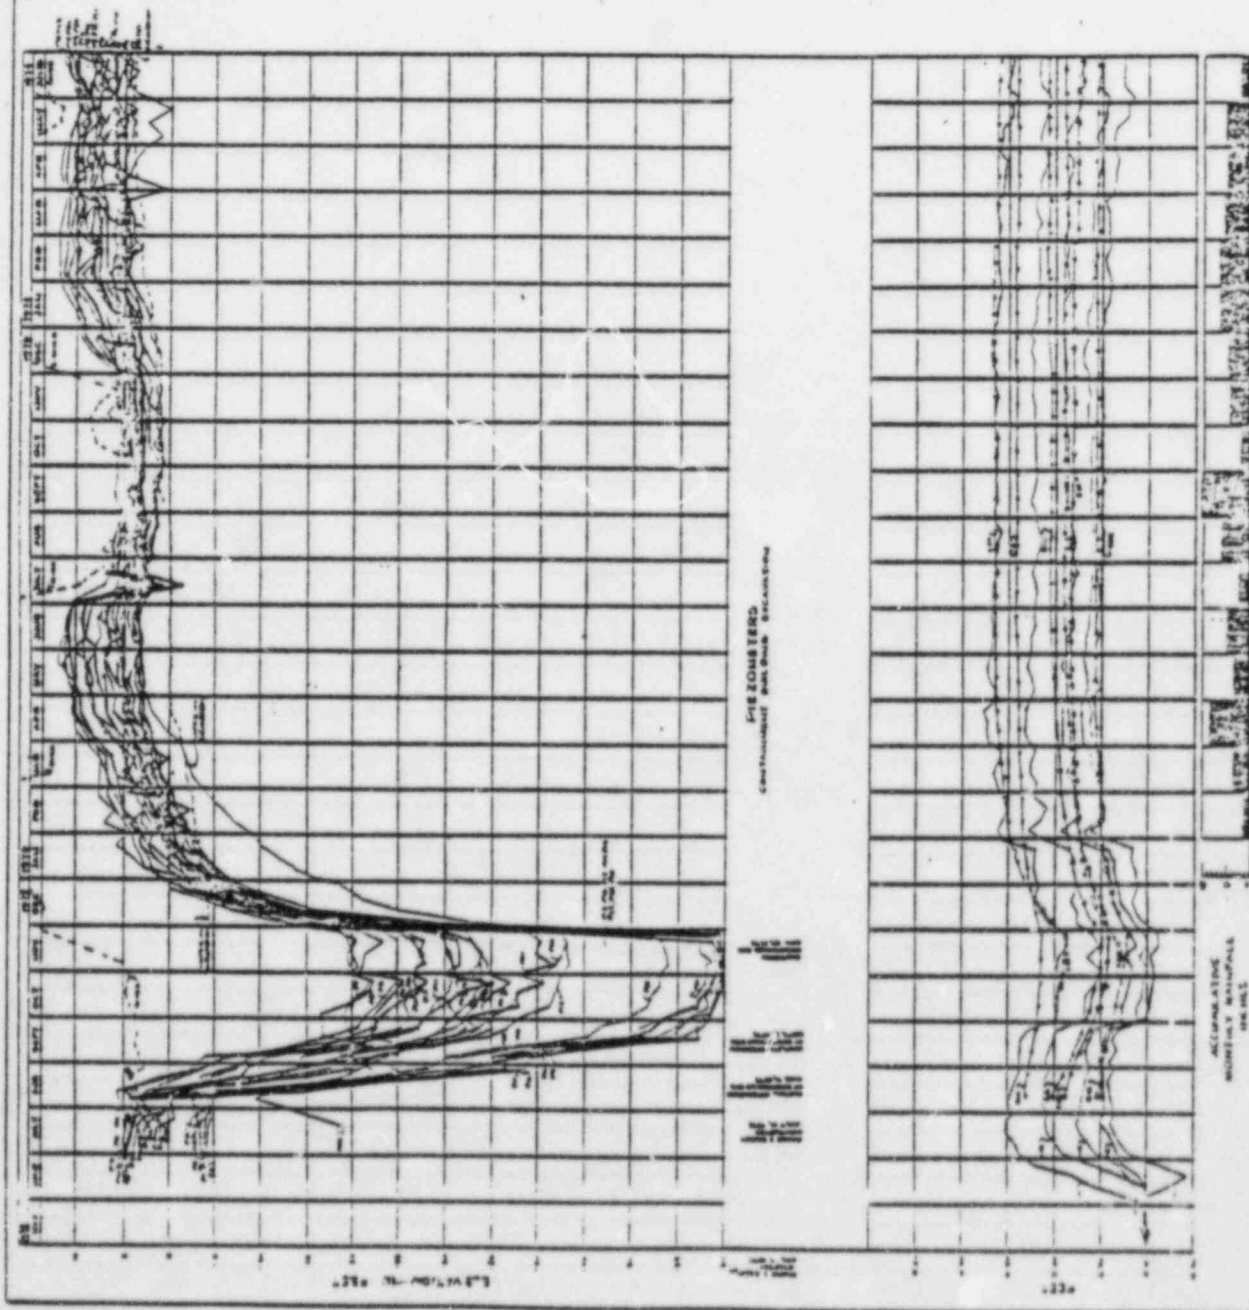
FIGURE 25 113

Groundwater control and foundation heave from the start of dewatering until recent time are exhibited in FSAR Fig. 2.5-113 (sheets 1/5 to 5/5).

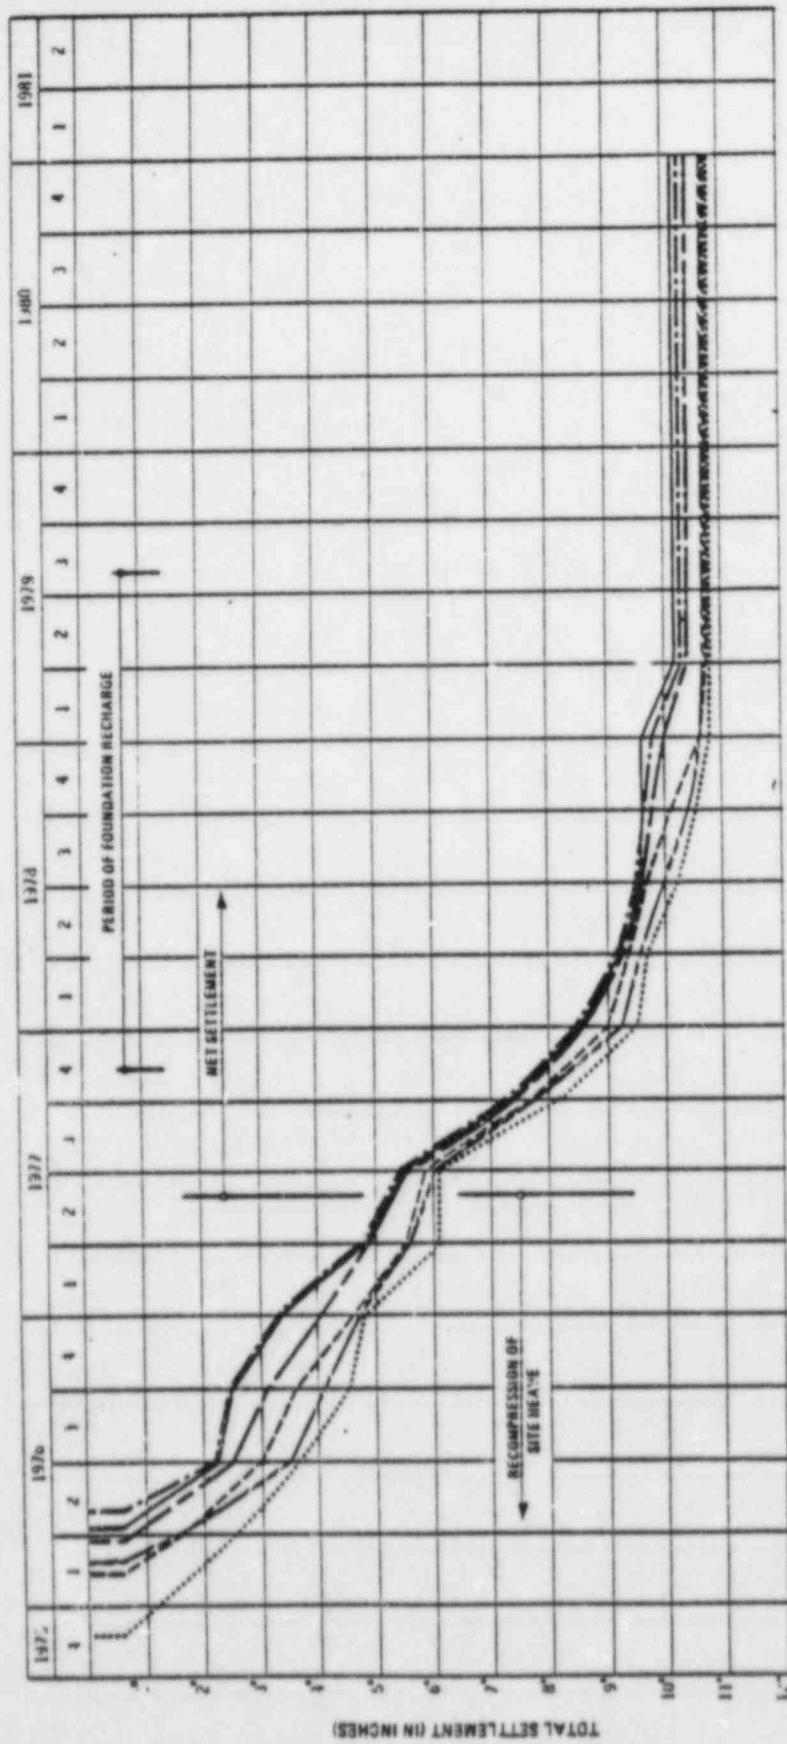
COMPOSITE FOUNDATION MAT

Backfilling and concrete construction was established through drawing no. LOU-1564-G-490, "General Nuclear Plant Island Structure Construction Sequence". This drawing provided the evaluation criteria for top of concrete as related to top of fill. Generally, construction was sequenced to place concrete (walls/floors, etc.) uniformly by constructing the buildings with minimal differentiation in loading. Consequently, backfilling operations followed suit and maintained a uniformity of placement as well.
