VERMONT YANKEE NUCLEAR POWER CORPORATION

LICENSEE EVENT REPORT (LER)

FACILITY NAME (1)
VERMONT YANKEE NUCLEAR POWER STATIONDOCKET NUMBER (2)
05000271PAGE (3)
1 OF 6

TITLE (4) NUMBER OF STACK RADIATION SAMPLING TRAINS LESS THAN REQUIRED BY TECHNICAL SPECIFICATIONS DUE TO POWER INTERRUPTION.

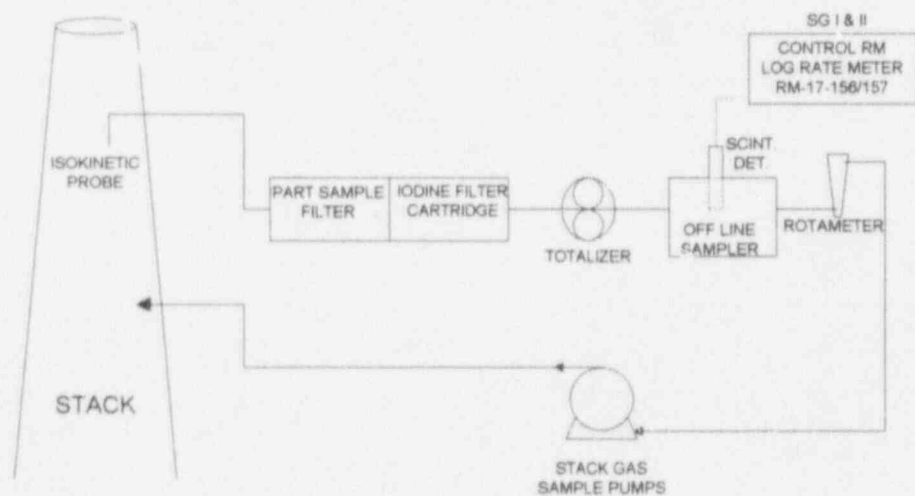
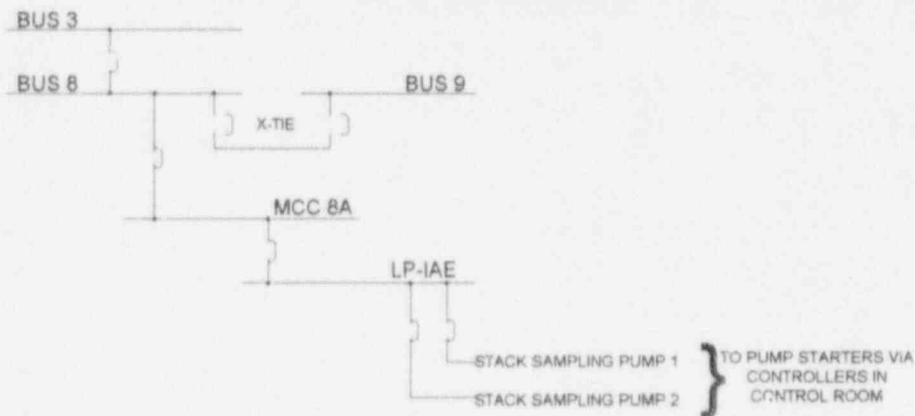
Figure 1, Simplified Overview

- 1) The control circuitry and power distribution is not designed with features consistent with the continuous operability requirements contained within the Technical Specifications. The control circuitry does not auto-start the pump following a loss of power and the two sampling loops are powered from the same source of power.
